# Technical Bulletin

# No.CGO-001

**SUBJECT:** Service Manual Correction

FAX5600L

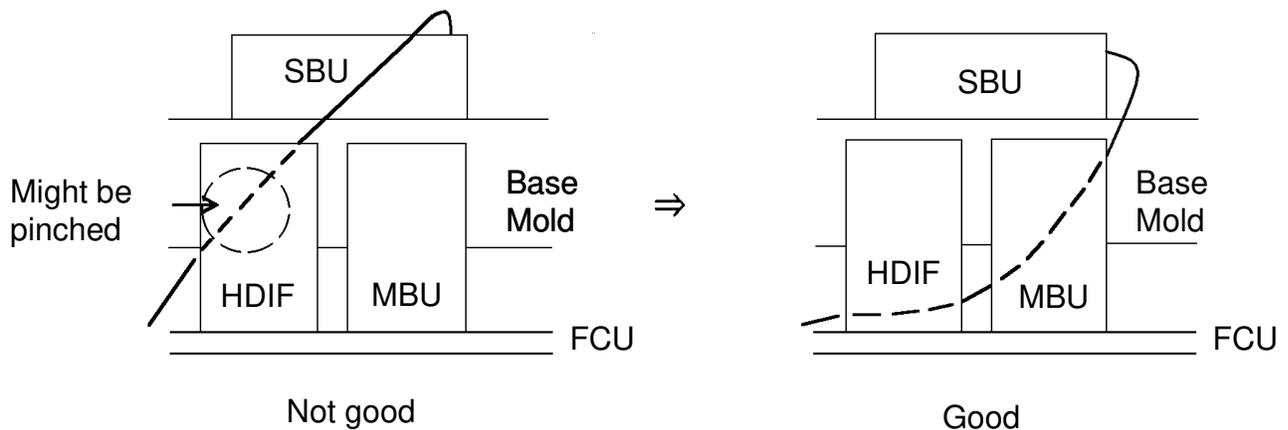
**Problem :** Damage to the SBU harness

Re-locate the SBU harness as follows after fixing the HD Interface Board or the Printer Interface Board :

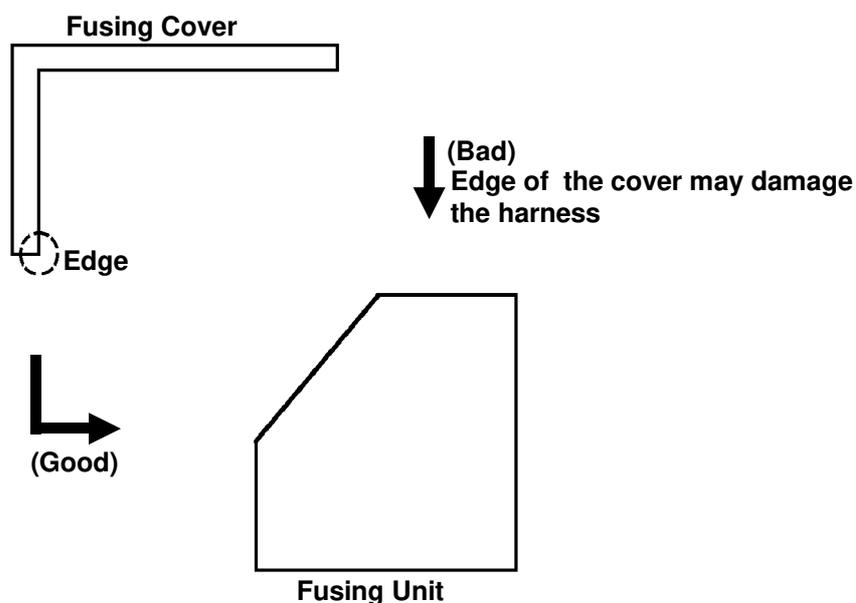
**If the metal wire of the harness contacts the thermistor bracket, a no power condition may occur. Please check the thermistor harness if this occurs.**

**(A): Please refer to the following instructions and fix the cover to the fusing unit and check that the harness is not pinched before installing the fusing unit in the machine.**
