Model: FR6 (FAX 3800L)		Date: 15-Feb-98	No: 001
Modified Article: FCE		Prepared by: Y.Okunishi	
From: QAC Field Information Dept.			
Reason for Modification:	<input type="checkbox"/> Parts catalog correction <input type="checkbox"/> Vendor change <input type="checkbox"/> To meet standards <input type="checkbox"/> To facilitate assembly <input checked="" type="checkbox"/> To improve reliability    (      ) <input type="checkbox"/> Part Standardization <input type="checkbox"/> Other		
Modification Schedule	December 1997.

Model: FX4,FX6,FX6MMK2,LSO,IFO,FLX7,FR4,LFO BR1		Date: 15-Sep-98	No: Multi - 012 <b>A</b>
Modified Article: NCU		Prepared by: Y.Okunishi	
From: QAC Field Information Dept.			
Reason for Modification:	<input type="checkbox"/> Parts catalog correction <input checked="" type="checkbox"/> Vendor change <input type="checkbox"/> To meet standards <input type="checkbox"/> To facilitate assembly <input type="checkbox"/> To improve reliability    (    ) <input type="checkbox"/> Part Standardization <input type="checkbox"/> Other		
Modification Schedule	Once the stock of the old part runs out.

Model: F/L Series, FR6 (F66), FR4 (F64)		Date: 31-Oct-98	No.: 201
Modified Article

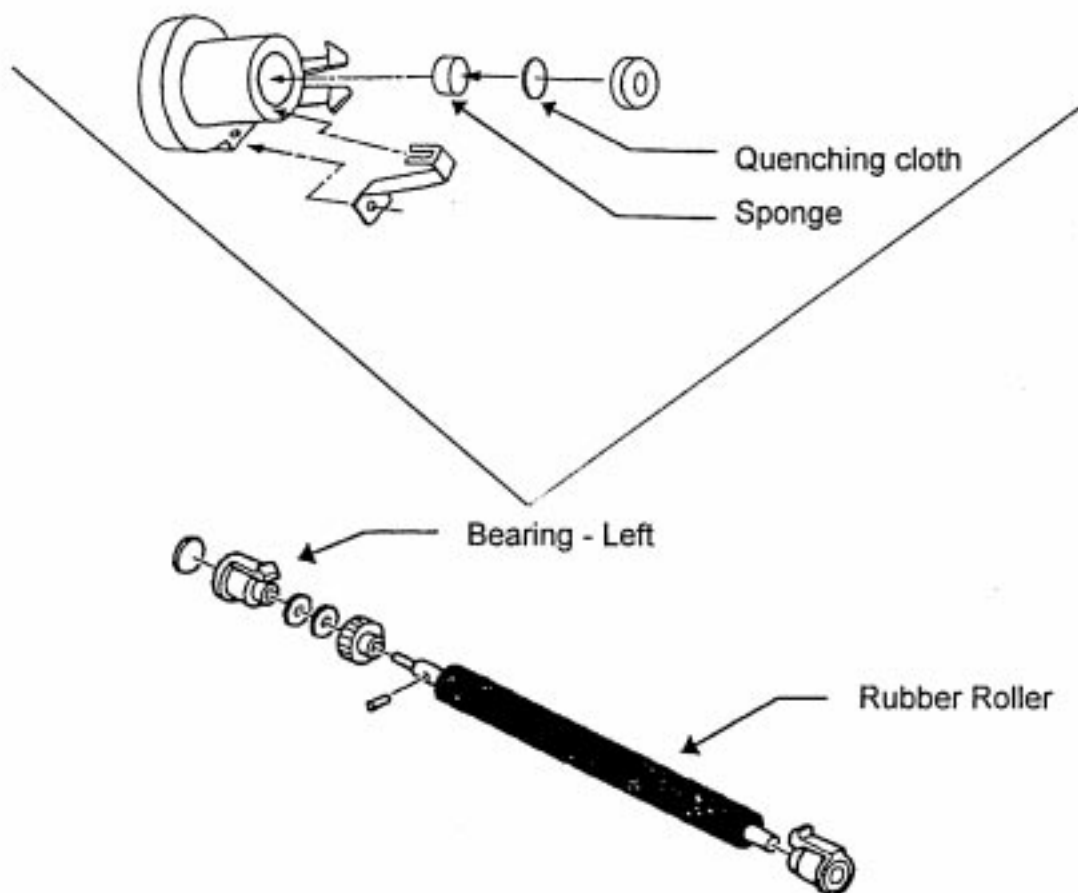
### 2) Bearing – Dvlp. Roller – Left

Small parts, which make better grounding, are added inside the bearing. See below. If the grounding is not completed, vertical black lines may occur on copies.
