RIGOH	Technical B	Bulletin	No.	F/L Series-001
SUBJECT: Introduction of the New	Tools for ROM/RAM [	Data Change		<b>DATE:</b> Apr. 30, 1995
PREPARED BY: Y. Okunishi CHECKED BY: M. Iwasa FROM: 2nd		d T.S. Section		
CLASSIFICATION:	_		MODE	L:
Action Required Revision of service manual		FX	(6, FX4, LSO	
Troubleshooting	Information only			
Retrofit Information	Other

**SUBJECT:** Introduction of the New Tools for ROM/RAM Data Change

## Technical Bulletin No. F/L series-005

SUBJECT: Paper size sense		<b>DATE:</b> Aug. 31, 1995		
PREPARED BY: T. Kimura CHECKED BY: M. Iwasa	l	FROM: 2nd	d T.S. S	ection
CLASSIFICATION:		L	MODE	L:
Action Required	Revision of servi	ice manual	M	V310 / FX6
Troubleshooting				
Retrofit Information	Other

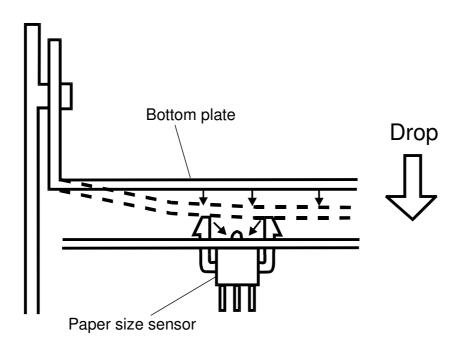
After installing the side cassette, it may be found that the paper size cannot be set properly in spite of setting the paper size indicator dial. If this problem occurs, the machine cannot detect any size other than LT/LEGAL.

In this case, it is assumed that the paper size sensor is out of position because of transportation damage.

If it is dropped from a height exceeding 80 cm, it is considered that the problem may occur because the bottom plate rebounds and presses down the paper size sensor.

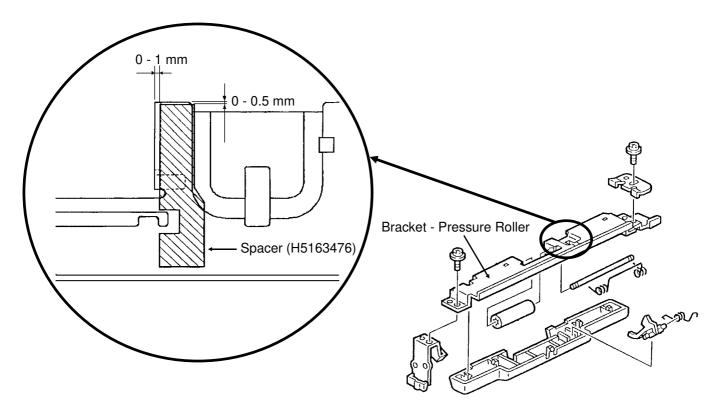
**Cause:** The Pressure Roller Bracket (FX6/FX6M2: Index no.17 on page 1-20 of the parts catalog, FX4: Index no.17 on page 1-28 of the parts catalog) of the paper cassette hits the Photointerruptor (Part no.AW020021, FX6/ FX6M2: Index no.34 on page 1-16, FX4: Index no.29 on page 1-24) for the bypass feed sensor and breaks it when the paper cassette is pushed back.

The machine detects the paper present signal from the broken sensor and tries to feed paper from the bypass tray instead of from the paper cassette even if there is no paper on the bypass tray.

This is the cause of the paper jam.

Change the broken photointerruptor and attach the plastic spacer (Part no. H5163476).

This spacer has been installed since November production in 1995.

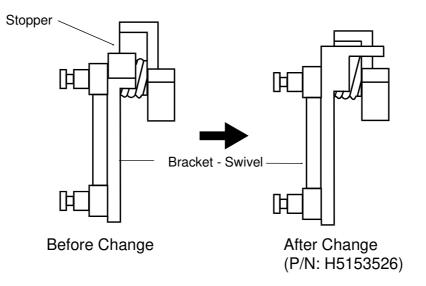
To prevent the stopper of the optional paper cassette from breaking , the shape of the Swivel Bracket was changed as shown below.

If you have this problem, please replace the part.

The part, Bracket-Swivel, is available as a service part.

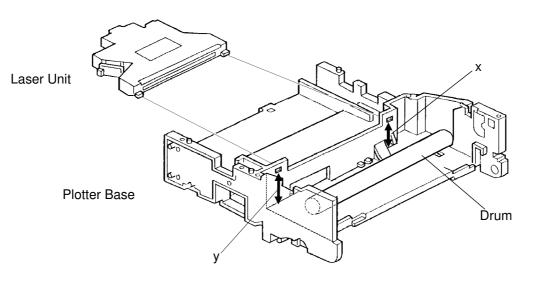
- Cause: The heights of the fixing holes for the laser unit are not even. x < y
  - So, the laser unit is not set parallel with the drum.

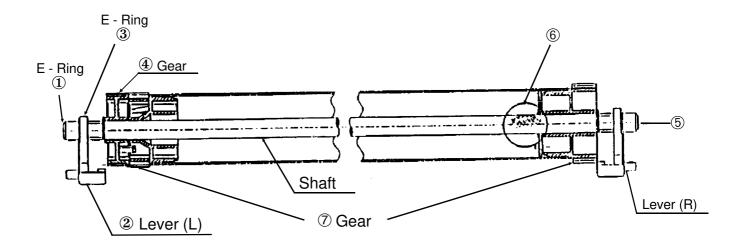
Cause : Evaporated material from the glue which is used to fix the gear (O) to the inside of the drum attaches to the drum shaft and creates a thin layer (O) on the shaft. It causes incomplete flow of charge from the drum to the ground through the shaft and causes white bands on copies.
