RIGOH	Technical B	Bulletin	No.	F/LX7 - 001
SUBJECT: ADF Mylar				<b>DATE:</b> 1996. 10. 30.
PREPARED BY: K. Misugi CHECKED BY: S. Fujii		FROM: 2nd	d Field Ir	nformation Group, QA Division
CLASSIFICATION:  Action Required Troubleshooting Retrofit Information	Revision of servi Information only Other			l FAX1700L 1765, SAVIN FAX 3650

Technical B	Bulletin	No.	F/LX7 - 003
SUBJECT: Print left margin from the optional paper	er feed unit		DATE: 15,Jan.1997
PREPARED BY: K.Moriizumi CHECKED BY: S.Fujii	FROM: Qu	ality Ass	surance Center
CLASSIFICATION:  Action Required Troubleshooting Retrofit Information  CLASSIFICATION: Revision of servi			I FAX 1700L 765,SAVIN FAX 3650

Model: F/X7			Date: 15-1	eb-97	No: 002	<b>1</b> /5
Subject: FX7 Sei	vice Manual Correction			Prepared	d by: K.Misugi	
From: 2nd field Ir	formation Group, QA Division			Checked	l by: S.Fujii	
Classification:	⊠Troubleshooting	⊠Pa	art informat	tion	Action required	
	☐Mechanical	□EI	lectrical		Service manual revision	n
	☐Paper path	□Tr	ransmit/rec	eive	Retrofit information	
	Other ( )

Model: F/LX7		Date: 28-	Feb-97	No: 004	1/1	
Subject: Scanner bottom margin			Prepared by: K.Moriizumi			
From: 2nd Technical Support Section

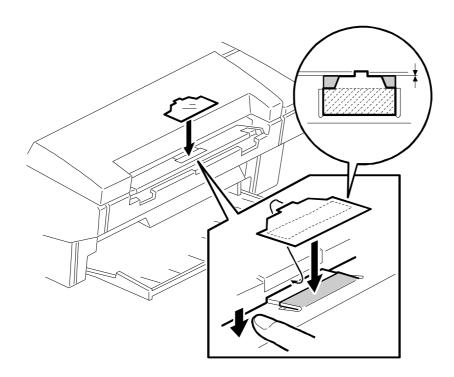
For customers who would like to use originals which contain silicone oil, place the mylar on the Document Separation Pad as shown in the diagram below.

The ADF mylar will be available as a service part.

Part Number: H528 9500

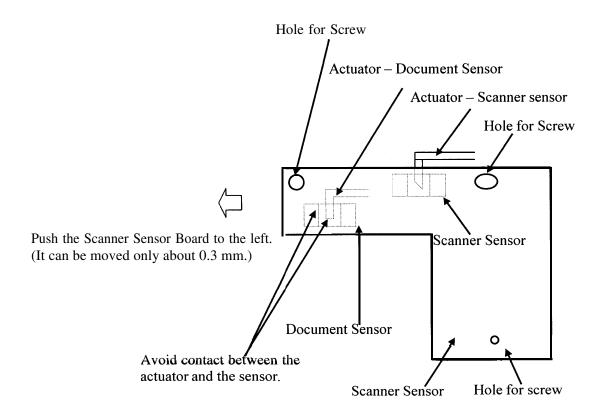
A document jam error occurs even though there are no documents in the ADF. This is because the Document Sensor is stuck.

The actuator of the document sensor touches the sensor unit on the Scanner Sensor Board.

From September, the scanner sensor board was shifted to the left during assembly, However, the board might be shifted due to vibration during transportation.

Temporary Countermeasure

- 1. Loosen the screws of the Scanner Sensor Board.
- 2. Push the Scanner Sensor Board to the left side.
- 3. Tighten the screws.

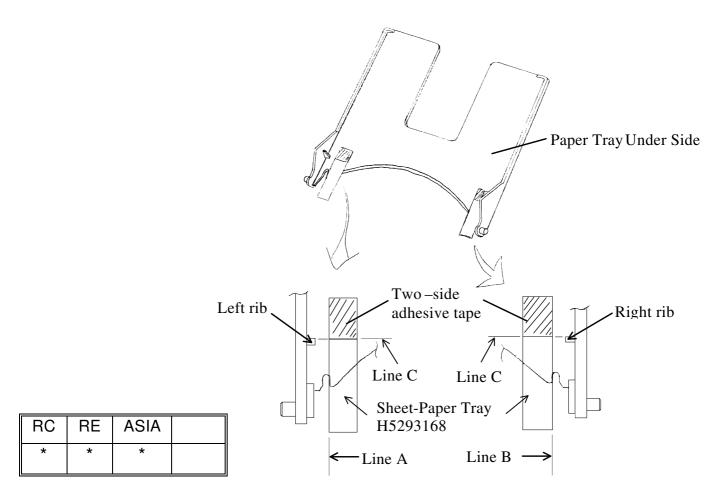
## **Sheet - Paper Tray Installation Procedure**

A paper jam occurs because the paper tray is in the wrong position.

Sheets have been added to the paper tray as a countermeasure to prevent the paper tray from being set in the wrong position. Please refer to the following installation procedure.

P/N: H5293168 (Sheet-Paper Tray)

- 1. Put two-sided adhesive tape on the underside of the paper tray near the hinges along the Line A and B and Line B and C as shown below.
- 2. Press down on the adhesive tape after application to remove any air bubbles.
