Model: FR6		Date: 31-Oct-97	No: 001	1/35
Subject: New Model FR6 Release			Prepared by: K. Misugi	
From: Technical Service Department			Checked by: S. Fujii	
Classification:	<input type="checkbox"/> Troubleshooting	<input type="checkbox"/> Part information	<input type="checkbox"/> Action required	
	<input type="checkbox"/> Mechanical	<input type="checkbox"/> Electrical	<input type="checkbox"/> Service manual revision	
	<input type="checkbox"/> Paper path	<input type="checkbox"/> Transmit/receive	<input type="checkbox"/> Retrofit information	
	<input checked="" type="checkbox"/> Other ( )

The new model FR6 (FAX3800L) has been released as a successor model to the FX6 (FAX2700L).

This technical bulletin contains information on differences between the FR6 and the FX6. They are listed in order of sections that appear in the service manual.

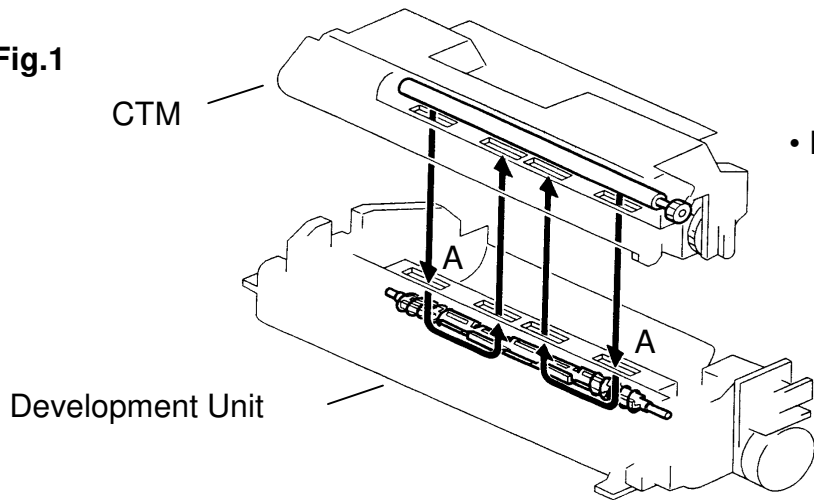
**Fig.1**

\*This modification prevents the Kattsumari problem (vertical gray bands on print outs) caused by blocked toner in the middle of the development unit. The blocked toner bends the toner metering blade. The toner enters the drum area through the gap made by the bent blade. Once in the drum area, the toner collects on the drum and causes the gray bands on the print out.

- Length of the toner entrance (A) becomes smaller. (30mm → 18mm)

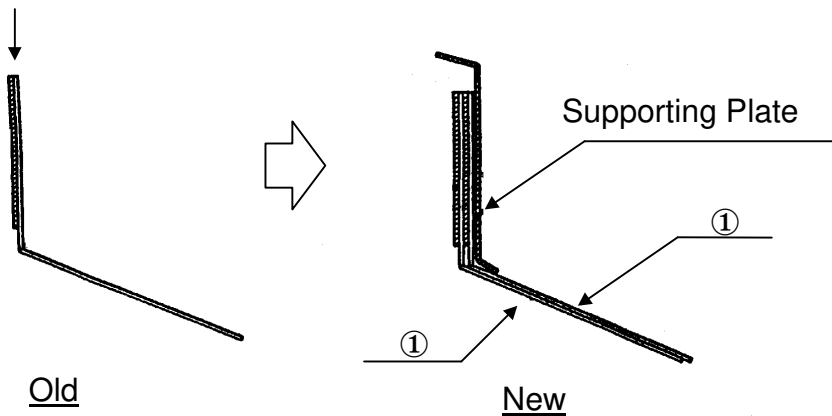
**Fig.3**

① Toner Hopper Film

- Two toner hopper films are stuck together.
- A supporting plate is attached to the toner hopper film.

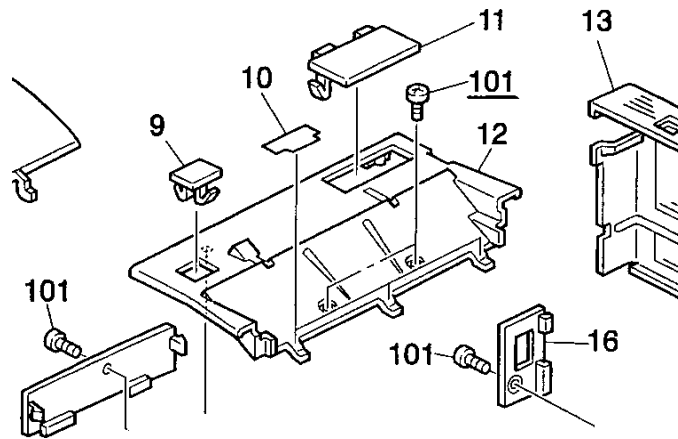
Two small seals have been attached to the Upper Rear Cover since April 2000 production. These seals must be peeled off when the screws are removed (Parts Catalog, Pg. 1-2, index 101).

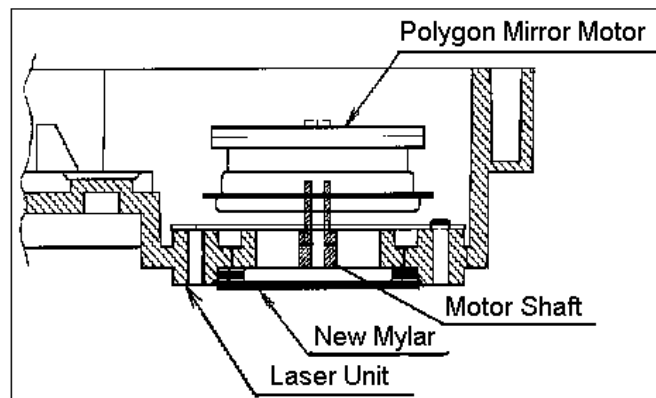
1. When installing for the first time, be sure to replace the new motor and Mylar **together as a set**.
2. The Polygon Mirror Motor itself has not been changed. The new P/N (H5529100) consists of the same motor plus the new Mylar.
3. This symptom does not occur with laser units used on other F/L series products (e.g. FX6/FX4/LSO/LFO), because the motor shaft and Mylar do not contact one another.

Replace with the modified Polygon Mirror Motor, which includes the modified Mylar.  
See MB MH551022 for details.
