**Technical Bulletin**  
**No. AF-001**Issued on  
January 16th, 1992**Subject:**  
**Pulse width setting****Model(s):** AF0/AF2FAX T.S. Section T.S. Department  
Assistant General Manager  
H. Motojima**Classification**

# Technical Bulletin No.AFO-002

**Technical Bulletin**  
**No.AFO-004**Issued on  
April 23rd, 1992**Subject:**  
**Modification of cutter unit****Model(s):** AFO/AF2FAX T.S. Section, T.S. Department  
Assistant General Manager**Classification**H. Motojima

**Subject: Modification of cutter unit**

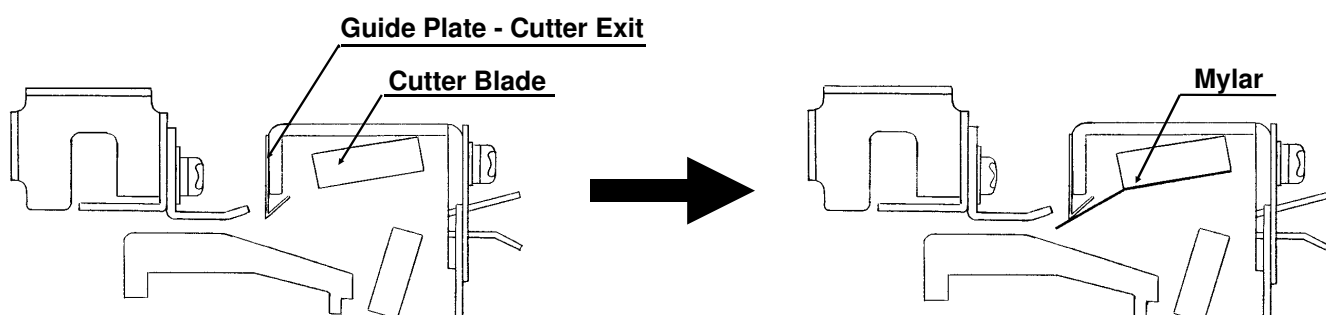
[Diagram A]

From the July, 1991 production, to prevent from paper jam at the cutter exit, a mylar has been attached to the cutter blade (Diagram A).

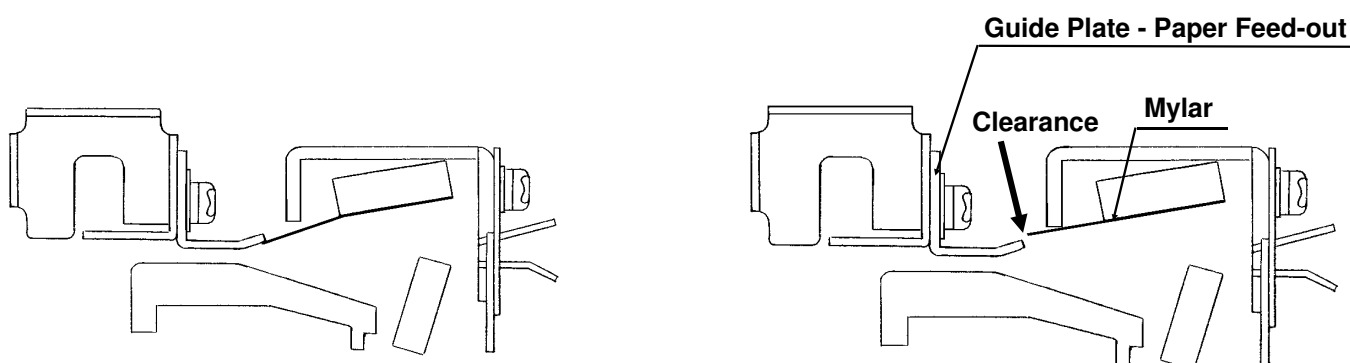
[Diagram B]

With this modification, the guide plate of the cutter exit was discontinued after the old cutter assembly was out of stock (Diagram B).

In some machines there might be a clearance between the guide plate for paper feed-out and the mylar (Diagram C).

Therefore, the printed page gets into the clearance and then a paper jam occurs.
