Model: IF2		Date: 15-Jul-97	No: 001
Subject: NCU Parameters		Prepared by: Y.Tamaoka	
From: QAC 2nd Field Information Dept.			
Classification:	<input type="checkbox"/> Troubleshooting	<input type="checkbox"/> Part information	<input type="checkbox"/> Action required
	<input type="checkbox"/> Mechanical	<input type="checkbox"/> Electrical	<input checked="" type="checkbox"/> Service manual revision
	<input type="checkbox"/> Paper path	<input type="checkbox"/> Transmit/receive	<input type="checkbox"/> Retrofit information
	<input type="checkbox"/> Other ()

Model: IF2		Date: 15-Jul-97	No: 002
Subject: NCU OH Relay Control		Prepared by: Y.Tamaoka	
From: QAC 2nd Field Information Dept.			
Classification:	<input type="checkbox"/> Troubleshooting	<input type="checkbox"/> Part information	<input type="checkbox"/> Action required
	<input type="checkbox"/> Mechanical	<input type="checkbox"/> Electrical	<input checked="" type="checkbox"/> Service manual revision
	<input type="checkbox"/> Paper path	<input type="checkbox"/> Transmit/receive	<input type="checkbox"/> Retrofit information
	<input checked="" type="checkbox"/> Other (Explanation)

Model: IF2		Date: 15-Dec-97	No: 006A
Subject: TAD mo

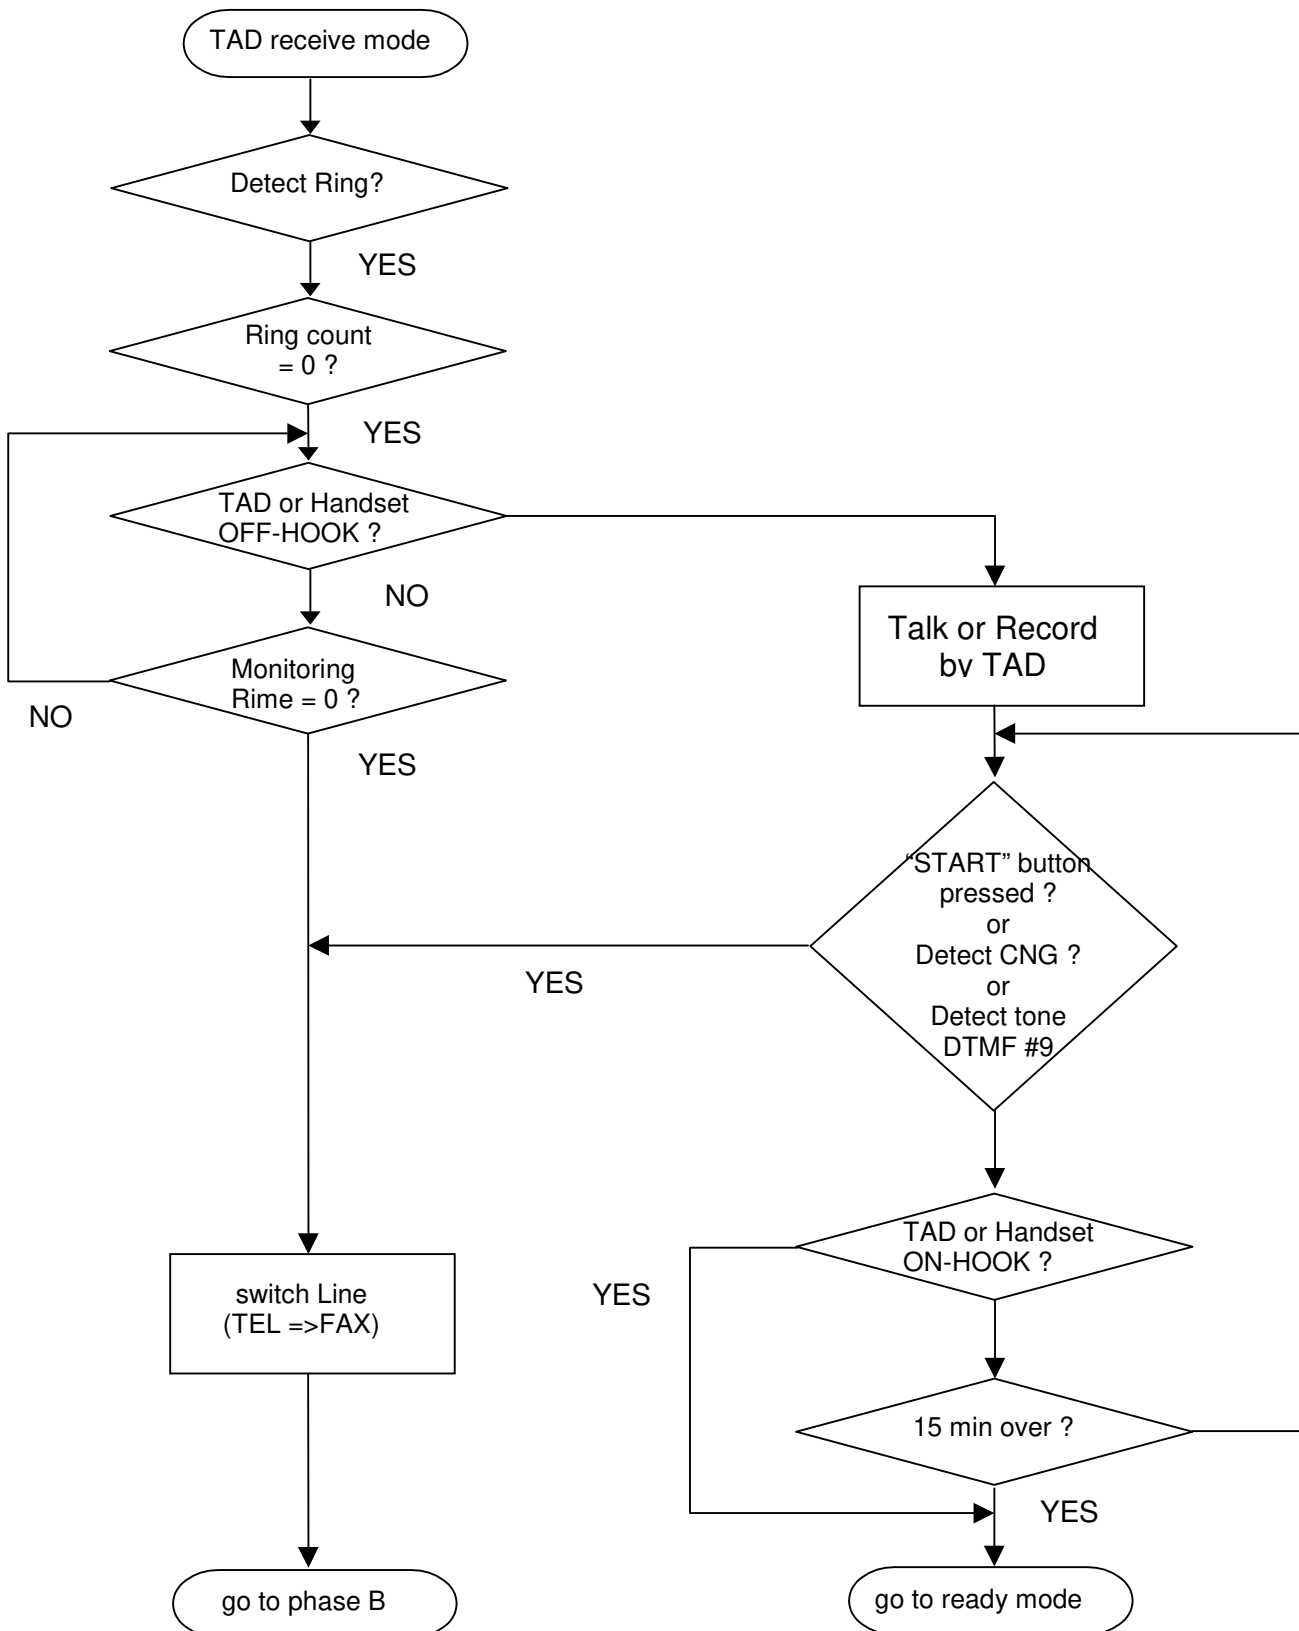
However, the FAX680MP does not monitor the telephone line with the above setting. The TAD detects the ring and closes the telephone line earlier than the FAX680MP. Then FAX680MP cannot detect the ring.

CAUSE

The FAX680MP TAD interface is different from the other fax models. Please refer to the following chart.

The TAD ring count of the FAX680MP must be ***always be set to one ring.***

---> FAX 680MP TAD ring count=1

Also, the monitoring time must be longer than the answering ring time of the telephone answering device. However, if the monitoring time is longer than the T1 timer of the transmission fax terminal, the FAX680MP cannot receive the fax message.

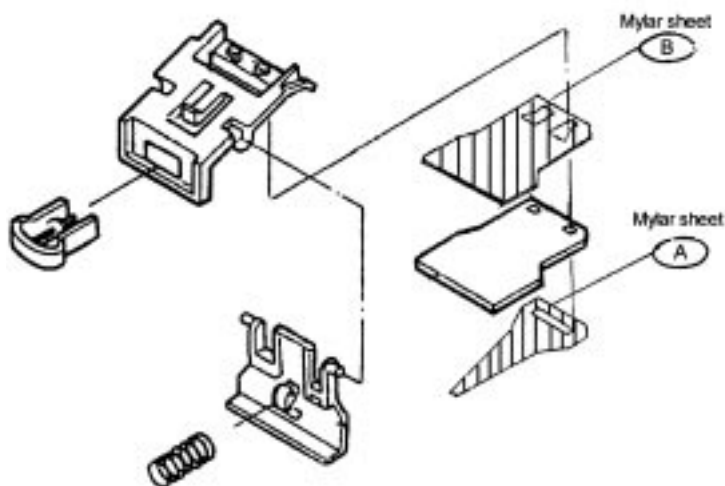
Originals not fed to the scan line leading to an error indication.

The force to feed documents decreases after a few months operation because of dust and oil from originals, depending on the types of originals used by the customer.

Add two Mylar sheets (H9059800) to the ADF holder ass'y as shown in the drawing below.
