Model : FAX 77/80/85/84
i-6212/6213/6215
Nashua 1040/1045
SAVINFAX 301/331
AT&T 9020FX/9022FX

RTB No. C-017

Subject: Changing the software

Subject: RX MOTOR

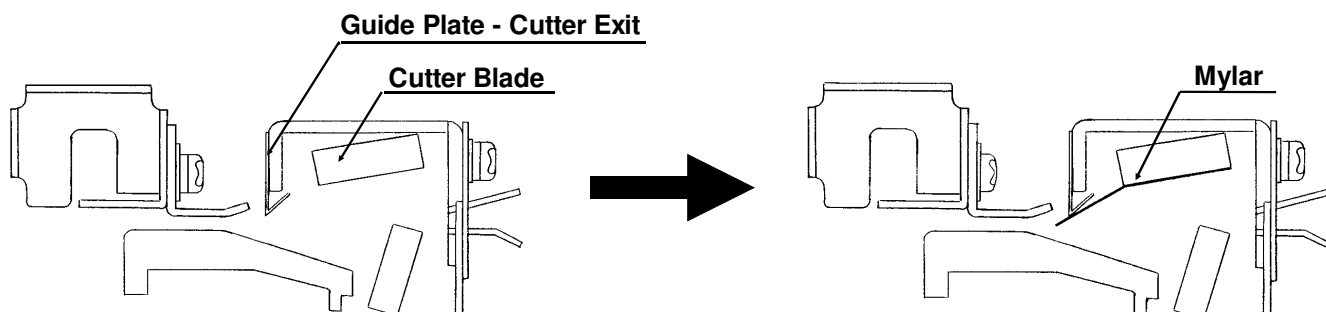
[Diagram A]

From the July, 1991 production, to prevent from paper jam at the cutter exit, a mylar has been attached to the cutter blade (Diagram A).

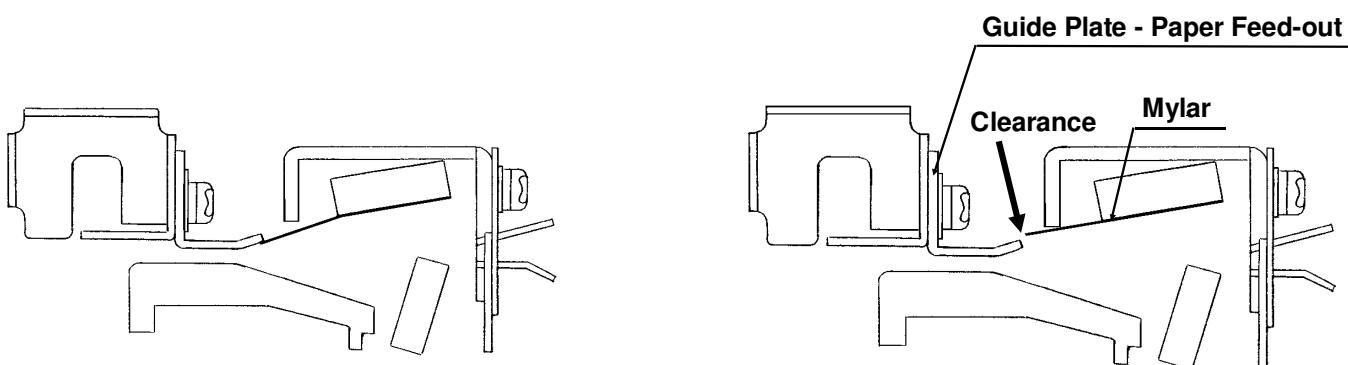
[Diagram B]

With this modification, the guide plate of the cutter exit was discontinued after the old cutter assembly was out of stock (Diagram B).

In some machines there might be a clearance between the guide plate for paper feed-out and the mylar (Diagram C).

Therefore, the printed page gets into the clearance and then a paper jam occurs.
