Technical Bulletin No. IXO-001

SUBJECT: Service Manual Correction	DATE: June 14th, 1993
---	---------------------------------

RICOH**Technical Bulletin No. IXO-002****SUBJECT:** The printer cover may not be closed.**DATE:**
July 14th, 1993

**Technical Bulletin****No. IXO-003****SUBJECT:** Adjusting the clock after disconnecting the FCE**DATE:**

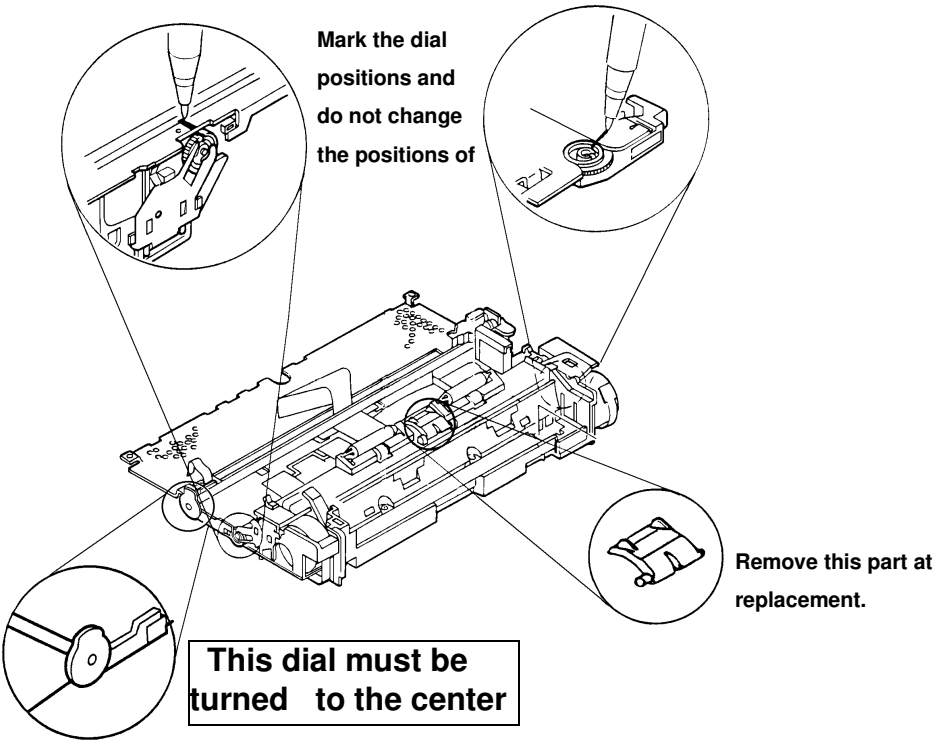
2. Section 5.3.2. (Page 5-5-a)

As from mass production the head gap adjustment dial will be changed to the center.

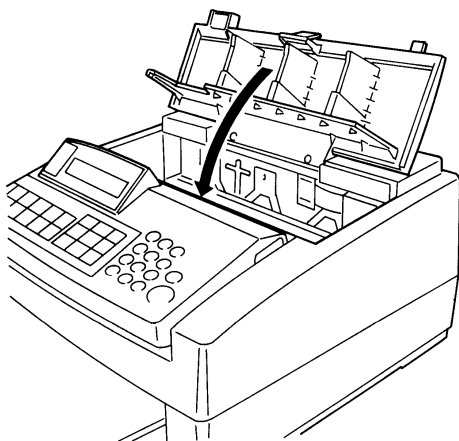
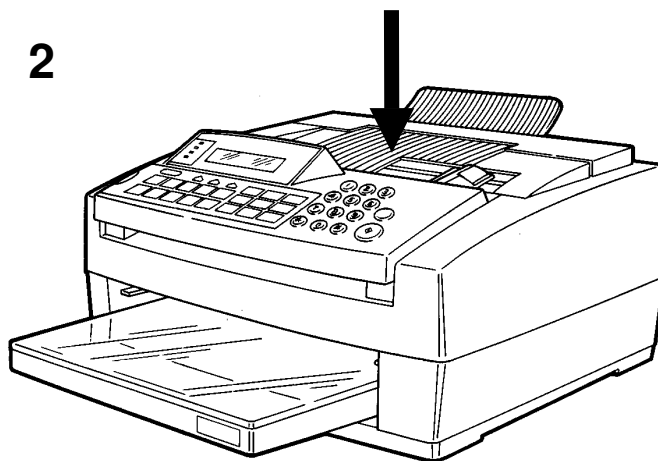
The printer cover may not be closed by pushing both eadges of the cover.
"CLOSE COVER" is displayed on the LCD continuously.

If you receive a complaint concerning this matter, please advise your customers to push the center when closing the cover.

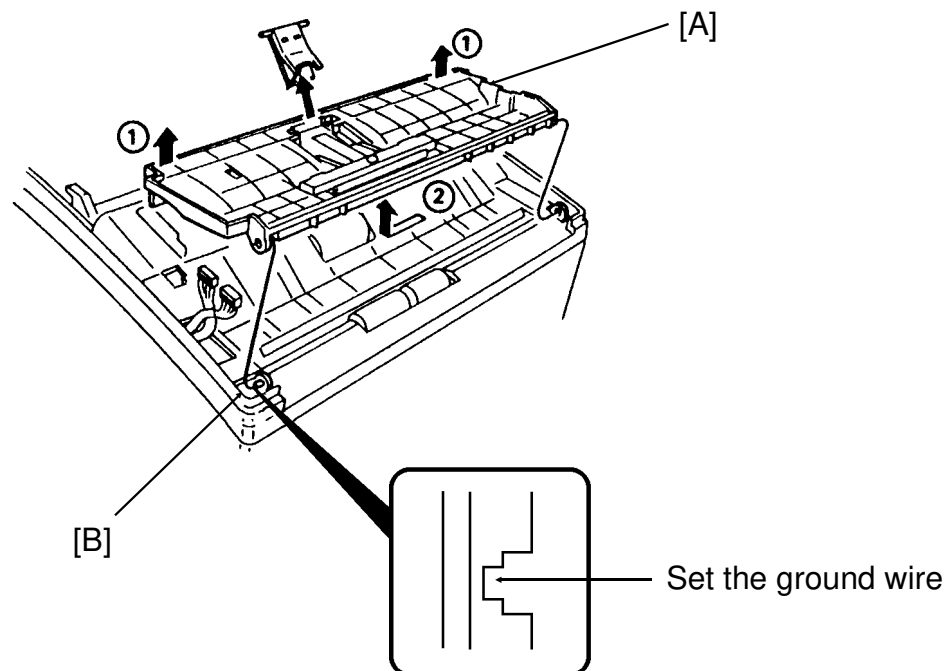
When removing the white pressure plate [A] of the operation panel assembly, set the ground wire into the recess in the upper cover and then slide out the white pressure plate. Otherwise, the scanner base pin [B] may be broken.

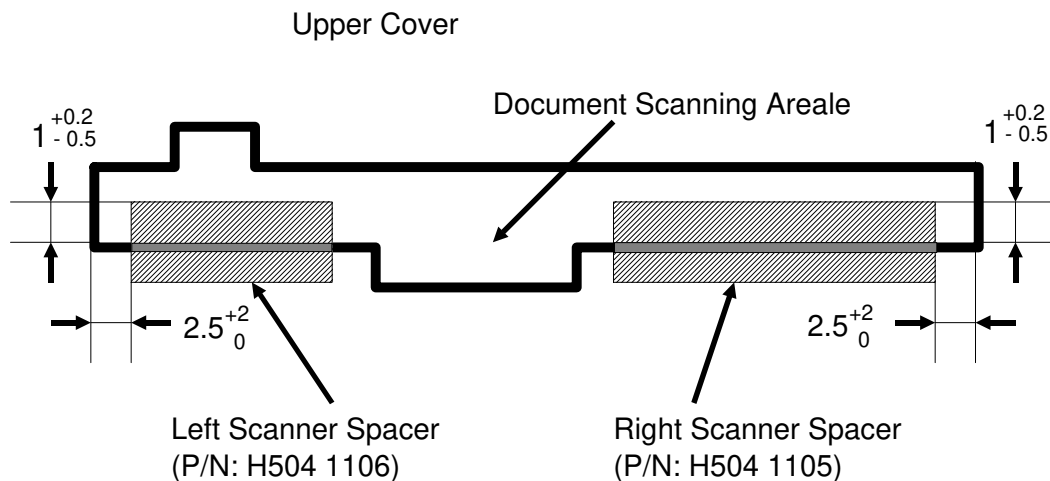
1. Attach the two scanner spacers to the upper cover as shown below.

2. Ensure that the distance between the spacers and the pressure plate is more than 0.2mm by using a thickness gauge.

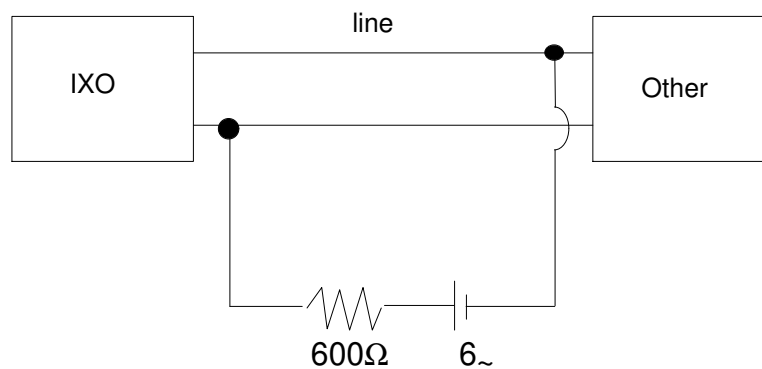
Photocouplers are used instead of mechanical relays on the NCU for IXO.

When you test back to back communication using IXO, pass current on the line as follows.

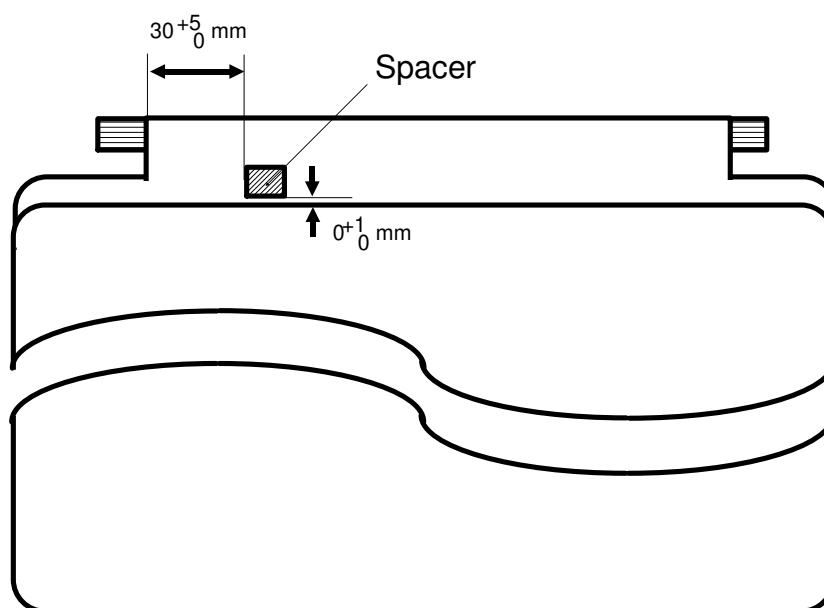
Cassette Cover

Cause : The edge of the paper reaches the feed roller if the paper is inserted far enough into the machine.

Countermeasure : A spacer has been attached to the cassette cover from March production so that the paper does not reach the roller.

Action in the field : Attach the spacer (P/N:H5044126) to the following position on the cover.

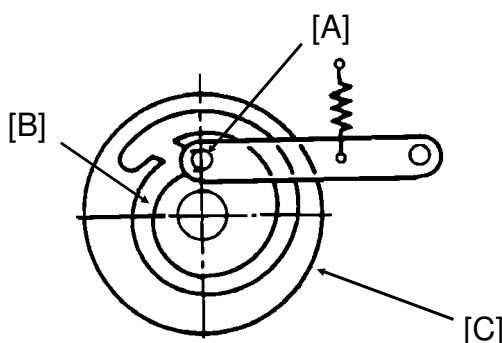
Symptom: The machine may feed a sheet of paper from the cassette immediately every time the cassette is installed.

Cause: The lever [A] of a certain lot is defective. The pin of the lever comes off the notch [B] of the paper feed cam [C] and the feed roller does not stop at the home position .

A spacer has been attached to the inside of the cover on the production line for the applicable lots so that the lever does not come off.

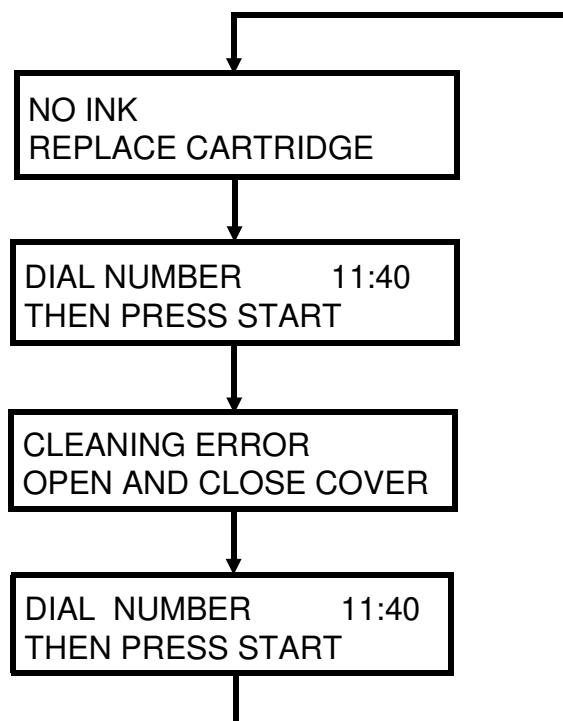
If not enough ink is supplied from the new cartridge to the printer head, the machine does not print anything, but displays an error message on the LCD.

According to this modification, the display on the LCD has been changed during ink end detection as follows.

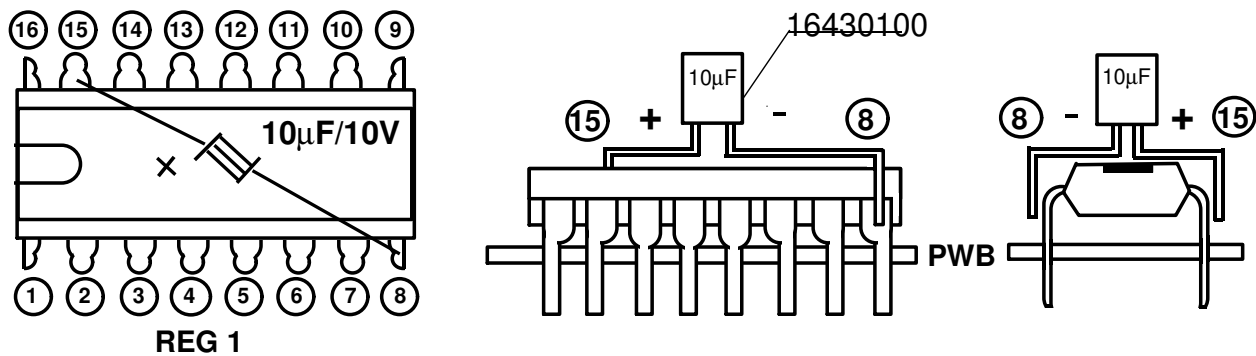
Cause: The 24V supply from the DC/DC converter on the FDU to the printer unit stops when the voltage of the main power drops to about 50% for more than 440ms. If the power loss is more/less than or of a shorter duration than the above, 24V is supplied properly after the power is back to normal.

Countermeasure:
Put a capacitor (10μf, 10V) between pin #8 and #15 of the IC REG1 on the FDU.
