RIGOH	Technical B	ulletin	No.	IFO-001
SUBJECT: Dial Tone Detection	on in the Netherland	ls		<b>DATE:</b> Feb. 29, 1996
PREPARED BY: K. Ugaeri CHECKED BY: M. Iwasa		FROM: Qua	ality Ass	urance Center
CLASSIFICATION:  Action Required Troubleshooting Retrofit Information	Revision of servi Information only Other	ce manual	MODE IF	
<b>NL</b> only

SUBJECT: Gear 3 of Paper Tray Came out			<b>DATE:</b> MAR.15.1996
PREPARED BY: K,Ugaeri CHECKED BY: M. Iwasa	FROM: QA	Center	
CLASSIFICATION:		MODE	L:
<ul><li>■ Action Required</li><li>□ Troubleshooting</li><li>□ Retrofit Information</li><li>□ Other</li></ul>		IF	0

RIGOH	Technical E	Bulletin	No.	IFO - 006
SUBJECT: Gear 3 of Paper	Tray (2)			DATE: Sep. 15, 1996
PREPARED BY: K.Ugaeri CHECKED BY: S.Fujii		FROM: Qu	ality Ass	urance Center
CLASSIFICATION:			MODE	L:
Action Required	Revision of servi	ce manual	IF	0
Troubleshooting	Information only			
Retrofit Information	Other

Technical Bulletin	No.	IFO - 007
SUBJECT: "Unable Use Print	er" (Error Codes 5-51,54,55,a	nd 5F)	DATE: REVISED Sep.30,1996
PREPARED BY: K.Ugaeri CHECKED BY: S.Fujii	FROM: Qu	ality Ass	surance Center
CLASSIFICATION:	·	MODE	L:

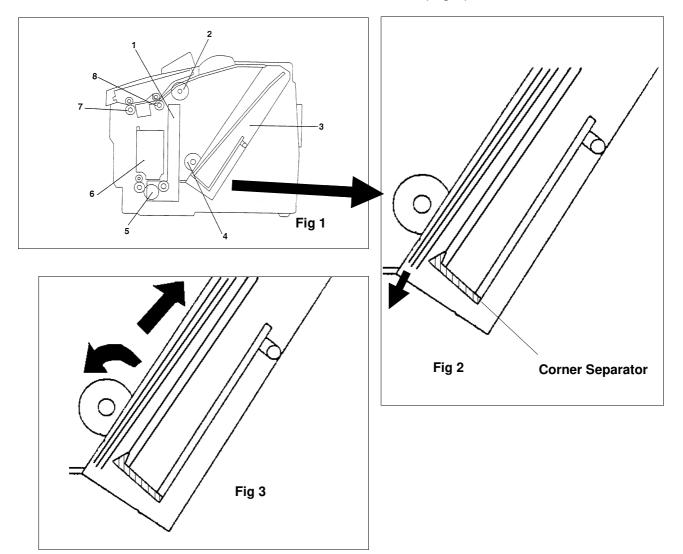
Symptom: Paper non-feed

Cause: This is caused by operator mistakes.

If the paper is added in the paper tray without pulling up

the release lever, the paper will be set over the corner separator.

This causes the paper to be multifed and jammed. (Fig 2)

If the operator removes the jammed paper from the paper tray without pulling up the release lever, the feed roller will be turned in the reverse

direction and Gear3 and/or Gear2 will come out. (Fig 3)

#### Temporary countermeasure:

The caution decal will be added beside the release lever. (refer to Fig 4.)

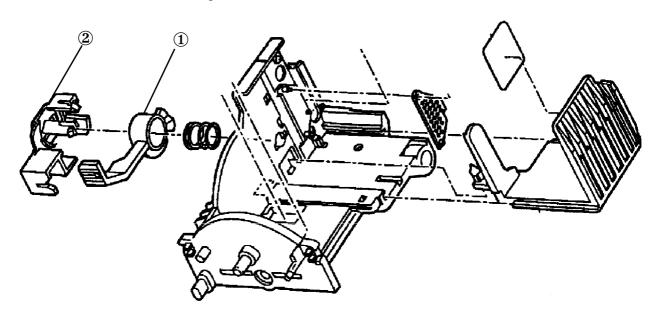
\* When the operator opens the ADF from the rear side, the hook of the operation panel cover may be broken.

2.Release Lever Kit for the TIJ unit.

H505 2519 Release Lever Kit - TIJ

- \* This kit consists of a Release Lever ① and a cover for the release lever ②.
- \* The cover must be changed with the release lever because it must be broken when the lever is changed.

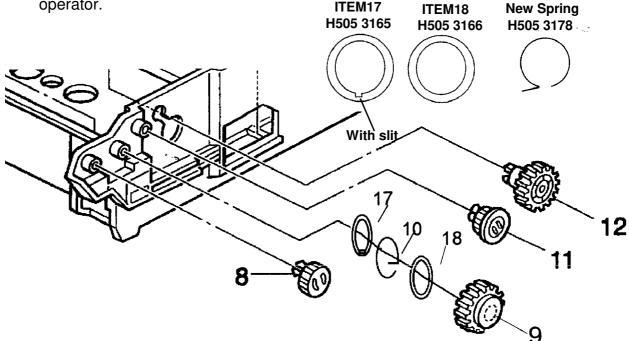
ITEM17 ITEM18 New Spring

Sympton: Paper non - feed. (Unable to Use Printer Display)

Cause: When the feed roller turns in reverse, a spring holds the shaft and presses against Gear2, then Gear3 and/or Gear2 are removed because of too much spring torque.

Permanent Countermeasure: A spiring has been changed and 2 collars have been added to Gear2. The new spring has less torque than the old one. New, Gear2 turns free even if the feed roller turns in reverse.

Action: When the machine has this problem, replace the spring and add the 2 collars.

If the machine does not have a a caution decal, place it and explain the caution to the operator.

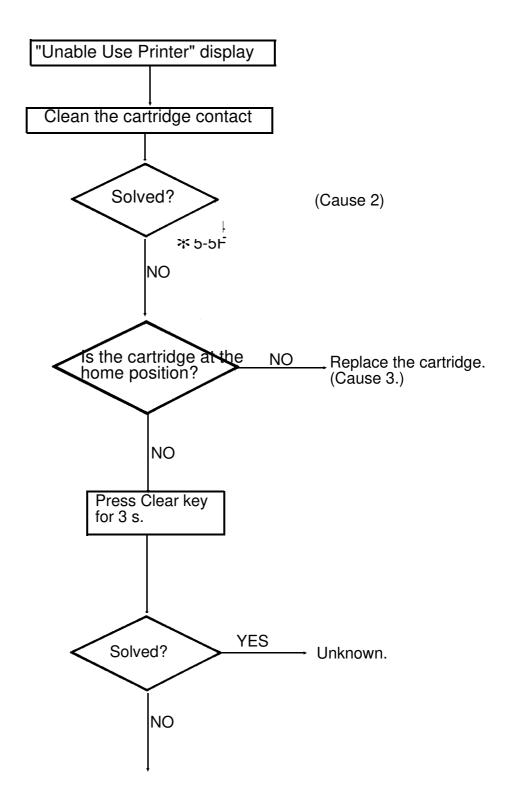
**Checking Procedure**

cause 5: Ram check error when initializing. (Error code5-55)

Unknown

<Action> : Switch off and on.

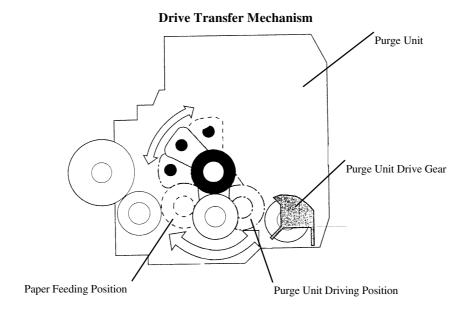
A blank page is fed out just before the start of printing.

This is especially likely to occur in the first printing run after a long time on standby (e.g. first print in the morning).

Ink is unexpectedly stuck to the drive transfer gear.

Impure ink is not absorbed into the absorber sheet and remains on the surface.

The absorber became full and the ink ended up sticking on the gear.

- 1.Replace the Ink absorber sheet and Ink absorbers (Do not forget to initialize the TIJ counter)
- 2.Clean the drive transfer gear.
- 3.Instruct the customer not to use impure ink.
