Model: S-P2 Duplex unit		Date: 22-Feb-10	No.: RG893001
Subject: Duplex jam		Prepared by: Y. Murata	
From: 2nd Overseas Tech. Support Sec., 2nd PQM Dept.			
Classification:	<input checked="" type="checkbox"/> Troubleshooting <input type="checkbox"/> Mechanical <input checked="" type="checkbox"/> Paper path <input type="checkbox"/> Other ()	<input checked="" type="checkbox"/> Part information <input type="checkbox"/> Electrical <input type="checkbox"/> Transmit/receive	<input type="checkbox"/> Action required <input type="checkbox"/> Service manual revision <input type="checkbox"/> Retrofit information <input checked="" type="checkbox"/> Tier2

Model: S-P1/P2		Date: 10-Dec-15	No.: RG893002
Subject: Parts Catalog Correction – Front and Rear Side Plate p/n		Prepared by: R.Tsurumi	
From: 1st Tech. Support Sec. Service Support Dept.			
Classification:	<input type="checkbox"/> Troubleshooting <input checked="" type="checkbox"/> Part information <input type="checkbox"/> Action required <input type="checkbox"/> Mechanical <input type="checkbox"/> Electrical <input type="checkbox"/> Service manual revision <input type="checkbox"/> Paper path <input type="checkbox"/> Transmit/receive <input t

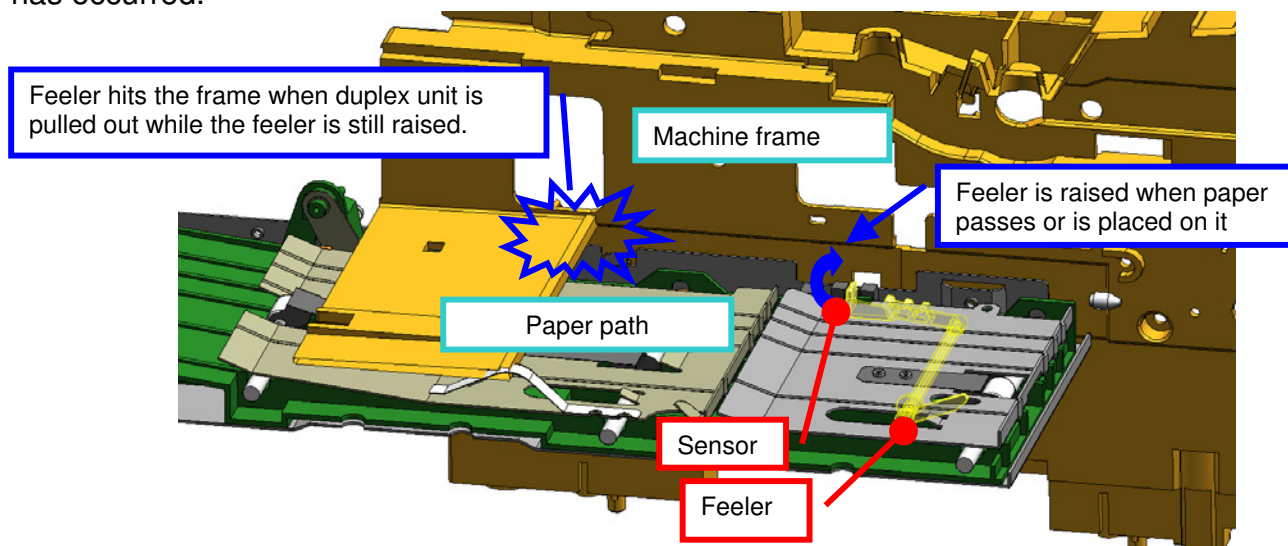
After jammed paper is removed following a misfeed, the “Remove Misfeed Duplex Unit” display does not clear.

The sensor feeler sometimes contacts the inside of the machine frame, damaging the feeler. This can happen if the operator lifts up the unit while pulling it out, or if a Z-fold jam has occurred.
