SUBJECT: Operation Procedures for the transmission of fax messages while making memory copies.

MODEL:

AD-1

SUBJECT: ROM History (AD1-FAX option)

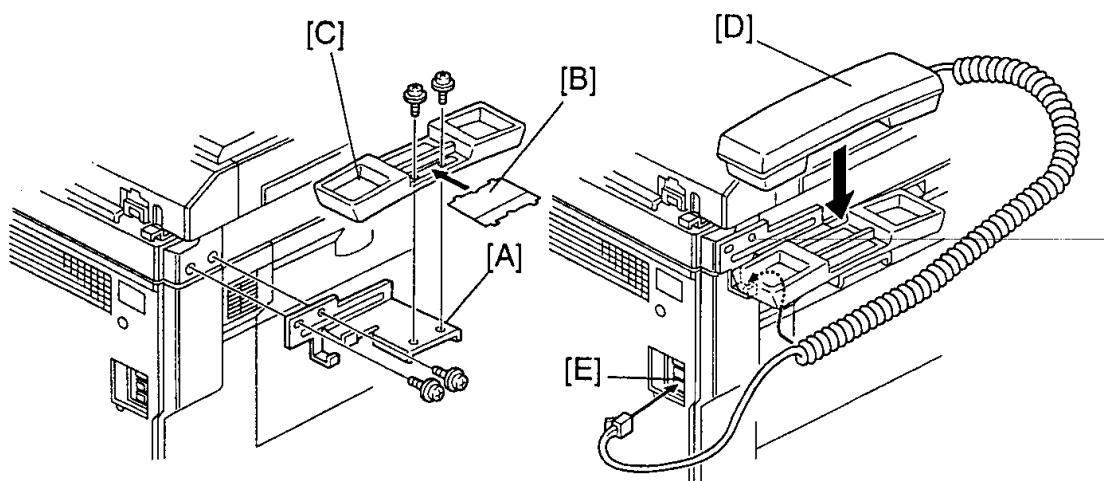
4.HANDSET

In some countries, the optional handset is available for the Aficio 200.

To install the optional handset, use the bracket which is included in the Fax Unit Option, Type 250. Also, correct the installation procedure in the Service Manual on page 3-12 as follows.

1. Install the bracket [A] (2 screws), as shown.

* The bracket [A] in the carton box of the Fax Unit Option Type 250 must be used.

2. Remove the label [B] from the handset cradle [C]. Install the cradle on the bracket [A] (2 screws), then replace the label [B].

3. Install the handset [D] as shown. Connect the handset cord to the " TEL " jack [E] on the machine.
