Model: AD1-E (Printer Controller)		Date: 30-Jun-97	No: 33
Subject: AD1-E Printer Controller Launching		Prepared by: A.Nakajima	
From: QAC 2nd Field Information Dept.			
Classification:	<input type="checkbox"/> Troubleshooting	<input type="checkbox"/> Part information	<input type="checkbox"/> Action required
	<input type="checkbox"/> Mechanical	<input type="checkbox"/> Electrical	<input type="checkbox"/> Service manual revision
	<input type="checkbox"/> Paper path	<input type="checkbox"/> Transmit/receive	<input type="checkbox"/> Retrofit information
	<input checked="" type="checkbox"/> Other (Launching Information)

Model: AD1-Printer Type 250		Date: 23-Jul-97	No: 35B
Subject: Firmware and Software History		Prepared by: K.Ugaeri	
From: QAC Field Information Dept.			
Classification:	<input type="checkbox"/> Troubleshooting <input type="checkbox"/> Part information <input type="checkbox"/> Action required <input type="checkbox"/> Mechanical <input type="checkbox"/> Electrical <input type="checkbox"/> Service manual revision <input type="checkbox"/> Paper path <input type="checkbox"/> Transmit/receive <input checked="" type="checkbox"/> Retrofit information <input type="checkbox"/> Ot

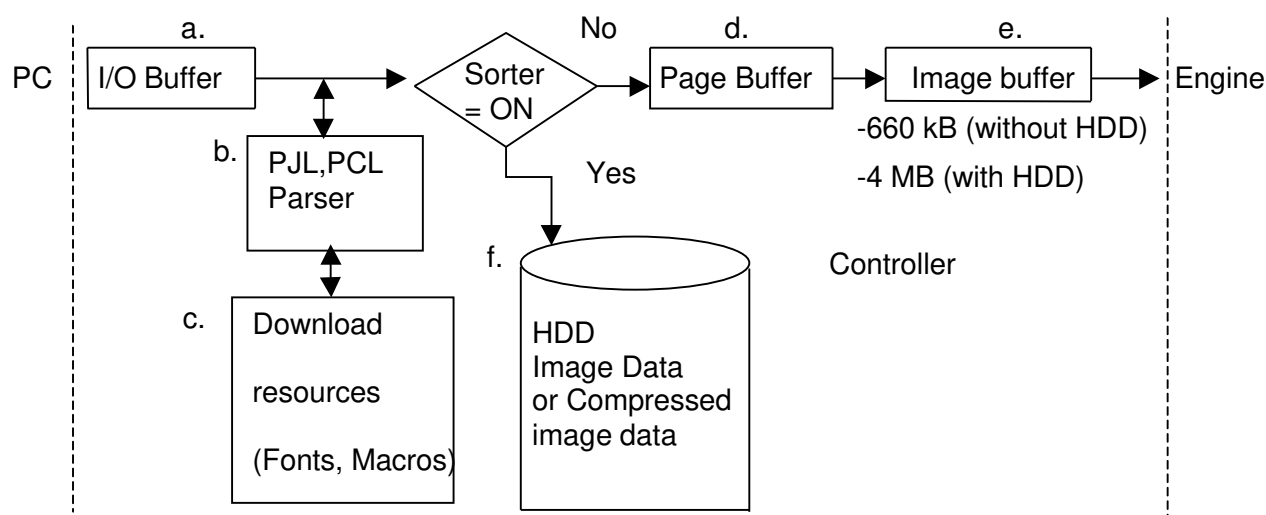
### 1. Data flow in the controller unit

a. I/O Buffer for receiving and sending data.

b. Stores the operation language software (such as PCL and PjL).

c. Manages downloaded resources (such as Fonts and Macros).

d. Holds and processes data from incoming print jobs.

e. Image video buffer for sending video data to the engine to print.

f. \*When the HDD is installed, it is used only for the sorting function.

If the sorting function is selected, the data is stored in the HDD.

\*With HDD, the SIMM memory must be more than 4MB from Ver.1.21 firmware.

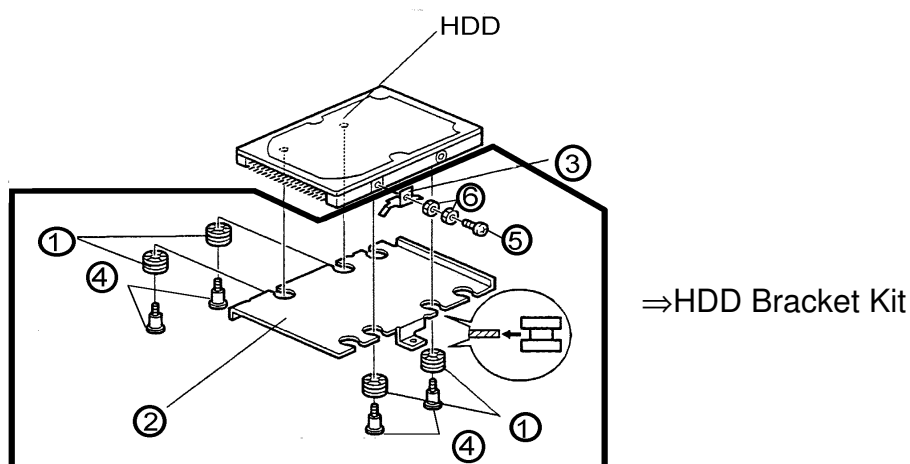
The HDD bracket has been modified for the print-overflow problem caused by vibration from the duplex unit (refer to RTB37). These new brackets have been available from June production in 1997 (the cut-in serial number is A7327060001-)

If you have the print overrun problem on an AD1 with a duplex unit or when you visit a customer whose machine has the old HDD bracket, please change the bracket to a new type.
