Model: C-P1 Duplex unit		Date: 22-Feb-10	No.: RG361001
Subject: Duplex jam		Prepared by: Y. Murata	
From: 2nd Overseas Tech. Support Sec., 2nd PQM Dept.			
Classification:	<input checked="" type="checkbox"/> Troubleshooting	<input checked="" type="checkbox"/> Part information	<input type="checkbox"/> Action required
	<input type="checkbox"/> Mechanical	<input type="checkbox"/> Electrical	<input type="checkbox"/> Service manual revision
	<input checked="" type="checkbox"/> Paper path	<input type="checkbox"/> Transmit/receive	<input type="checkbox"/> Retrofit information
	<input type="checkbox"/> Other ( )		<input checked="" type="checkbox"/> Tier2

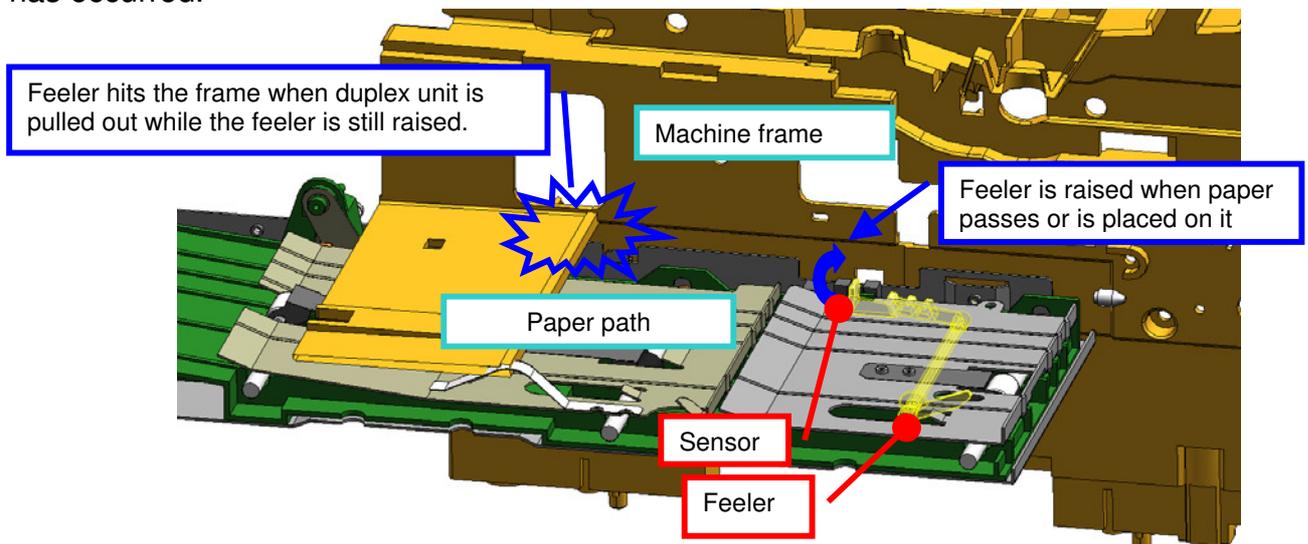
After jammed paper is removed following a misfeed, the “Remove Misfeed Duplex Unit” display does not clear.

The sensor feeler sometimes contacts the inside of the machine frame, damaging the feeler. This can happen if the operator lifts up the unit while pulling it out, or if a Z-fold jam has occurred.

The shape of the feeler was changed so that it does not contact the frame in such cases.
