Model: Katana		Date:14-Jul-06	No.: RB234015
Subject: Service Manual Revision		Prepared by: S. Ishizu	
From: 2nd Tech Support Sec. Service Support Dept.			
Classification:	<input type="checkbox"/> Troubleshooting <input type="checkbox"/> Mechanical <input type="checkbox"/> Paper path <input type="checkbox"/> Product Safety	<input type="checkbox"/> Part information <input type="checkbox"/> Electrical <input type="checkbox"/> Transmit/receive <input type="checkbox"/> Other (     )	<input type="checkbox"/> Action required <input checked="" type="checkbox"/> Service manual revision <input type="checkbox"/> Retrofit information

**This document summarizes the corrections in the Service Manual for “Katana” (Machine Code: B234/235/236).**

Model: AG-P1 / C1		Date: 14-Jul-10	No.: RG178107
Subject: BK5000 Modified Exit/Driven Rollers for Roller Marks		Prepared by: Hiroaki Matsui	
From: PPBG QA/Service Planning Dept.			
Classification:	<input type="checkbox"/> Troubleshooting <input type="checkbox"/> Mechanical <input type="checkbox"/> Paper path <input type="checkbox"/> Product Safety	<input type="checkbox"/> Part information <input type="checkbox"/> Electrical <input type="checkbox"/> Trans

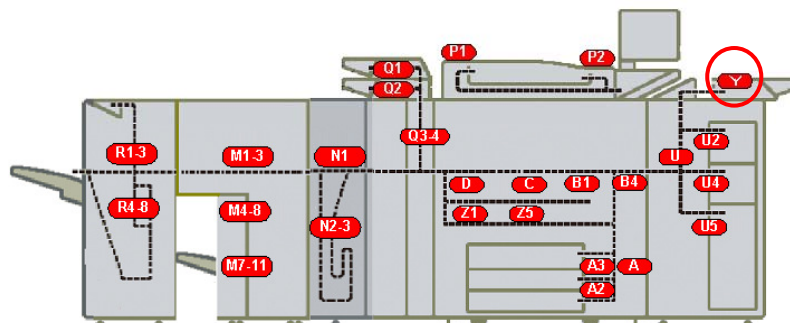
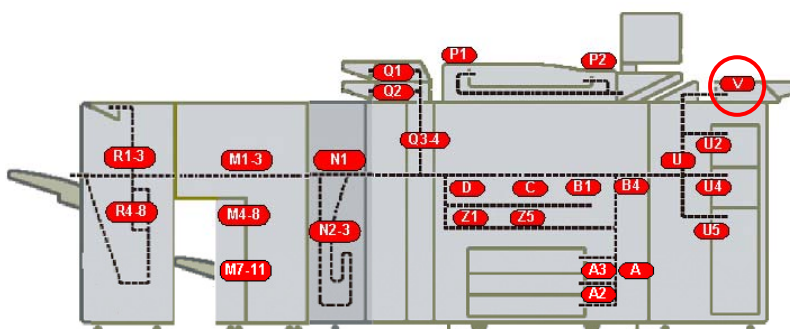
**5. Corrected the label "Y" to "V". <Page: 4-5>**

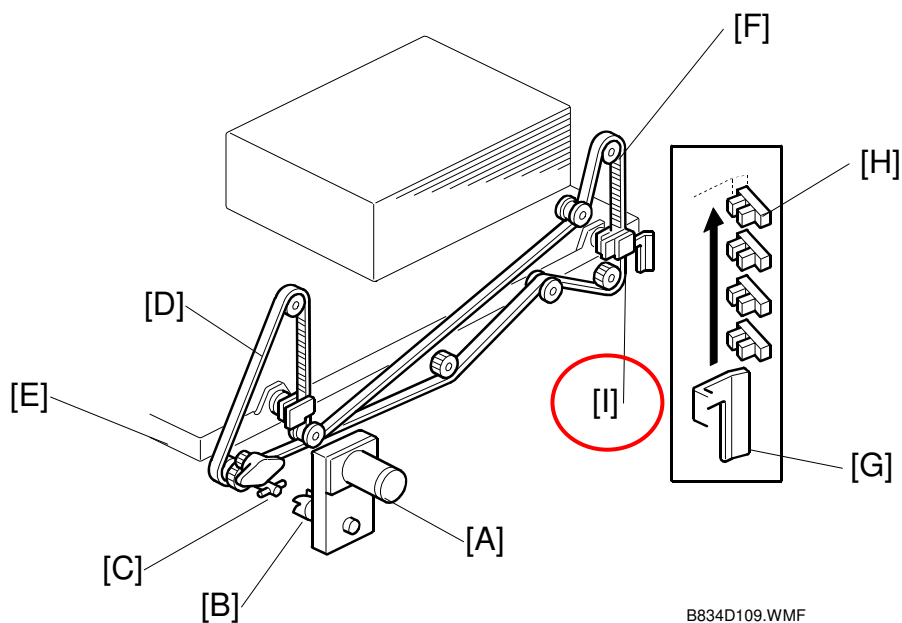
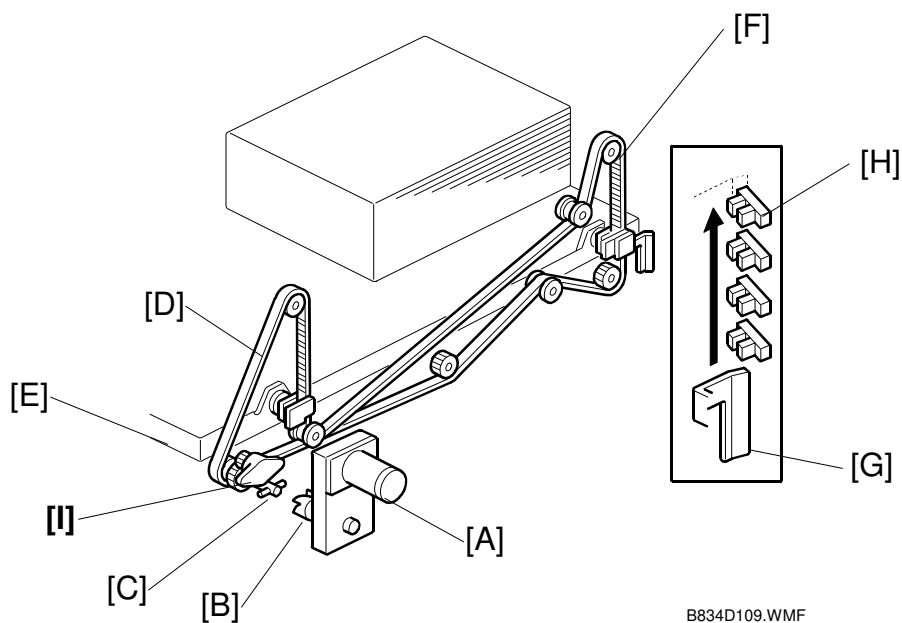
**10. Moved callout “[I]” to correct position. <Page: B834-24>**

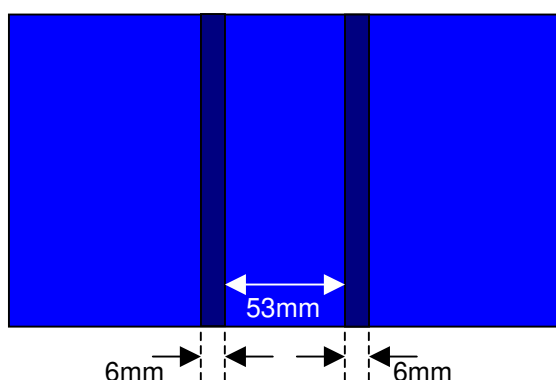
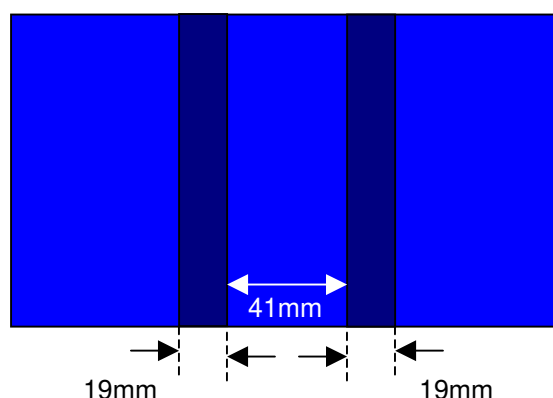
Depending on the print pattern, either of the roller marks shown below could appear when making booklets on the BK5000.

The previous Exit Rollers with large ribs causes excessive pressure against the sheets.

Paper Exit Rollers and Driven Rollers have been modified as described below.

Degree of curl adjustment has been reduced for the Paper Exit Rollers.

1. Size of the ribs surrounding the two Exit Rollers has been reduced.
2. Width between the two Driven Rollers has been widened.

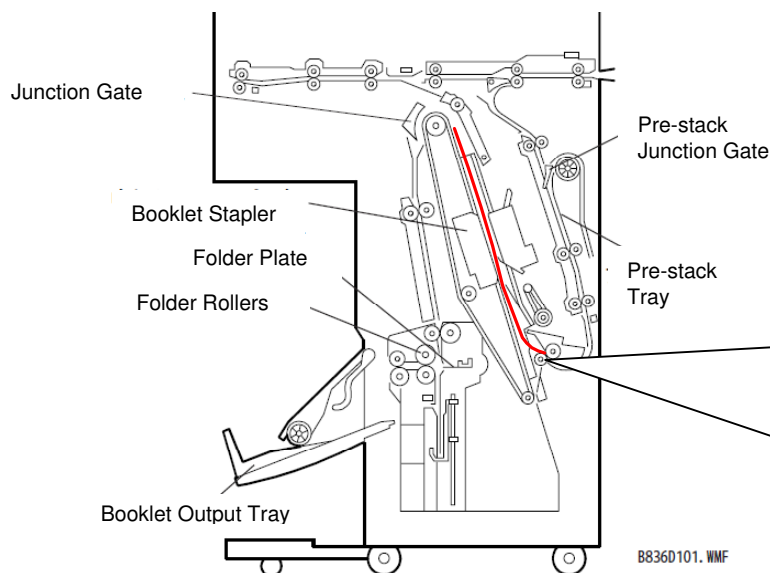
**Incomplete Feed-out of Trailing Edge**

The reduction of curl adjustment at the paper exit could cause the sheet to remain incompletely fed – the trailing edge stays in the Exit Roller area, which could result in incorrect folding positions or jams caused by collision with the succeeding sheet.

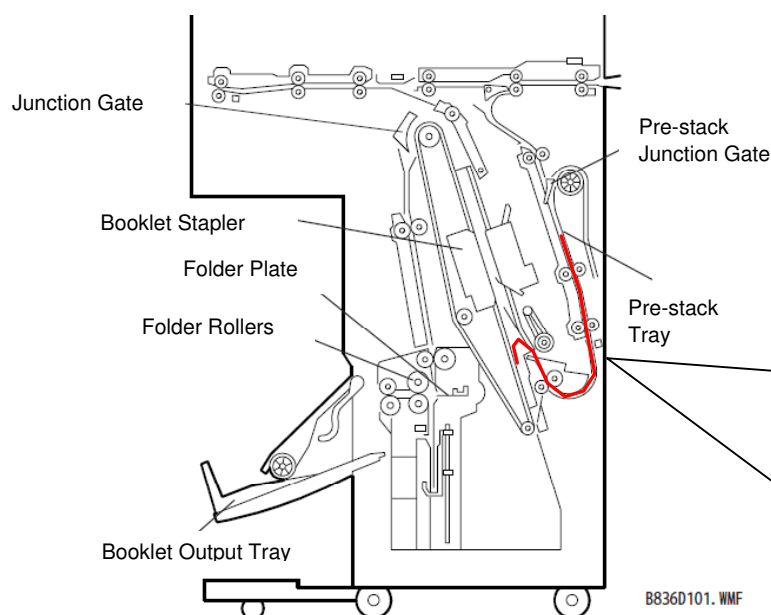
**Curls Generated at the Leading Edge**

As the sheets are fed out with the curls less adjusted, the leading edge is curled immediately after having been fed out from the exit rollers, which could result in jams. The rate of jam occurrence rises especially when feeding "thin and/or curled" sheets.

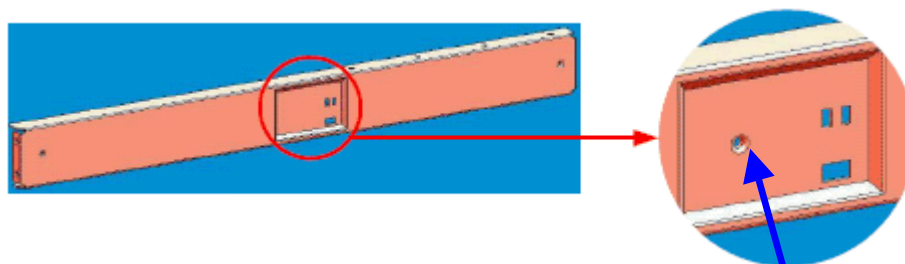
## B7004167 → D3734167 STAY: LOWER: POSITIONING SENSOR

The stapler tray (B7004185) could deform over time and cause the positioning sensor (B7004167) to falsely detect an error.

To prevent the stapler tray from deforming, a new screw hole has been added to fix the tray more firmly, which will ultimately prevent the false detection.
