Model: Mojito		Date: 10-Nov-00	No.: RA293015
Subject: Printer Controller (B337) System Firmware Histories		Prepared by: A. Sasaki	
From: Technical Service Dept., GTS Division			
Classification:	<input type="checkbox"/> Troubleshooting <input type="checkbox"/> Part information <input type="checkbox"/> Action required <input type="checkbox"/> Mechanical <input type="checkbox"/> Electrical <input type="checkbox"/> Service manual revision <input type="checkbox"/> Paper path <input type="checkbox"/> Transmit/receive <input type="checkbox"/> Retrofit information <input checked="" type="checkbox"/> Other (Information)

This is to inform about the modification histories of the system firmware of Printer Controller Type 700 (B337).

Model: Bellini		Date: 23-Aug-00	No.: RA294030
Subject: Interface Board Installation		Prepared by: A. Sasaki	
From: Technical Services Dept., GTS Division			
Classification:	<input checked="" type="checkbox"/> Troubleshooting <input type="checkbox"/> Part information <input type="checkbox"/> Action required <input type="checkbox"/> Mechanical <input type="checkbox"/> Electrical <input type="checkbox"/> Service manual revision <input type="checkbox"/> Paper path <

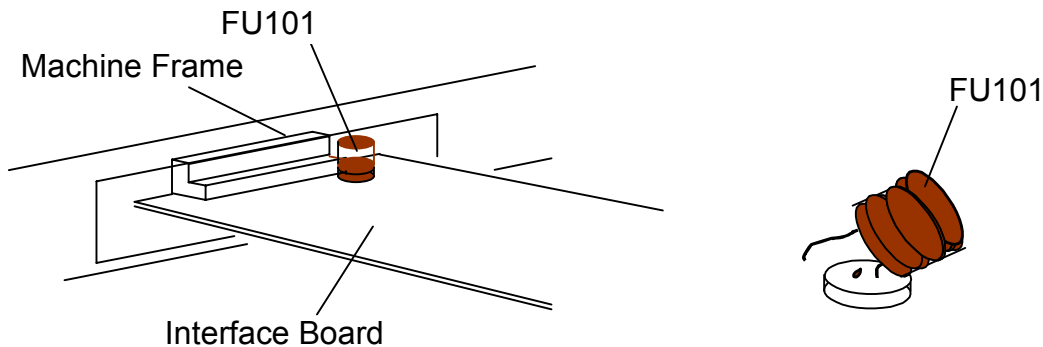
The fuse FU101 on the interface board is damaged.

When the interface board is inserted, the top part of the fuse brushes against the machine frame and a leg of the fuse comes loose.

Please make sure that the fuse on the interface board does not touch the machine frame when you insert the interface board.
