Model: AL-C2/AP-C3 1Bin Tray		Date: 10-Mar-15	No.: RD6320001
Subject: Prevention of injury due to burrs		Prepared by: Takuya Hirakawa	
From: 2nd Tech. Support Sec. Service Support Dept.			
Classification:	<input checked="" type="checkbox"/> Troubleshooting <input type="checkbox"/> Mechanical <input type="checkbox"/> Paper path <input type="checkbox"/> Other ()	<input type="checkbox"/> Part information <input type="checkbox"/> Electrical <input type="checkbox"/> Transmit/receive	<input type="checkbox"/> Action required <input type="checkbox"/> Service manual revision <input type="checkbox"/> Retrofit information

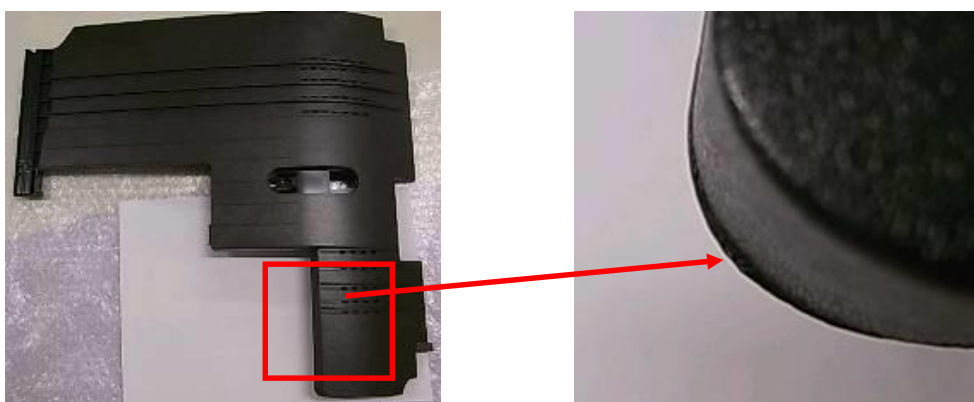
There may be burrs on the edge of some one-bin trays, which may contact the operator's hand when a printout is removed from the tray.

The exit tray was produced by an aging mold.

Remove the burr using the following sandpaper:

Part number	Description
D1299900	SANDPAPER:SERVICE
