Model: Multi Bypass Tray BY5000 (B833)		Date: 25-Mar-11	No.: RB833001
Subject: Part change – Push Switch and Harness		Prepared by: T. Komori	
From: PP Service Planning Department 1G			
Classification:	<input type="checkbox"/> Troubleshooting <input type="checkbox"/> Mechanical <input type="checkbox"/> Paper path <input type="checkbox"/> Product Safety	<input checked="" type="checkbox"/> Part information <input type="checkbox"/> Electrical <input type="checkbox"/> Transmit/receive <input type="checkbox"/> Other ()	<input type="checkbox"/> Action required <input type="checkbox"/> Service manual revision <input type="checkbox"/> Retrofit information <input type="checkbox"/> Tier 2

Model: Multi Bypass Tray BY5000 (B833)		Date: 16-Dec-11	No.: RB833002
Subject: Part Changes		Prepared by: A. Takada	
From: PP Tech Service Dept., 1st PP Tech Service Sect.			
Classification:	<input type="checkbox"/> Troubleshooting <input type="checkbox"/> Mechanical <input type="checkbox"/> Paper path <input type="checkbox"/> Product Safety	<input checked="" type="checkbox"/> Part information <input type="checkbox"/> Electrical <input type="checkbox"/> Transmit/receive <input type="checkbox"/> Other ()	<in

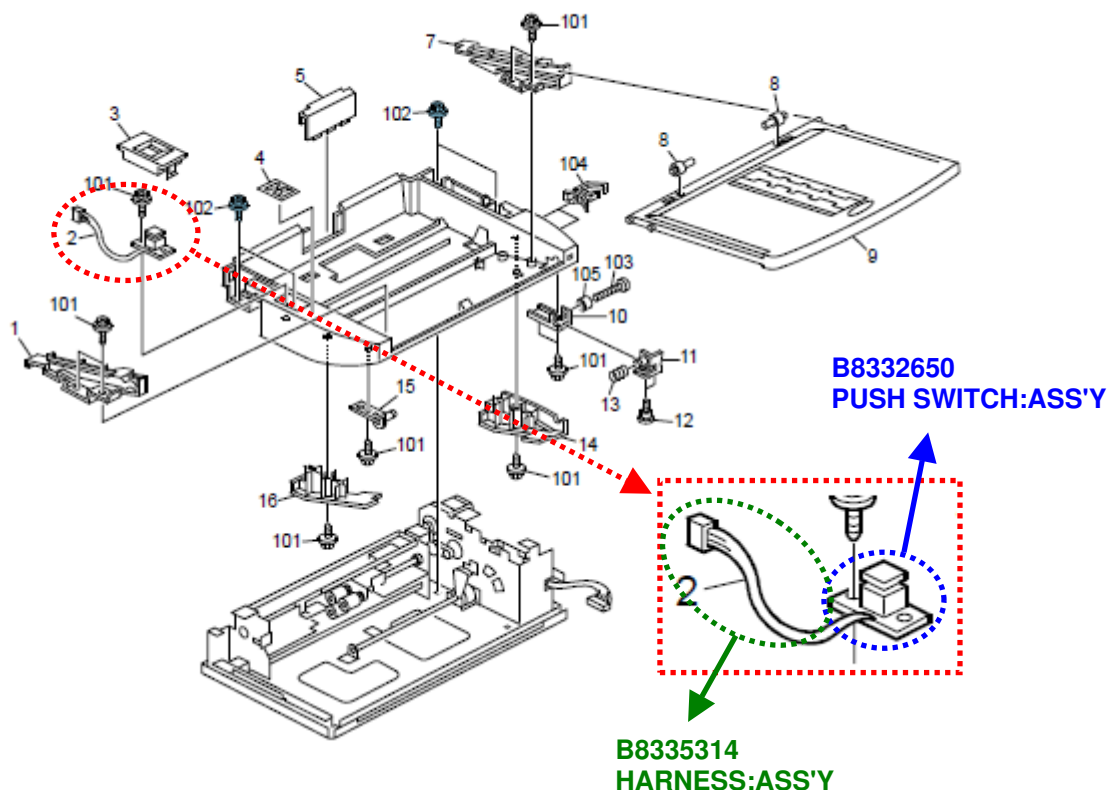
3.Original Tray 2 (B833)

The push switch previously assigned with one p/n has been reassigned with two separate p/n for the switch and the harness respectively.

Old Part Number	New Part Number	Description	Q'ty	Int	Page	Index	Note
B8335170	B8332650	PUSH SWITCH:ASS'Y	1	O/O	as a	7	2
	B8335314	HARNESS:ASS'Y	1		set	7	17
							add

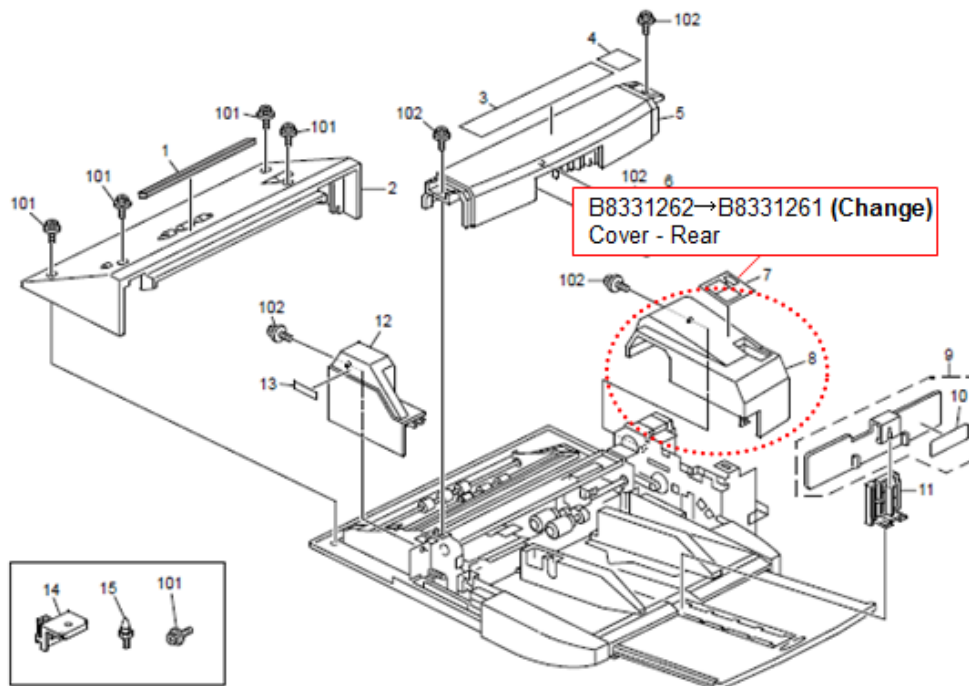
1.Exterior (B833)

Change: DC Motor-1.7W and its accompanying parts

Reason: Change in the vendor of the motor

Old Part Number	New Part Number	Description	Q'ty	Int	Page	Index	Note
AX040123	B8352520	DC Motor - 1.7W	1	X/O	15	15	A
B8331262	B8331261	Cover - Rear	1	X/O	3	8	A
-	B8332704	Bracket: Rising Tray: Paper feed	1	-	15	19	A
B8332705	B8332702	Side Plate – Rear	1	X/O	15	7	A
B8335303	B8335313	Harness – Sensor	1	X/O	15	13	A
C4165301	B8335311	Harness: Drawer: Plug: Ass'y	1	X/O	9	7	A

When replacing any of the above parts, replace all 6 parts as a set using the following screw:

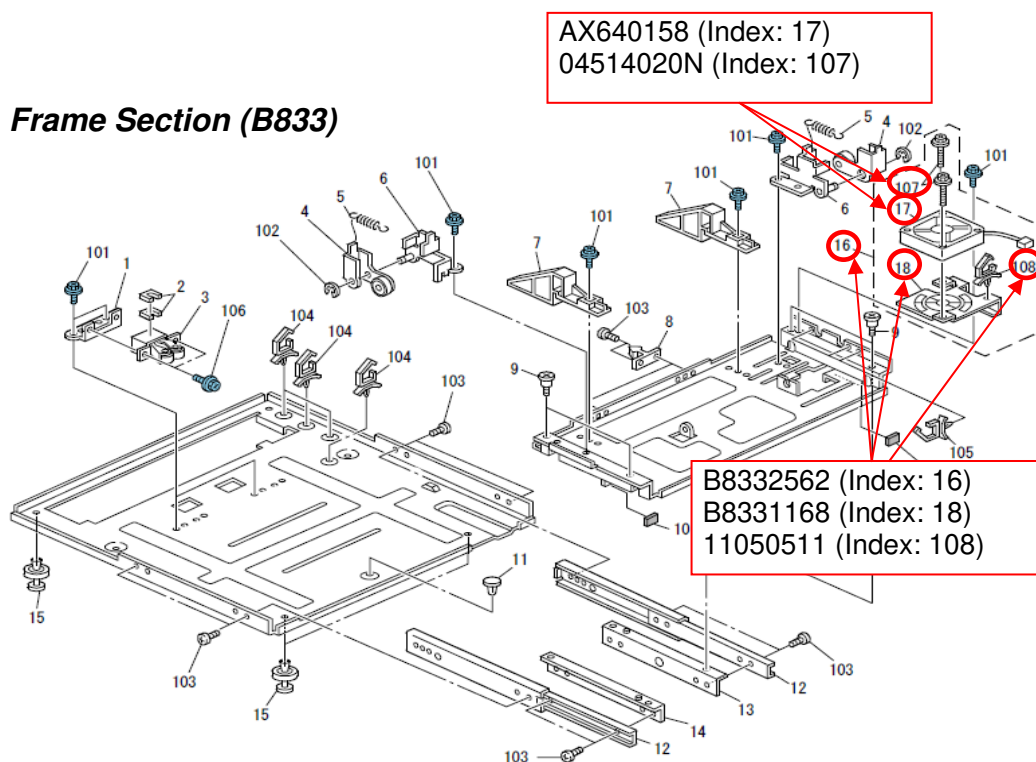
8. Frame Section (B833)

Change: The following parts of the Multi Bypass Tray (B833) were added as individual service parts.

Reason: These parts were missing from the Multi Bypass Tray (B833) parts catalog.

Part number	Description	Q'ty	Int	Page	Index	Note
B8332562	COOLING UNIT:ASS'Y	1		17	16	Add
AX640158	FAN MOTOR MM60/15MM:24V	1		17	17	Add
B8331168	STAY:COOLING UNIT	1		17	18	Add
04514020N	TAPPING SCREW - M4X20	2		17	107	Add
11050511	HARNESS CLAMP – LWS-0306ZC	1	-	17	108	Add
