Model: Model-J CF		Date: 4-Mar-02	No.: RG570001
Subject: Language Software History		Prepared by: H. Someya	
From: Technical Services Dept., GTS Division			
Classification:	<input type="checkbox"/> Troubleshooting <input type="checkbox"/> Part information <input type="checkbox"/> Action required <input type="checkbox"/> Mechanical <input type="checkbox"/> Electrical <input type="checkbox"/> Service manual revision <input type="checkbox"/> Paper path <input type="checkbox"/> Transmit/receive <input type="checkbox"/> Retrofit information <input checked="" type="checkbox"/> Other (      )

Language software history for the Model-J CF.

Model: Model-J CF		Date: 15-Mar-02	No.: RG570002
Subject: Remarks at firmware update		Prepared by: T. Itoh	
From: Technical Services Dept., GTS Division			
Classification:	<input type="checkbox"/> Troubleshooting <input type="checkbox"/> Part information <input checked="" type="checkbox"/> Action required <input type="checkbox"/> Mechanical <input type="checkbox"/> Electrical <input type="checkbox"/> Service manual revision <input type="checkbox"/> Paper path <input type="checkbox"/> Transmit/receive <input type="checkbox"/> Retrofit information <input t

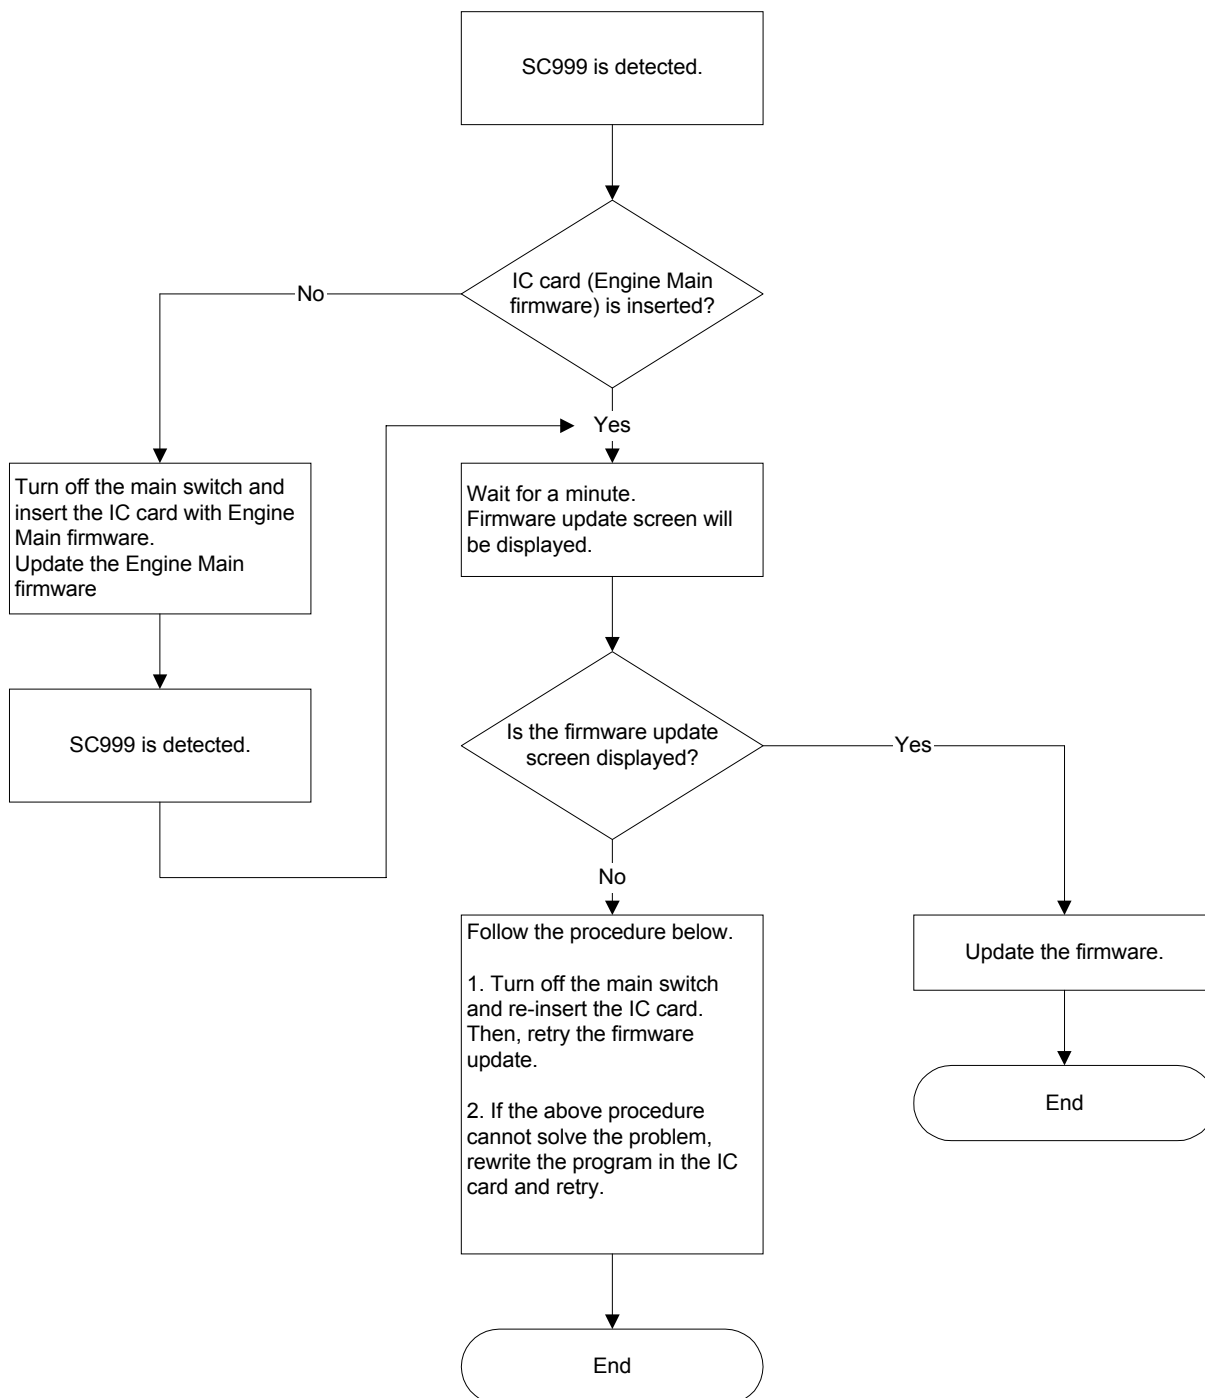
If for some reason NOTES 2 and 3 above are not followed, and SC999 occurs at power up when trying to update the system firmware to V1.07, please use the following flowchart to clear the condition.

**NOTE 2:** To prevent SC999 occurring at power up, whenever updating the system firmware to V1.07 or newer, make sure to install engine main firmware 1.17C or newer first.

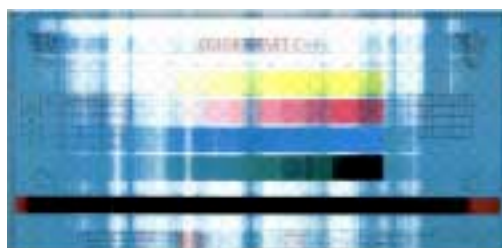
The following symptoms may occur intermittently or continuously.

- SC142 (White Level Detection Error)
- SC101 (Exposure Lamp Error)
- Colored vertical lines/bands/background (see photo).

The adhesive used to attach the glass to the CCD assembly was changed. However, it generated a gas when exposed to the heat from the PCB during machine operation. The gas caused the soldered points of wires on the CCD to oxidize and deteriorate, resulting in poor contact.

Retrofit parts (lens block assemblies) will be provided to the field FOC for all affected units. Therefore, at the next service visit or when the issue is reported, please replace with P/N B1169455.

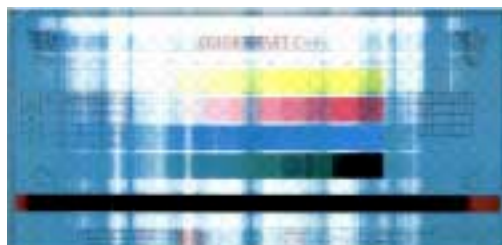
The following symptoms may occur intermittently or continuously.

- SC142 (White Level Detection Error)
- SC101 (Exposure Lamp Error)
- Colored vertical lines/bands/background (see the photo).

The adhesive used to attach the glass to the CCD assembly was changed, but it generated a gas when exposed to the heat from the PCB during machine operation. The gas caused the soldered points of wires on the CCD to oxidize and deteriorate, resulting in poor contact.

Retrofit parts (lens block assemblies) will be provided to the field FOC for all affected units. Therefore, at the next service visit or when the issue is reported, please replace with P/N B1169455.
