| Model: General RTB | Date: 4-Feb-03 | No.: RGene013b |

| Subject: Service remarks at installation | | Prepared by: T. Itoh | |

| Model: Model J-P2CF | | Date: 30-Apr-03 | No.: RG367001 |

| Subject: SC142 due to defective CCD | | Prepared by: H.Taguchi | |

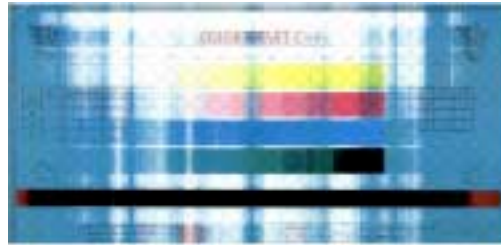
The following symptoms may occur intermittently or continuously.

- SC142 (White Level Detection Error)
- SC101 (Exposure Lamp Error)
- Colored vertical lines/bands/background (see photo).

The adhesive used to attach the glass to the CCD assembly was changed, but it generated a gas when exposed to the heat from the PCB during machine operation. The gas caused the soldered points of wires on the CCD to oxidize and deteriorate, resulting in poor contact.

Retrofit parts (lens block assemblies) will be provided to the field FOC for all affected units. Therefore, at the next service visit or when the issue is reported, please replace with P/N B1169455.

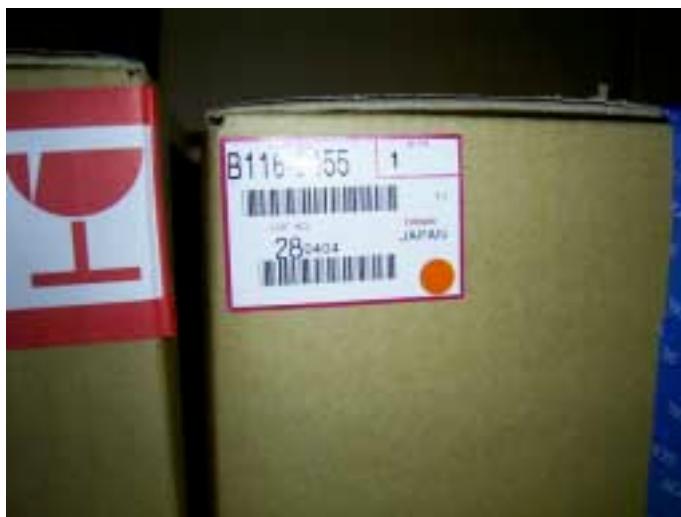
***Step 7 on pg. 4 below, i.e. checking to make sure SP4-205 is at 70, is necessary due to a RAM data error with the retrofit lens block assemblies (#B1169455) discovered at the manufacturer's side. Specifically, one of the several special tools used by the manufacturer was defective, causing a limited amount of assembly RAMs to contain a value of 8 instead of the normal 70. Therefore, please ensure that this value is at 70 in Step 7 below, as dirty background in ADS mode may occur if this value is 8.***

***Please note that all boxes bearing the seal shown below contain lens block assemblies with the correct data (70).***

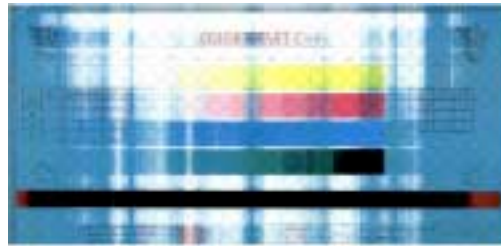
The following symptoms may occur intermittently or continuously.

- SC142 (White Level Detection Error)
- SC101 (Exposure Lamp Error)
- Colored vertical lines/bands/background (see the photo).

The adhesive used to attach the glass to the CCD assembly was changed, but it generated a gas when exposed to the heat from the PCB during machine operation. The gas caused the soldered points of wires on the CCD to oxidize and deteriorate, resulting in poor contact.

Retrofit parts (lens block assemblies) will be provided to the field FOC for all affected units. Therefore, at the next service visit or when the issue is reported, please replace with P/N B1169455.
