Model: Cover Interposer Tray CI5000	Date: 21-Nov-06	No.: RB835001e
-------------------------------------	-----------------	----------------

Subject: Cover Interposer Tray CI5000		Prepared by: T.Tadokoro	
From: PPBG QA/Service Planning Dept.			
Classification:	<input type="checkbox"/> Troubleshooting <input type="checkbox"/> Mechanical <input type="checkbox"/> Paper path <input checked="" type="checkbox"/> Other ()	<input type="checkbox"/> Part information <input type="checkbox"/> Electrical <input type="checkbox"/> Transmit/receive	<input type="checkbox"/> Action required <input type="checkbox"/> Service manual revision <input type="checkbox"/> Retrofit information

Model: Cover Interposer Tray CI5000 (B835)		Date: 17-Dec-10	No.: RB835002
Subject: Modification to prevent false detection		Prepared by: T. Komori	
From: PP Service Planning Department 1G			
Classification:	<input type="checkbox"/> Troubleshooting <input checked="" type="checkbox"/> Part information <input type="checkbox"/> Action required <input type="checkbox"/> Mechanical <input type="checkbox"/> Electrical <input type="checkbox"/> Service manual revision <input type="checkbox"/> Paper path <input type="checkbox"/>

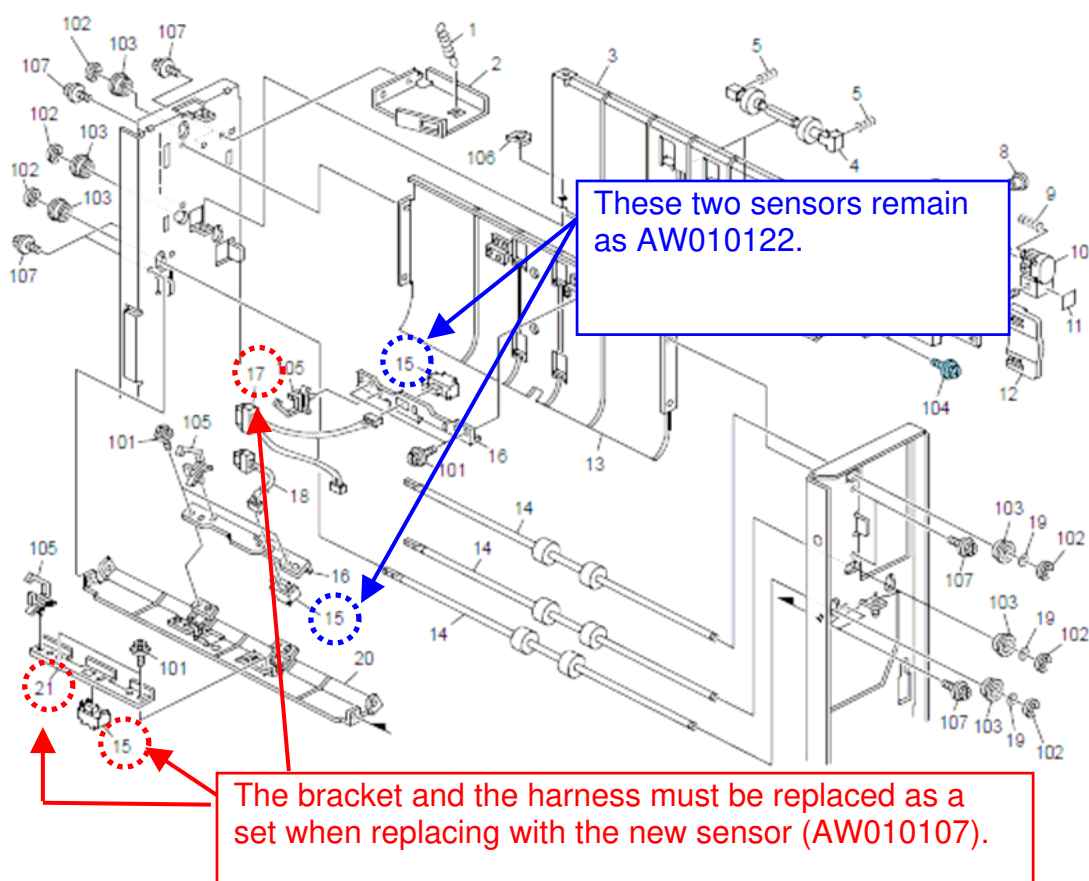
7.Original Transfer 1 (B835-57/66)

Change: Paper feed sensor

Reason: To prevent false detection

The new sensor (AW010107) can detect a wider area in comparison to the former sensor (AW010122), which will lower the chances of misdetection.

Shape of the bracket and the length of the harness have also changed accordingly with this modification.

Old Part Number	New Part Number	Description	Q'ty	Int	Page	Index	Note
	AW010107	PAPER FEED SENSOR	1	X/O	15	22	Add
B8353967	B8353966	BRACKET:SENSOR:EXIT	1	X/O	15	21	
B8355315	B8355319	HARNESS:SENSOR:ASS'Y	1	X/O	15	17

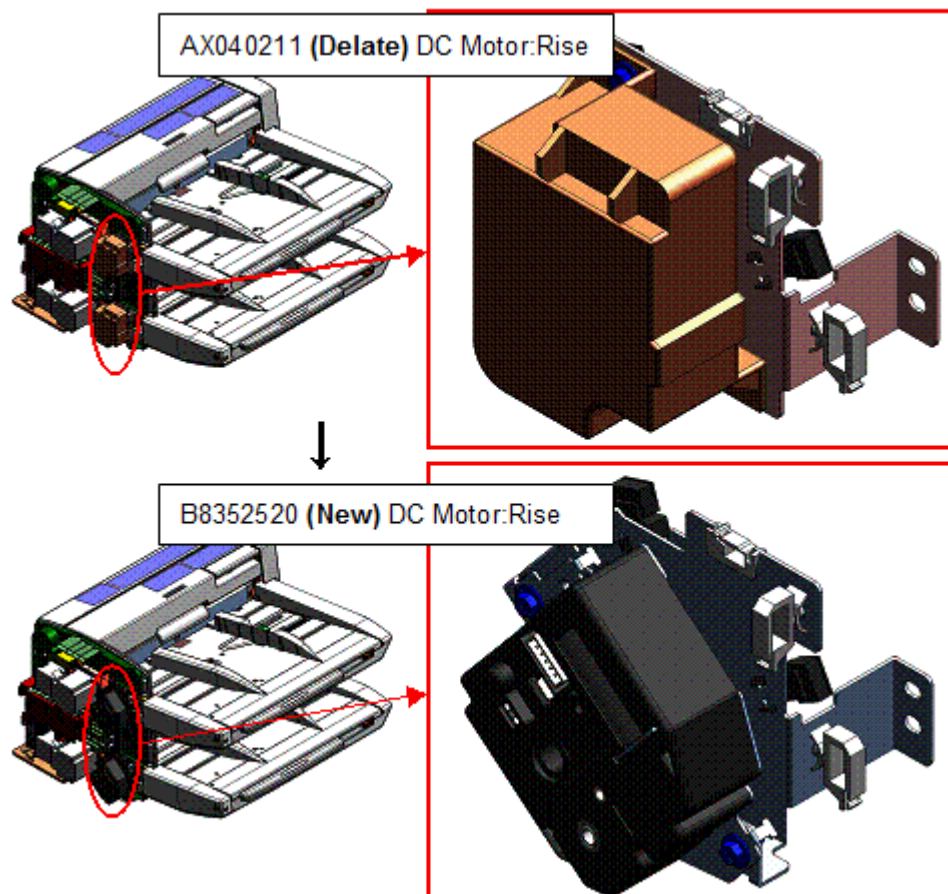
Change: Shape of the DC motor for lifting the tray

Reason: Vendor change

Old Part Number	New Part Number	Description	Q'ty	Int	Page	Index	Note
AX040211	B8352520	DC Motor:Rise	1	O/O	5	2	A
B8352669	B8352522	Lift Motor Bracket	1	O/O	5	5	A
B8355320	B8355328	Harness - Motor No.1	1	X/O	21	5	A
B8355324	B8355329	Harness - Motor No.2	1	X/O	21	6	A

• When replacing these parts, replace all 4 parts as a set.

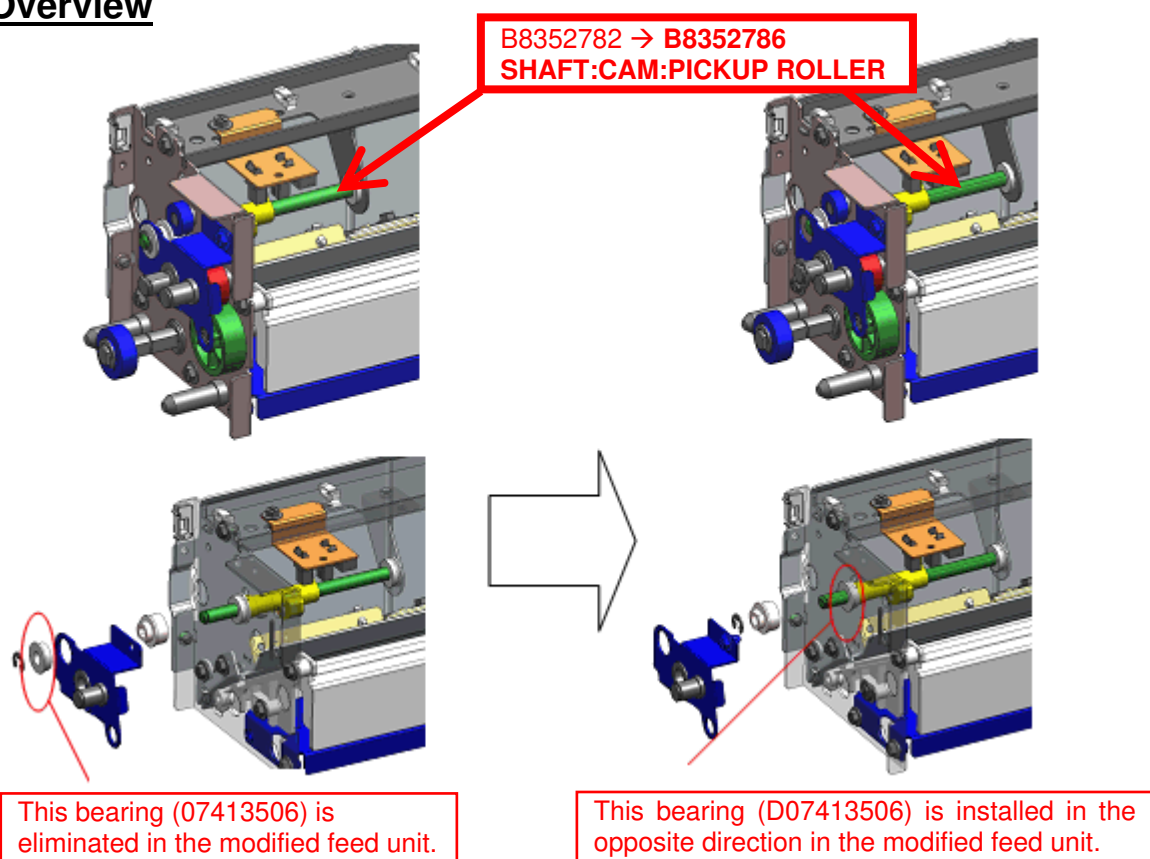
Overview

Change: The length of the cam shaft and the quantity of the bearings in the feed unit

Reason: To reduce the load on the cam shaft and the bearings

Old Part Number	New Part Number	Description	Q'ty	I/C	Page	Index	Note
B8352782	B8352786	SHAFT:CAM:PICKUP ROLLER	1	X/O	11	11

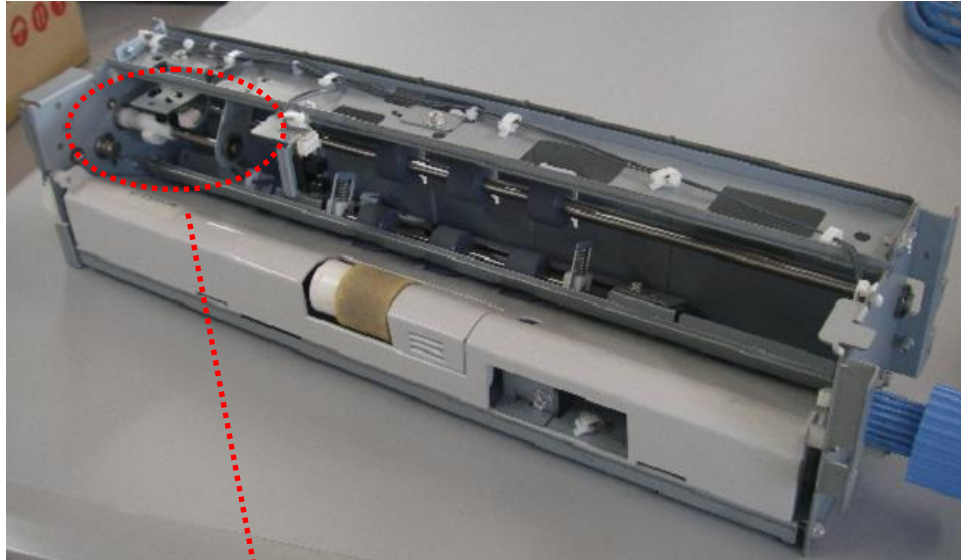
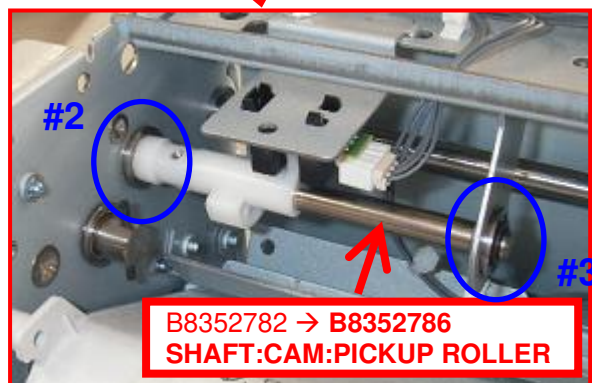
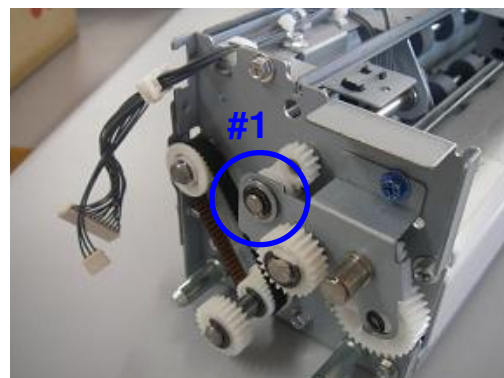
Feed unit

The photos below show the original feed unit before implementing the modification.

The following are the modified points of the new feed unit:

- ✓ Bearing #1 was eliminated.
- ✓ An E-ring was attached.
- ✓ The cam shaft was shortened (B8352786).
- ✓ Bearing #2 is installed in the opposite direction. (Installed from the outside of the bracket)
