Model: Iris/Lilac (Controller Interface Type E)	Date: 15-Nov-99	No.: RA258014a
---	-----------------	----------------

RTB Correction

Subject: SC326 / Abnormal Image		Prepared by: T. Itoh	
From: Technical Service Dept., GTS Division			
Classification:	<input checked="" type="checkbox"/> Troubleshooting	<input type="checkbox"/> Part information	<input type="checkbox"/> Action required
	<input type="checkbox"/> Mechanical	<input type="checkbox"/> Electrical	<input type="checkbox"/> Service manual revision
	<input type="checkbox"/> Paper path	<input type="checkbox"/> Transmit/receive	<input type="checkbox"/> Retrofit information
	<input type="checkbox"/> Other ()

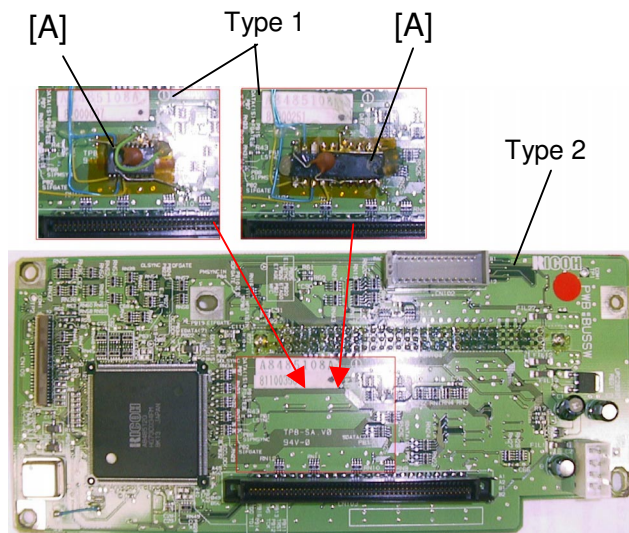
As shown in the picture, there are two types of BUSSW board (P/N #A8485108). Type 1 is the board on which an IC [A] has been manually soldered. Type 2 contains an IC18 soldered onto the circuit pattern by machine.

Type 1 is the board that was modified in the production (from #A8485105). This board contains one of the two ICs as shown in the picture to the right [A]. The only difference is in the size.

The function of the additional IC and IC18 is exactly the same. IC18 is soldered onto the reverse side of the Type 2 board.

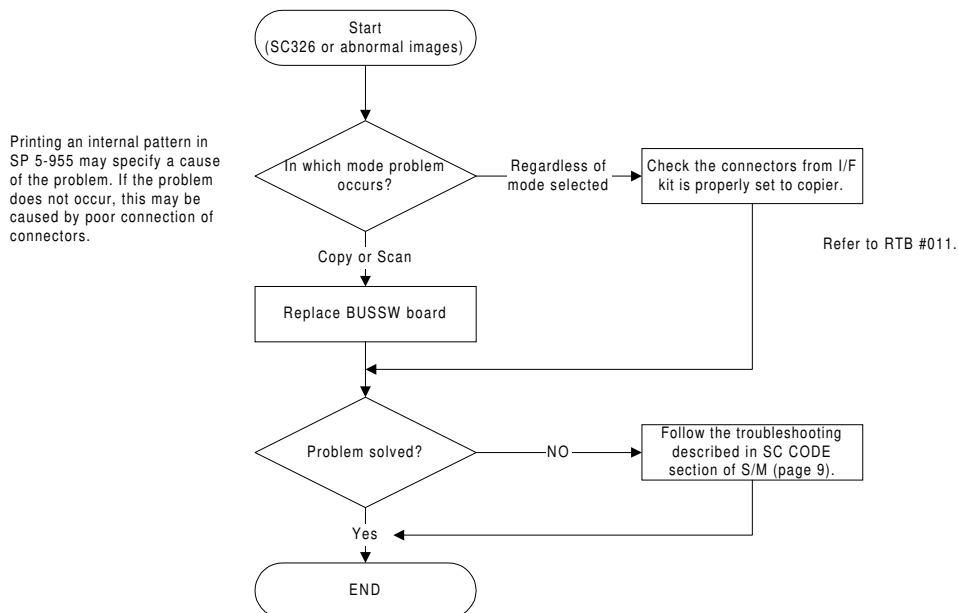
[1] Troubleshoot as shown below when the problem is reported.

NOTE: If the problem is related to IC18, the replaced (old) PCB can be re-used after cutting pins #12 - 17. (If the PCB is Type 1, it is not repairable and therefore not re-usable.) If occurrences still continue after cutting the pins, the problem is being caused by another PCB component.

NOTE: If the BUSSW board (IC18) causes the problem and the part is not available, cutting the pins (#12 - 17) of IC18 as explained section [2] on page [6](#) of this RTB solves the problem. (If the PCB is Type 1, the procedure on page 6 is not applicable.)

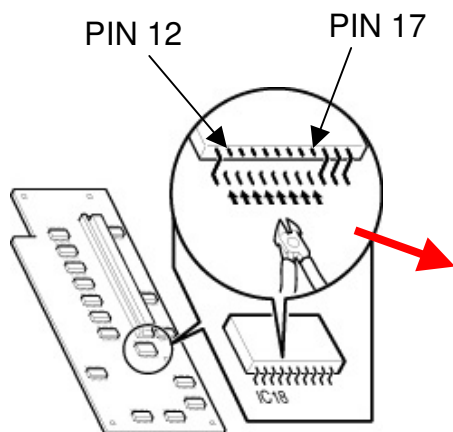
If the BUSSW board contains an IC [A], that has been manually soldered on, the procedure described below is not applicable. The BUSSW board would need to be replaced with #A8485112 when the problem occurs.

[2] Follow the procedure below at installation or next visit to prevent any future occurrence.

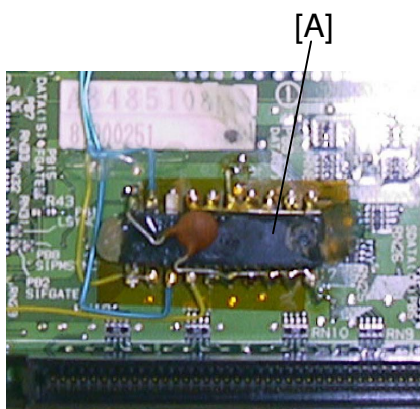
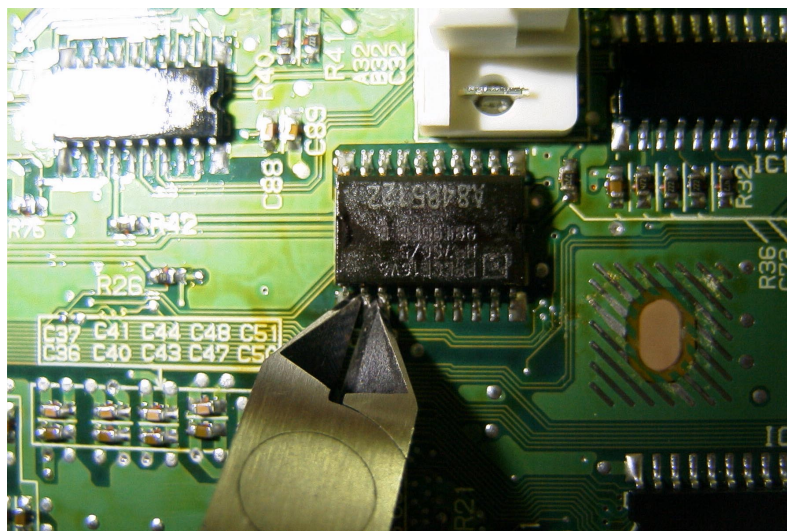
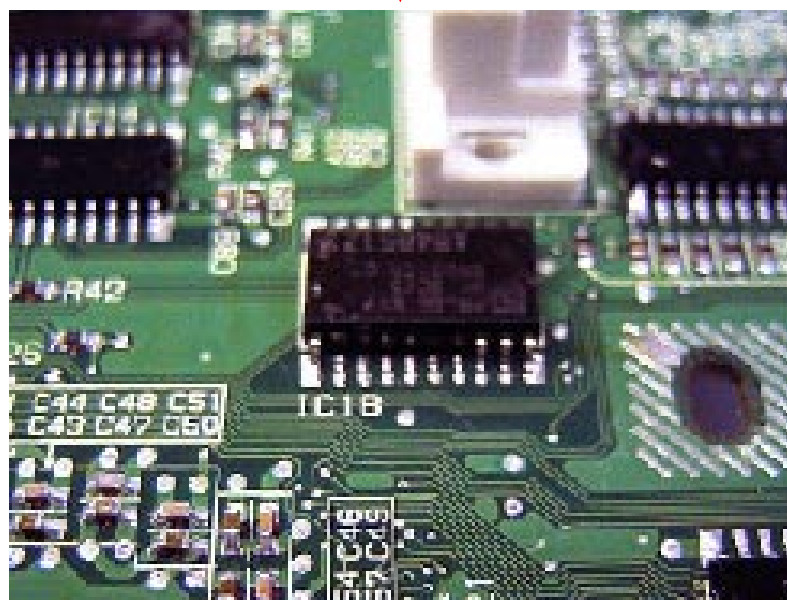
NOTE: Be careful not to damage the PCB pattern or cut other pins. If pins #11 or 18 are cut, this will cause SC326.

1. Remove the BUSSW board by following the procedure described on the previous page.
2. Using small cutting pliers, cut pins #12 to 17 so that they do not touch other pins or patterns. This will prevent a short circuit.
3. Remove the cut pins from the board surface.
