Model: V-C1 Mail Box CS391 (Ontario-B)	Date:15-May-09	No.: RB762001
--	----------------	---------------

Subject: Software Bug		Prepared by: T.Toriumi	
From: 2nd Tech. Support Sec. Service Support Dept.			
Classification:	<input type="checkbox"/> Troubleshooting <input type="checkbox"/> Mechanical <input type="checkbox"/> Paper path <input type="checkbox"/> Other ()	<input checked="" type="checkbox"/> Part information <input type="checkbox"/> Electrical <input type="checkbox"/> Transmit/receive	<input type="checkbox"/> Action required <input type="checkbox"/> Service manual revision <input type="checkbox"/> Retrofit information

No.: RB762002

Subject: Parts Registration(GUIDE PLATE:COUPLING:ASS'Y)

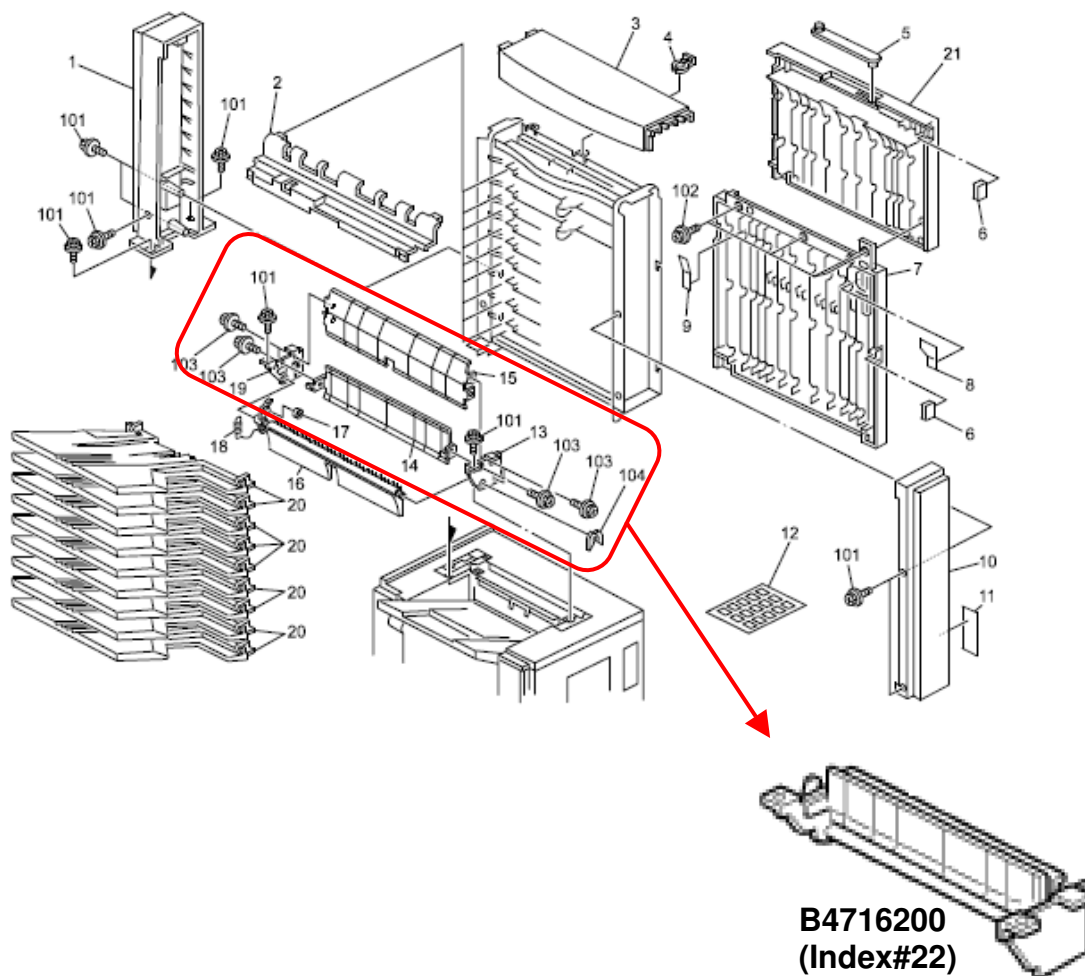
1.Exterior (B762)

Change: The individual parts circled in red below were registered as a single service part (assembly).

**B4716200
(Index#22)**

Old part number	New part number	Description	Q'ty	Int	Page	Index	Note
-	B4716200	GUIDE PLATE:COUPLING:ASS'Y	0-1	-	3	22	New Index
