Model: Apollon-C1 ARDF DF3010	Date: 5-Oct-07	No.: RB802001a
-------------------------------	----------------	----------------

Subject: The ARDF cover closes quickly		Prepared by: T.Kiyohara	
From: 1st Tech. Support Sec. Service Support Dept.			
Classification:	<input checked="" type="checkbox"/> Troubleshooting	<input type="checkbox"/> Part information	<input type="checkbox"/> Action required
	<input type="checkbox"/> Mechanical	<input type="checkbox"/> Electrical	<input type="checkbox"/> Service manual revision
	<input type="checkbox"/> Paper path	<input type="checkbox"/> Transmit/receive	<input type="checkbox"/> Retrofit information
	<input type="checkbox"/> Product Safety	<input type="checkbox"/> Other ()

Model: ARDF 3010		Date: 19-Aug-09	No.: RB802003
Subject: Parts information		Prepared by: M. Kumagai	
From: 2nd Tech Support Sec. Service Support Dept.			
Classification:	<input type="checkbox"/> Troubleshooting <input checked="" type="checkbox"/> Part information <input type="checkbox"/> Action required <input type="checkbox"/> Mechanical <input type="checkbox"/> Electrical <input type="checkbox"/> Service manual revision <input type="checkbox"/> Paper path <input type="check

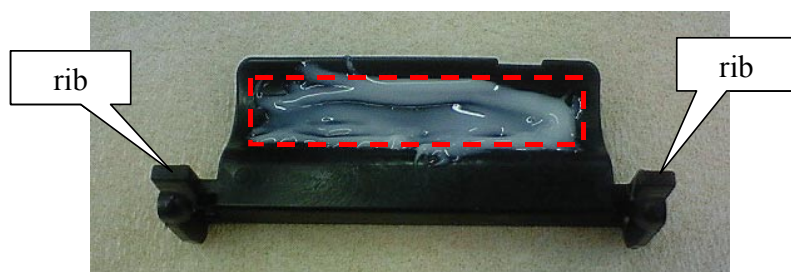
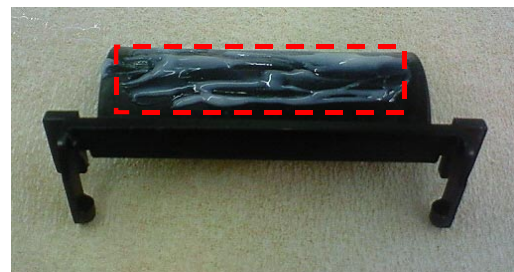
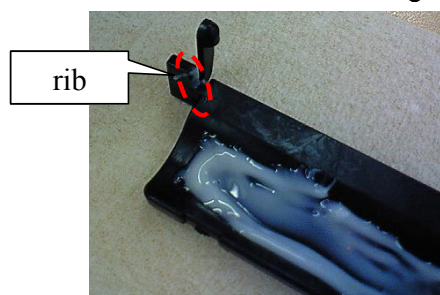
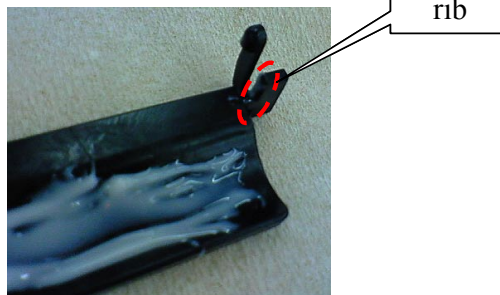
Not enough grease was applied to the cam.

1. Make sure that enough grease is applied to the concave surface of the spacer shown in Fig. 1, the convex surface shown in Fig. 2, and the inside of the rib shown in Fig. 3 and 4.

Attach **the spacer: B2239450** in left hinge of ARDF. See procedure below

Important: *This hinge already has grease applied to it when it comes from the factory. Do not apply any other type of grease to this hinge. If there is insufficient grease, install another spacer that has sufficient grease.*

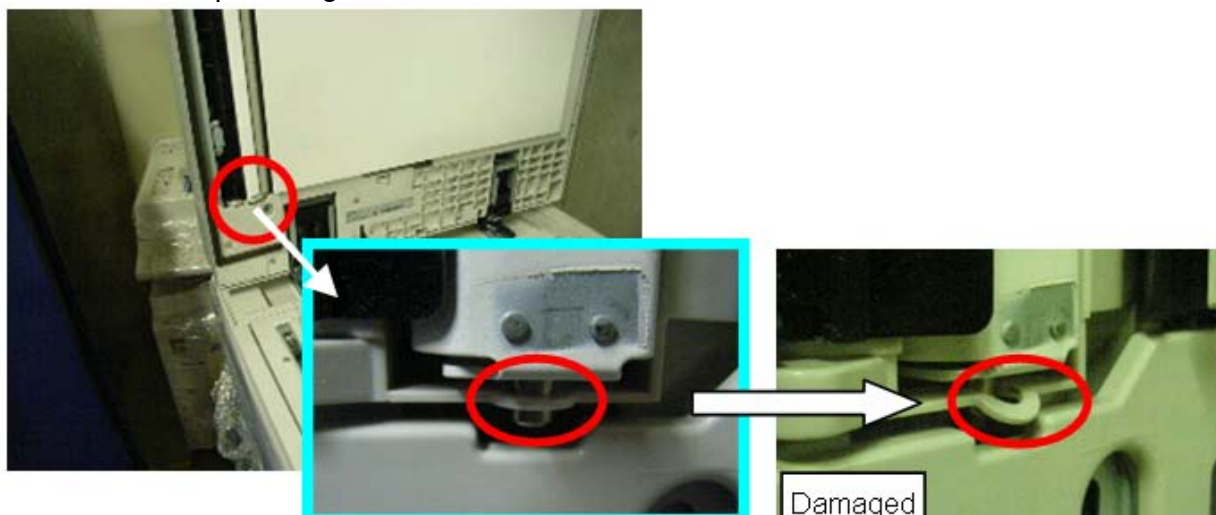
Symptom: ADF original feed Jam

The following circled part was bent because the customer inserted something like a pencil between the exposure glass and the ADF

1. If the unit serial number is earlier than shown in the following table, replace the following guide plate.

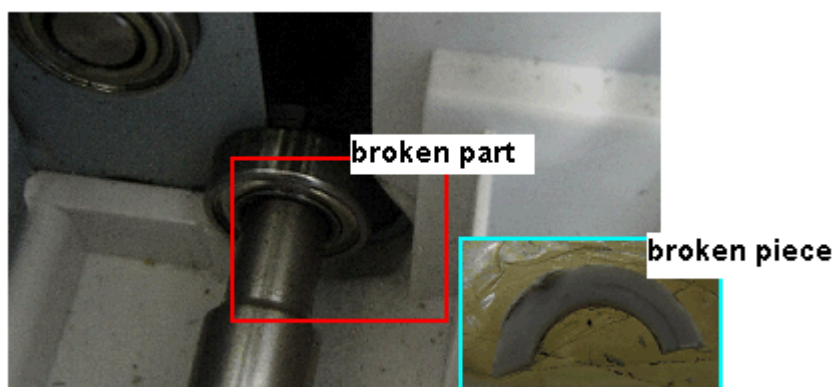
Original JAM 57 occurs frequently.

The following part is broken.

The bearing was modified (new P/N: #07413506), and applied to machines in production from the following serial numbers:

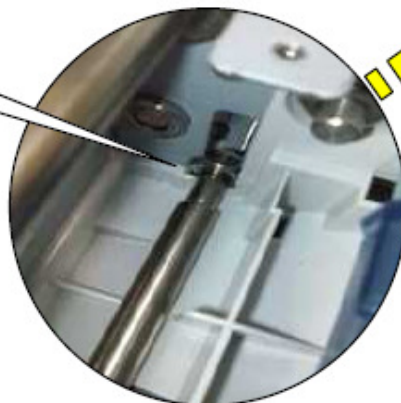
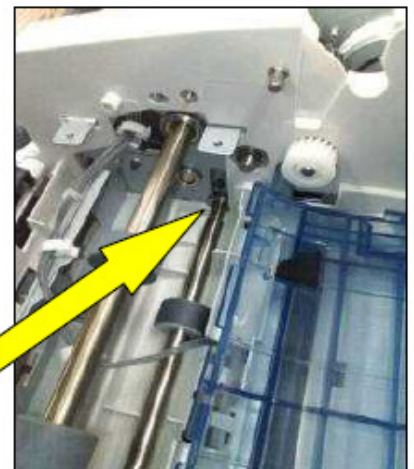
crack or broken piece

2. If there are any cracks in the following part (or broken pieces), go to Step 3.
