Model: SPDF DF3080	Date: 26-Jun-13	No.: RD683001c
--------------------	-----------------	----------------

Subject: Firmware Release Note: SPDF DF3080		Prepared by: T. Toriumi	
From: 1st Tech Service Sect., MFP/Printer Tech Service Dept.			
Classification:	<input type="checkbox"/> Troubleshooting <input type="checkbox"/> Mechanical <input type="checkbox"/> Paper path <input type="checkbox"/> Product Safety	<input type="checkbox"/> Part information <input type="checkbox"/> Electrical <input type="checkbox"/> Transmit/receive <input checked="" type="checkbox"/> Other (Firmware)	<input type="checkbox"/> Action required <input type="checkbox"/> Service manual revision <input type="checkbox"/> Retrofit information <input checked="" type="checkbox"/> Tier 2

Model: MET-C1b		Date: 10-Apr-15	No.: RD147138
Subject: Thread and tear the feed belt		Prepared by: N. Yoshida	
From: 1st Tech Service Sect., MFP/P Tech Service Dept.			
Classification:	<input checked="" type="checkbox"/> Troubleshooting <input type="checkbox"/> Mechanical <input type="checkbox"/> Paper path <input type="checkbox"/> Product Safety	<input type="checkbox"/> Part information <input type="checkbox"/> Electrical <input typ

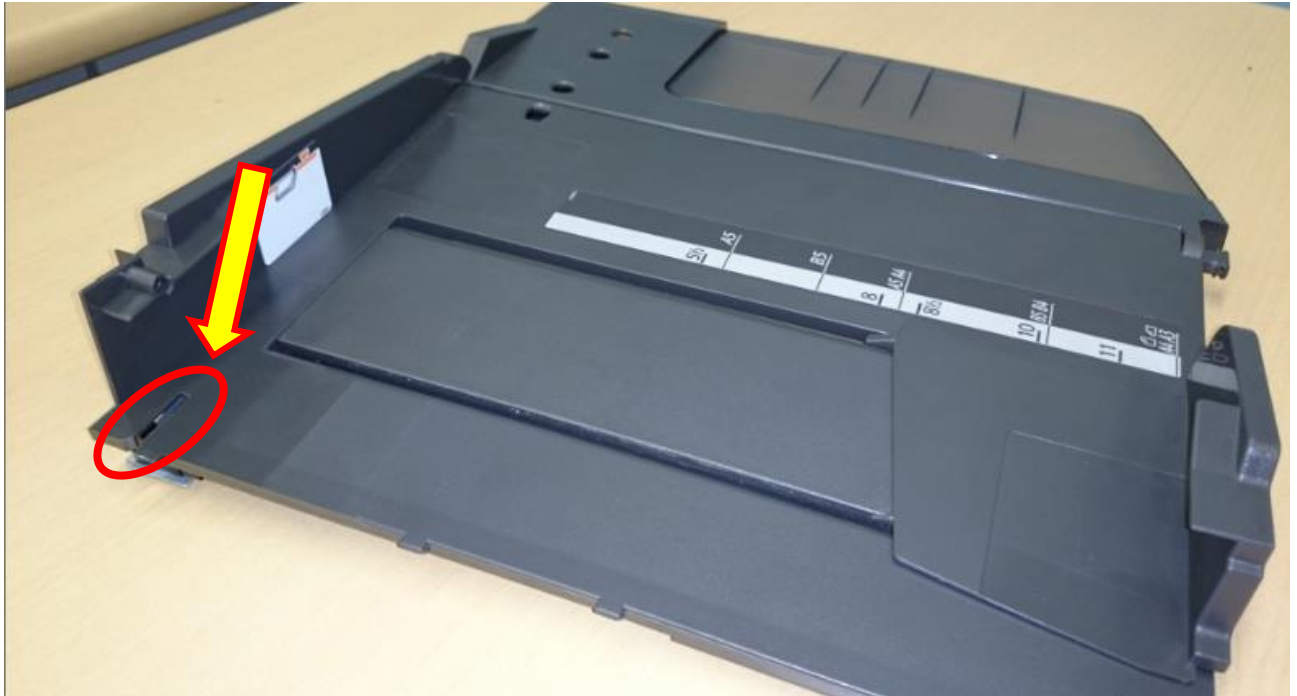
Location:

The shape of the BASE:ORIGINAL TABLE and ORIGINAL SENSOR was changed to avoid possible jams on the last page of an original.

Table below shows the interchangeability. Jam may occur in the combinations indicated NG. Be sure to use new sensor (p/n: AW020190) when replacing the ORIGINAL TABLE.
