SUBJECT: Caution about not mixing different size originals with DF-43

MODEL:

AD-1

Model: AD1 (DF43)		Date: 28-Feb-97	No: 019	1/2
Subject: Black stripes			Prepared by: K. Ugaeri	
From: QAC 2nd Field Information Dept .			Checked by: S. Fujii <i>T. Inoue</i>	
Classification:	<input checked="" type="checkbox"/> Troubleshooting <input type="checkbox"/> Mechanical <input type="checkbox"/> Paper path <input type="checkbox"/> Other ()	<input type="checkbox"/> Part information <input type="checkbox"/> Electrical <input type="checkbox"/> Transmit/receive	<input type="checkbox"/> Action required <input type="checkbox"/> Service manual revision <input type="checkbox"/> Retrofit information

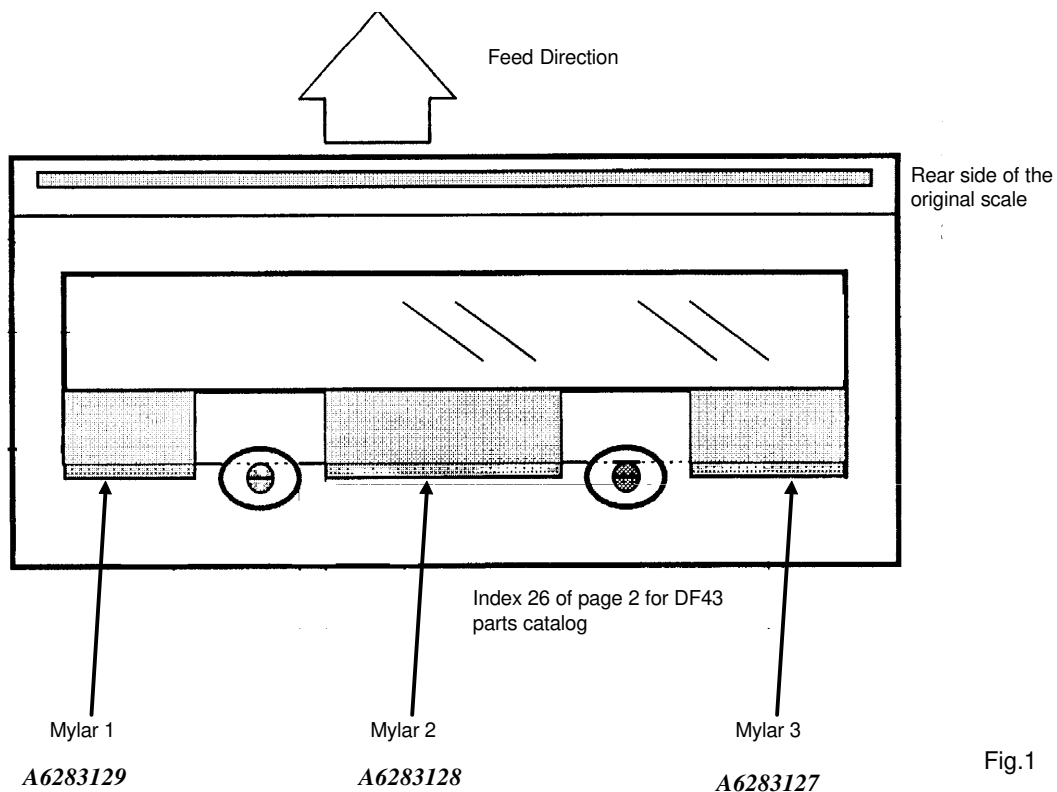
Fig.1

Black stripes when using the sheet scanner

Dust on the exposure glass.

1. The **three** mylars have been added on the original scale (A6283192) to prevent the scanning position on the exposure glass from becoming dirty.

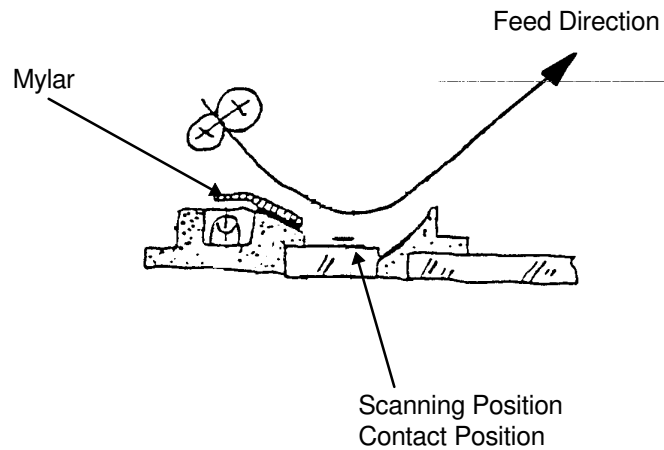
Fig. 2

Because the contact position of the original becomes dirty with paper dust, it has been moved from the scanning position by using mylars.

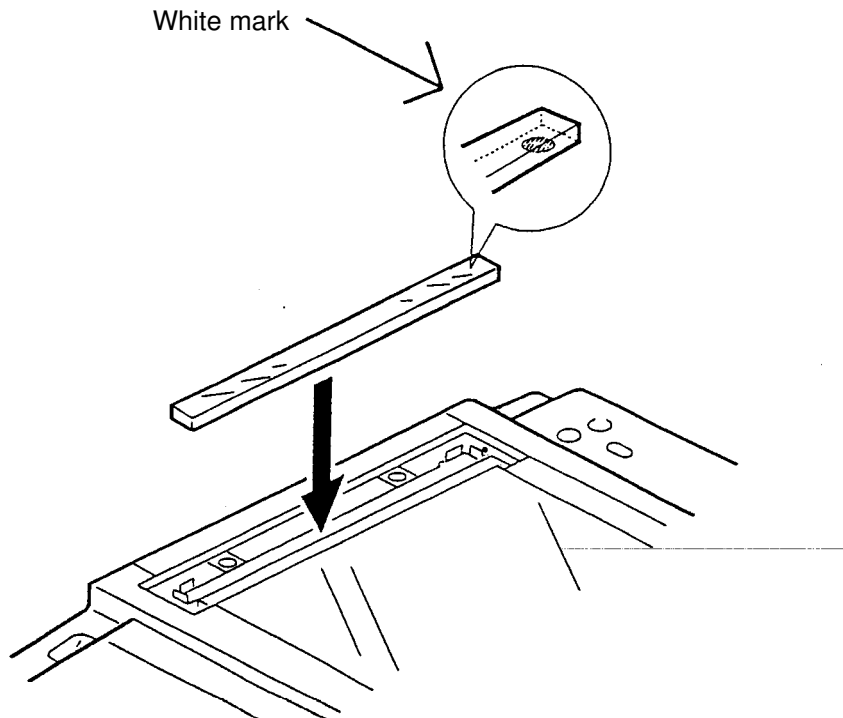
Fig. 3

Note: This exposure glass has a white mark. This mark must be at the bottom rear side at installation.

2. The surface of the exposure glass has been treated by the mater replant process.

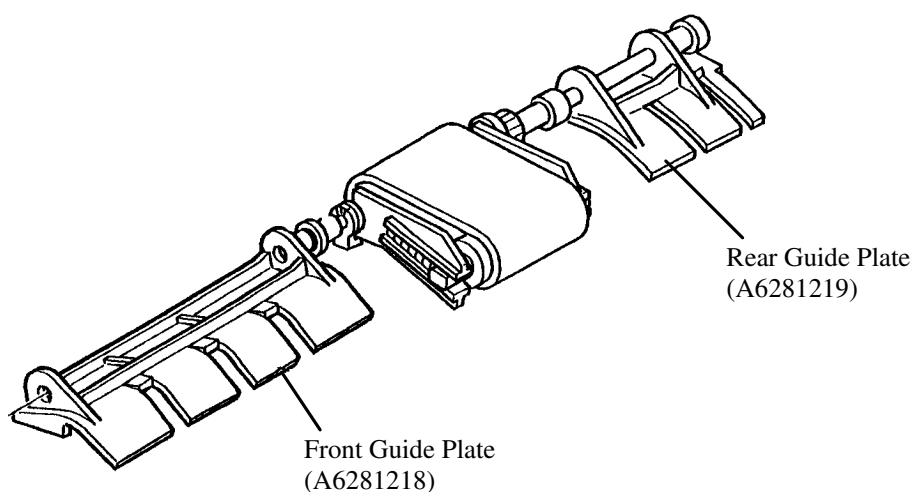
The left cover cannot be closed.

The Front or Rear Guide Plate was accidentally turned to the left when the operator removed a jammed original, because these plates are difficult to see.

The color of the Front and Rear Guide Plates has been changed from black to a clear color.

Current	New
Front Guide Plate	A628 1218B	A628 1218C
Rear Guide Plate	A628 1219B	A628 1219C

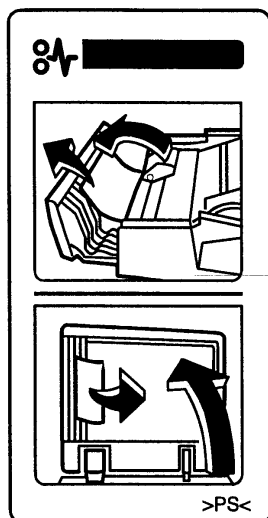
OLD

To make the removal procedure for a jammed original easier to understand, the drawing on the decal has been changed
