SUBJECT: F400/F410 Dual Job Feeder separation belts
(manual correction)

FROM: Copier Technical Support Group

MODEL: F400/F410

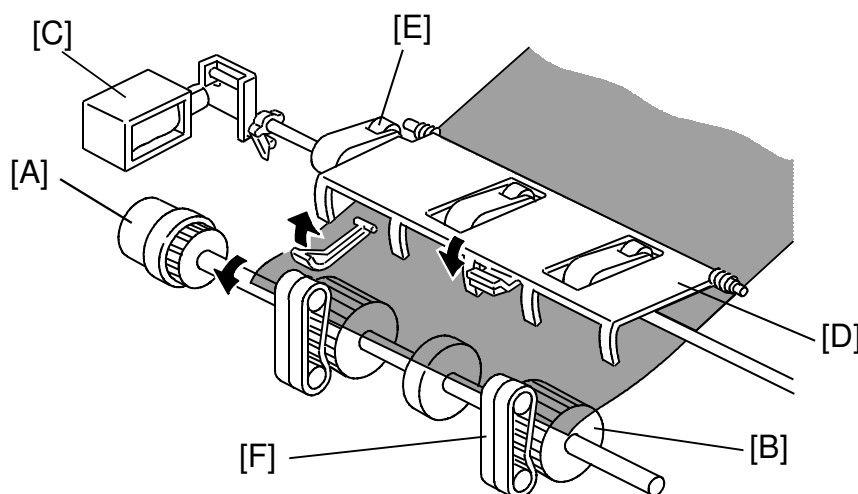
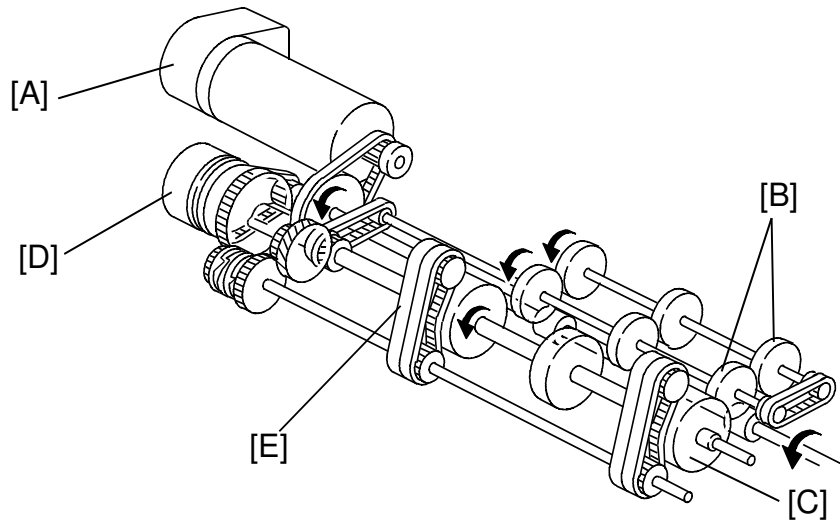
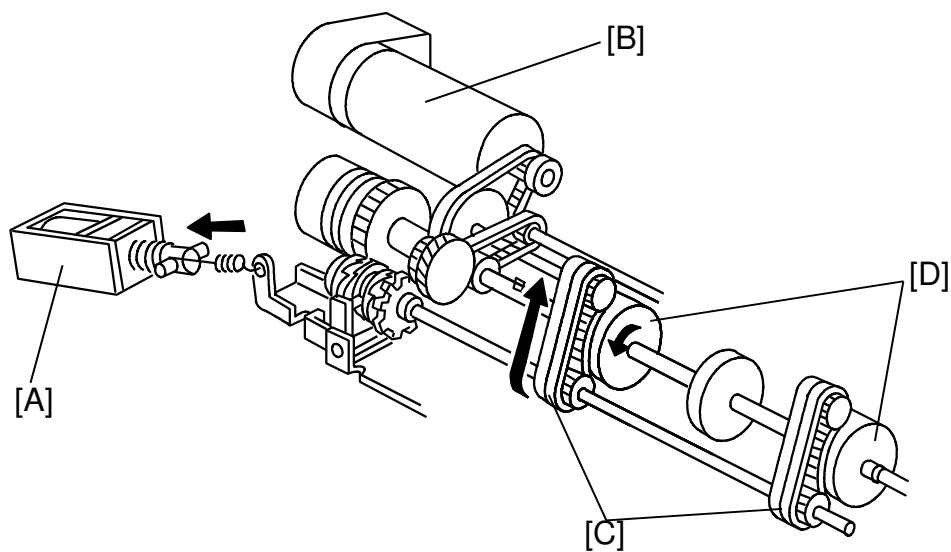
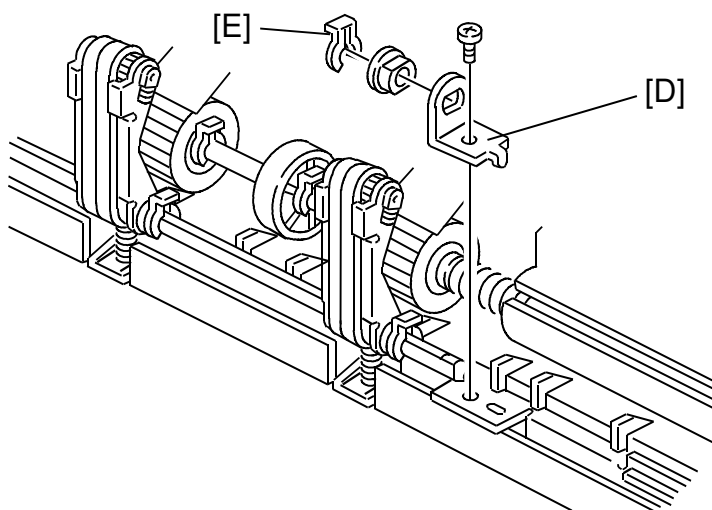
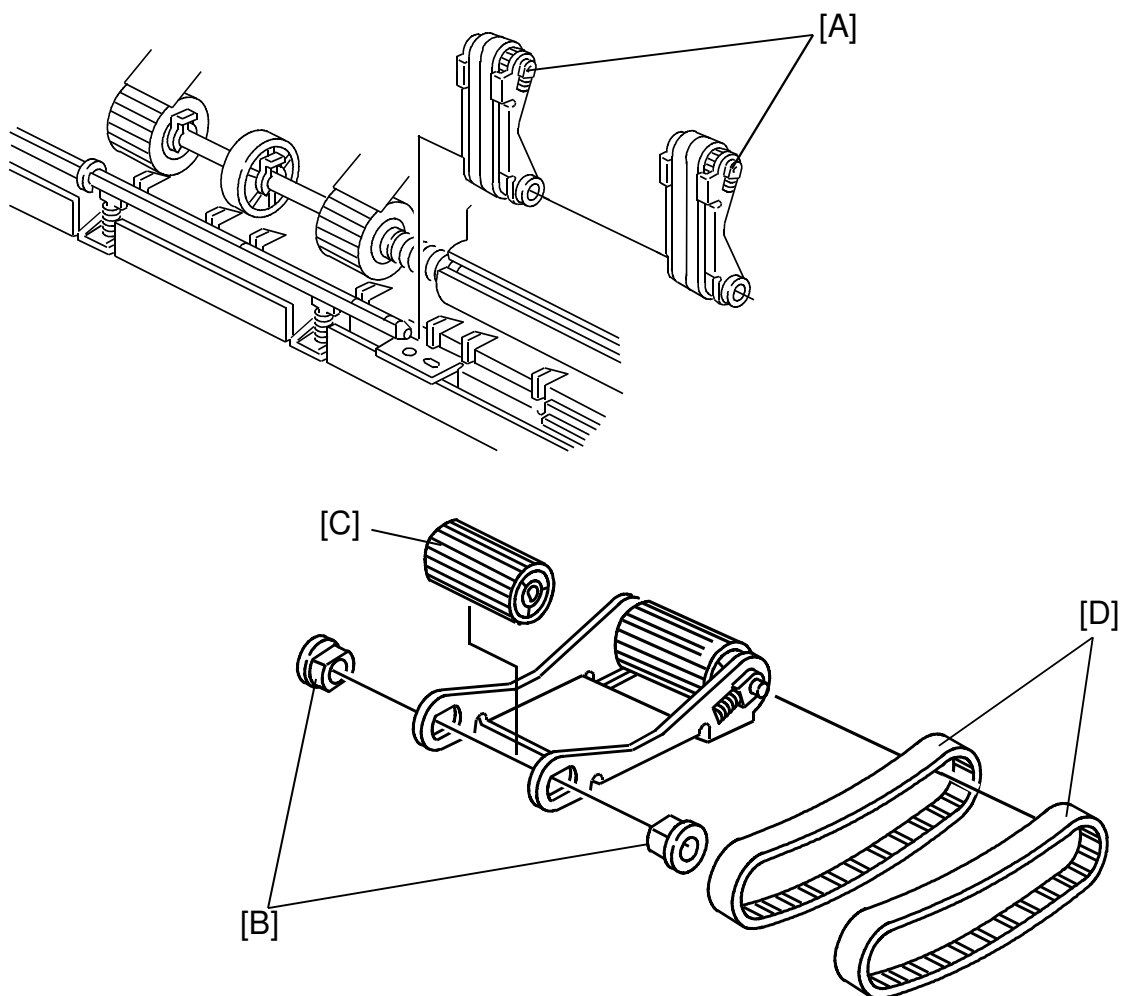
The quantity of the separation belt have been changed from two to four.

On the original printed by the laser printer, the toner may not be fused sufficiently and the image may smeared by the separation belts.

To prevent this, two more separation belts are added to widen the contacting area between the separation belts and the original so that the separation pressure is not concentrated to the narrow area.

Because of this modification, the illustrations in page 7, 14, 15, 34 and 35 should be changed. The quantity of the separation belts should be doubled. There is no correction except illustrations.

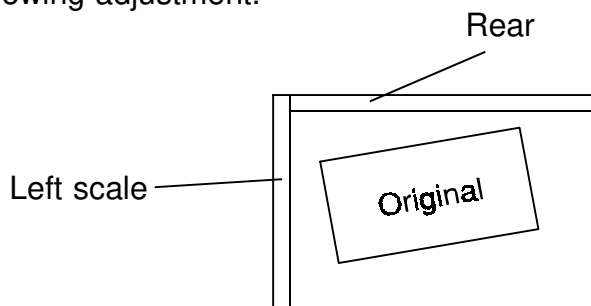
9. DJF Original Skew

If original skews occur as illustrated even if the DJF height is correctly adjusted, perform the following adjustment.

This skew is caused because the transport belt is faster than the feed-in motor speed, even if both motor speeds are within the specification.

1. Feed-in motor speed adjustment

Adjust the feed-in motor speed so that the motor speed becomes higher (within specification).

- 1-1 Turn DIP SW 101-1, 2, 4 to "ON".
- 1-2 Turn DIP SW 102-1 to "ON".
- 1-3 Turn VR 103 towards "H" to turn LED 101 (Red) on.
- 1-4 Turn VR 103 towards "L" to turn LED 102 (Green) on.

2. Transport belt motor speed adjustment

Adjust the transport belt motor speed so that the motor speed becomes lower (within specification).

- 1-1 Turn DIP SW 101-1, 2, 4 to "ON".
- 1-2 Turn DIP SW 102-2 to "ON".
- 1-3 Turn VR 104 towards "L" to turn LED 103 (Red) on.
- 1-4 Turn VR 104 towards "H" to turn LED 102 (Green) on.

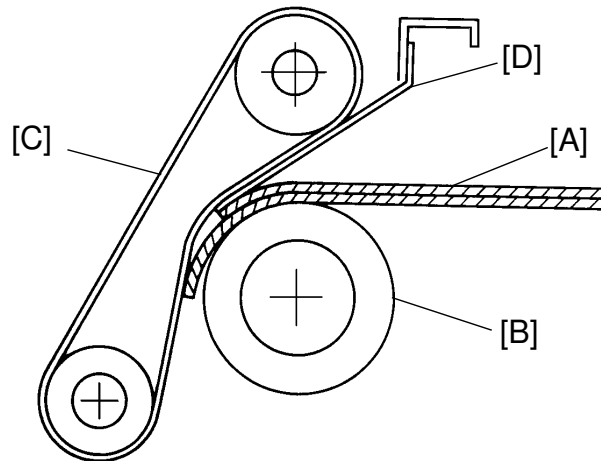
Original multiple feeding occurs when there is high friction between the originals. This tends to occur especially when the originals have staple holes, or computer forms with rough edges.

When the originals [A] comes between the feed rollers [B] and the separation belts [C], they meet the mylar [D] between them and the separation belts. This guide mylar transports the originals smoothly to the gap between the feed rollers and the separation belts. The mylar length determines the original separation force. If the mylar is longer, the area where the originals touch the separation belt becomes narrower, therefore the separation force become weaker. If the mylar is shorter, the separation force becomes stronger. (If it is too short, too much separation force stops original feed)
As a result of our investigation, we found that making the mylar 2mm shorter is the best condition (higher separation ability without feeding error).

Replace the original guide mylars (2 mylars per machine). New part is the assembled part of the mylar and the bracket. New part number is A3761254.

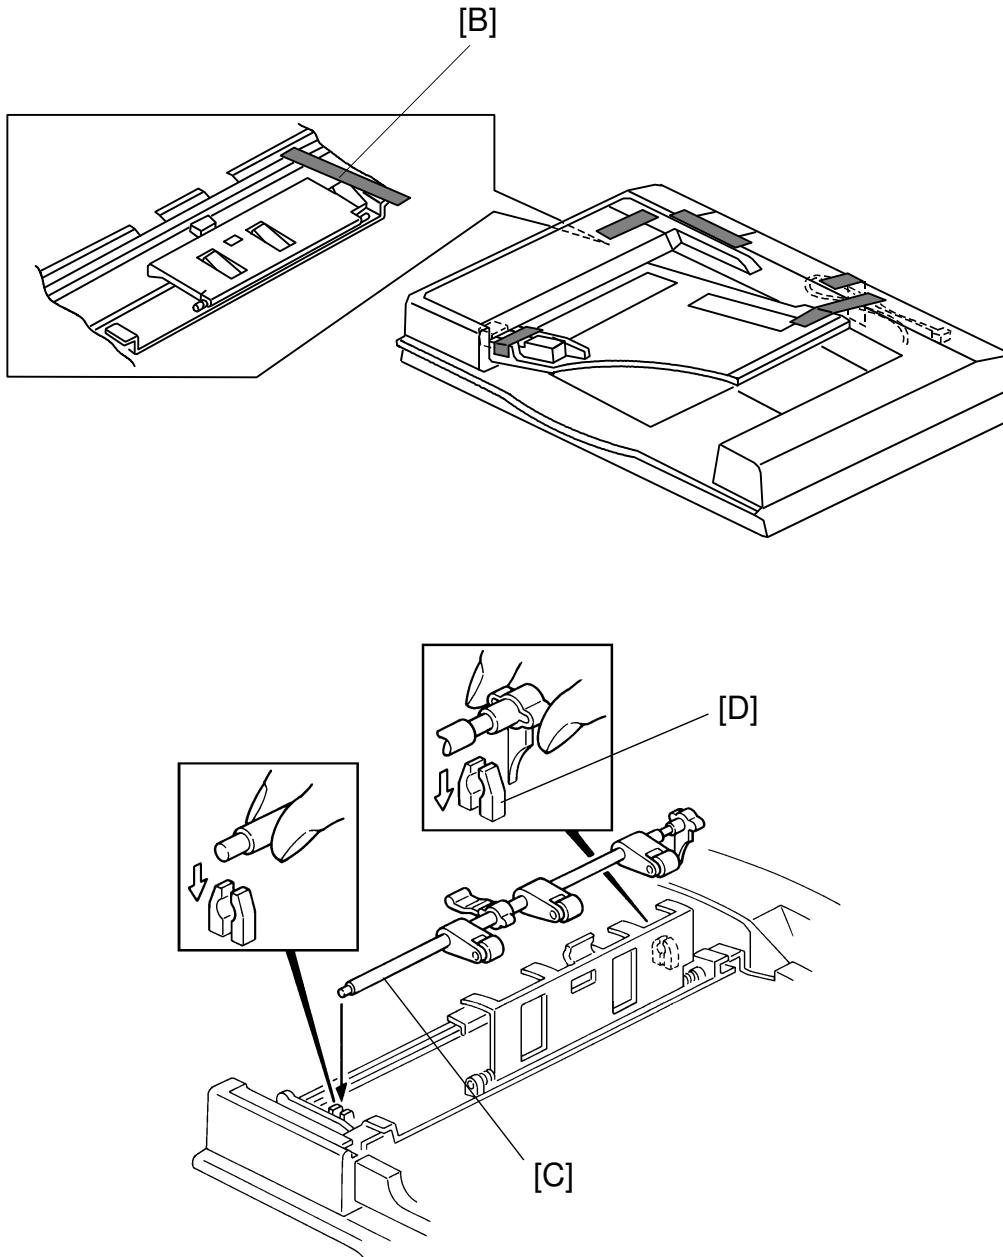
3. Caution for DJF shipping tape removal (dual job feeder service manual - installation procedure page, 24)

When removing the tape [B] fixing the original press roller shaft [C], be careful to confirm that the shaft is correctly in the holder [D]. It is possible that the shipping tape adheres strongly to the shaft. The shaft might be pulled out from the holder when the tape is removed.

If the shaft is out of position, the original will not feed.

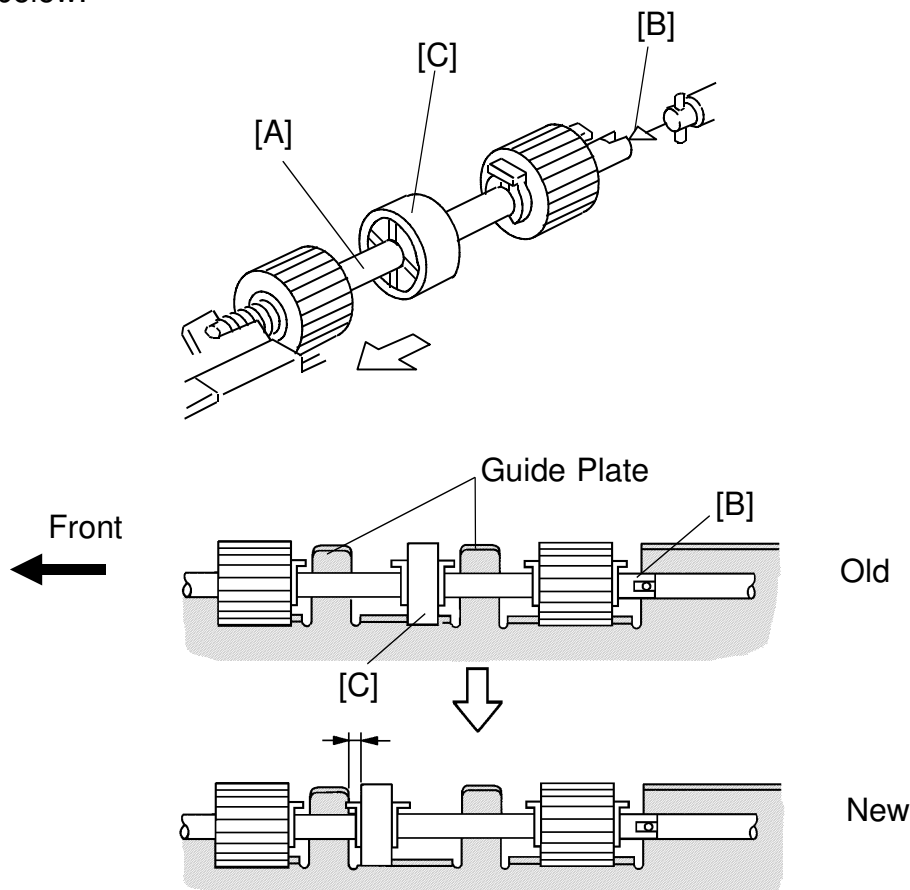
In the domestic market, we have experienced that the customer took off the feed roller assembly [A] when removing a jammed original. When the jammed original is pulled to the front, the feed rollers are pulled to the front and the joint part [B] comes out from the drive shaft. To prevent this, The middle roller [C] position has been changed (to the rear) as shown below.

Before the modification, the middle roller could be shifted to the front when the feed roller was pulled to the front. After the modification, when the feed roller is pulled to the front, the middle roller hits the guide plate and it cannot be moved to the front. This prevents the joint part from being separated by mistake.

To replace the feed roller assembly, the following procedure is necessary before performing step 6 (slide the feed roller assembly to the front, then remove it).

- * Remove the guide mylars
- * Remove the snap ring.
- * Hold the feed roller.

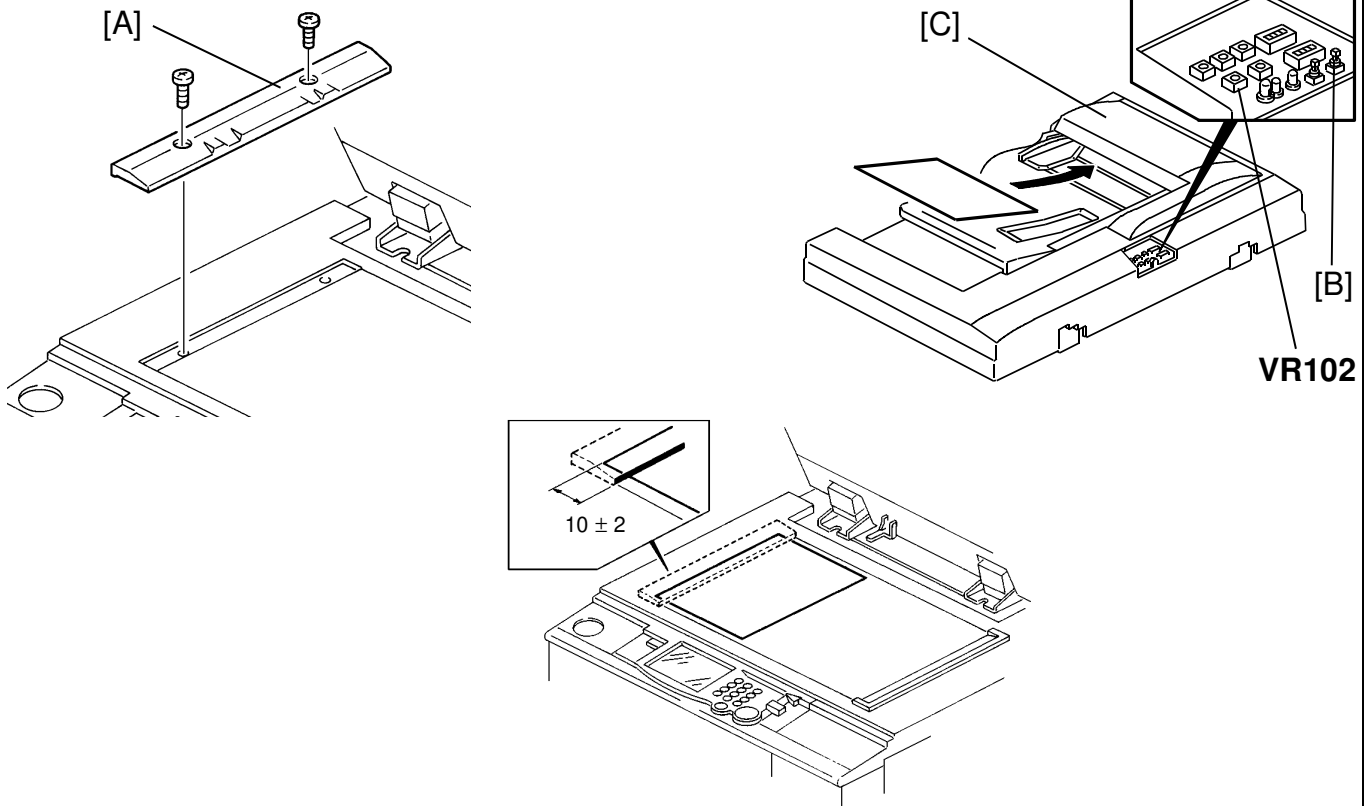
Two Sided Original Mode

Dual job feeders with the following serial numbers have the possibility that the vertical registration for two sided original mode is improper due to insufficient inspection during production.

1. Remove the copier's left scale [A] (2 screws).
2. Remove the small cover at the rear side on the upper DJF cover then turn on DIP SW 101-2, 101-4, and 102-1.
3. Set a sheet of A4 / 8 1/2" x 11" (53 ~ 80 g/m² / 14 ~ 22 lb) paper sideways on the original table.
4. Push SW 101 [B].
5. After the original stops on the exposure glass, gently raise the DJF (so that the original does not move).
6. Confirm that the gap between the trailing edge of the paper and the left edge [C] of the original rear scale is 10 ± 2 mm.
7. If the gap is not within specification, adjust the registration by using the copier SP mode (☐ 1 SP Adjustment - PAGE 6).

1. Before setting the original on the original table again, open and close the feed unit cover [C].
2. After completing the adjustment, return the DIP switches to their original condition.

8. If the registration cannot be adjusted even though the SP data is changed to the maximum value, return the data to "00".
9. Adjust the vertical adjustment by turning VR102 on the DJF main board.

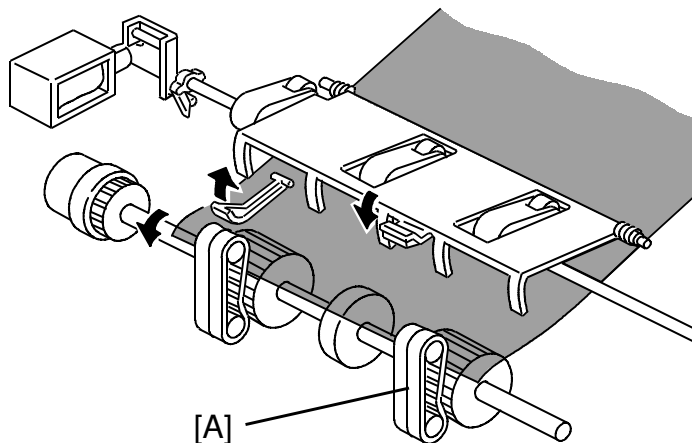
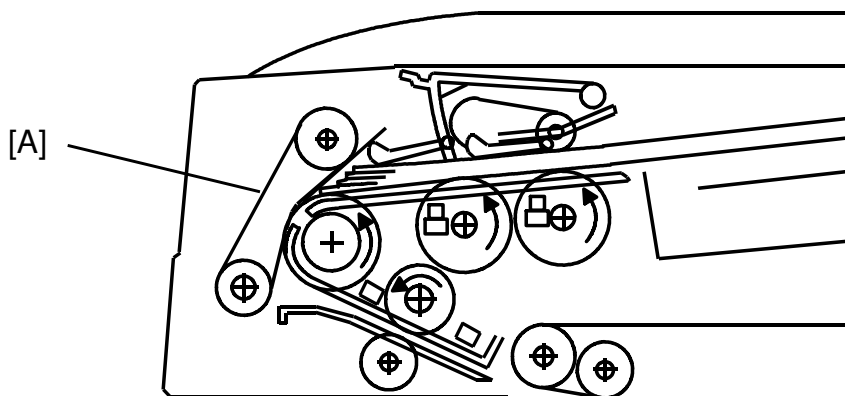
Original double feeding (two originals are fed at a time) tends to occur when the separation belts [A] become dirty with foreign matter which being transferred from the original surface.

When the separation belt surface is covered with foreign matter, the friction between the original and the separation belt decreases. This reduces the original separation ability.

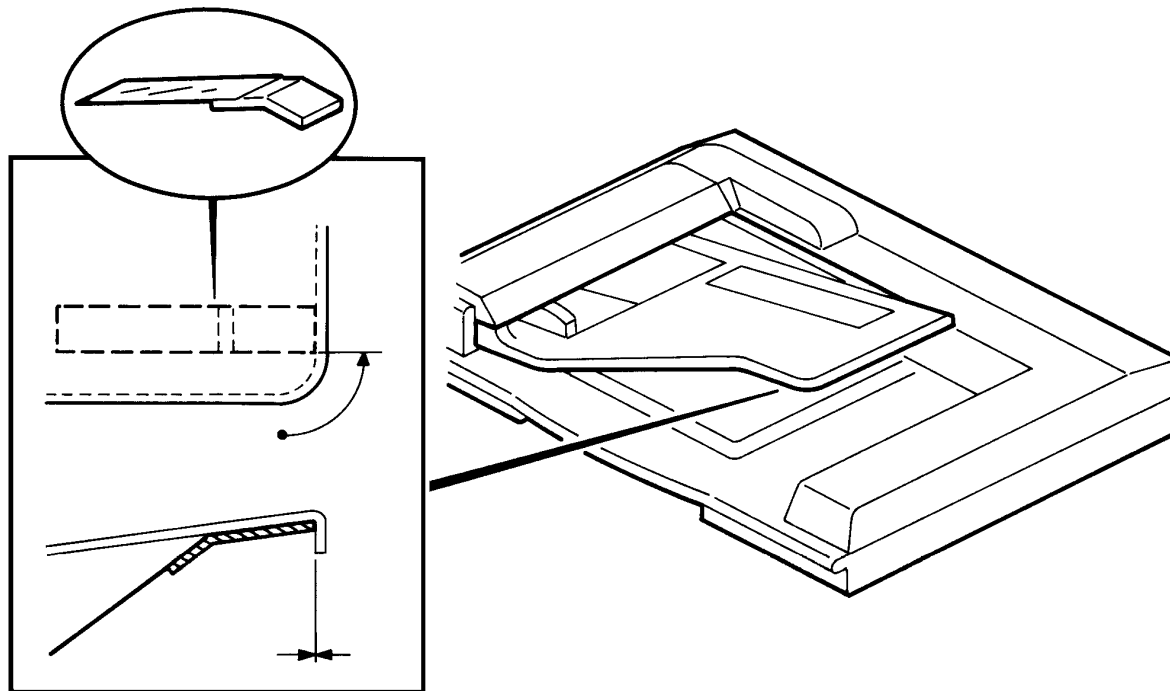
During auto counting mode, the original delivery speed varies. The original stack alignment become irregular, and in the worst case, the original order changes.

When the original is delivered in auto counting mode, the original exit motor changes its speed. Just before the trailing edge of the original passes through the exit roller, its speed decreases to correct the original stack. Normally the original exit motor changes to the quicker speed after completely feeding out the original. However, sometimes, the exit motor returns to the quicker speed before the original trailing edge passes through the exit roller. In this case, the original is pushed out quickly, resulting in the irregular original stack.

The original stack guide mylar is added. This mylar is attached to the DJF as an accessory. Please install the mylar at installation as shown in the illustration below.

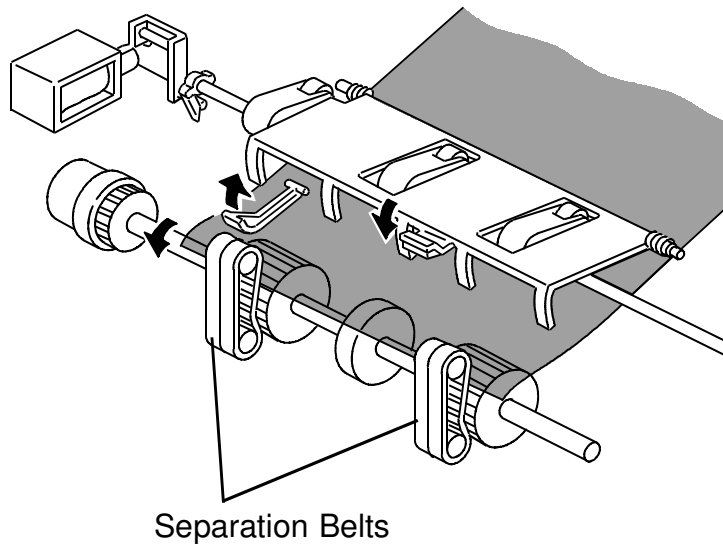
Original double feeding (two or more sheets of the originals are fed at a time)

The separation belts become dirty with the toner, losing the friction to separate the originals.

This is especially true when the customer feeds lots of poorly fused originals such as laser output or cotton paper.

Replace the separation belts with the new parts. The new part number is A3769502.

The material of the separation belts has been changed to the one which less toner adheres to.

To completely eliminate the original double/multiple feeding, replace both original guide mylar (new part number A3761254) and separation belts.

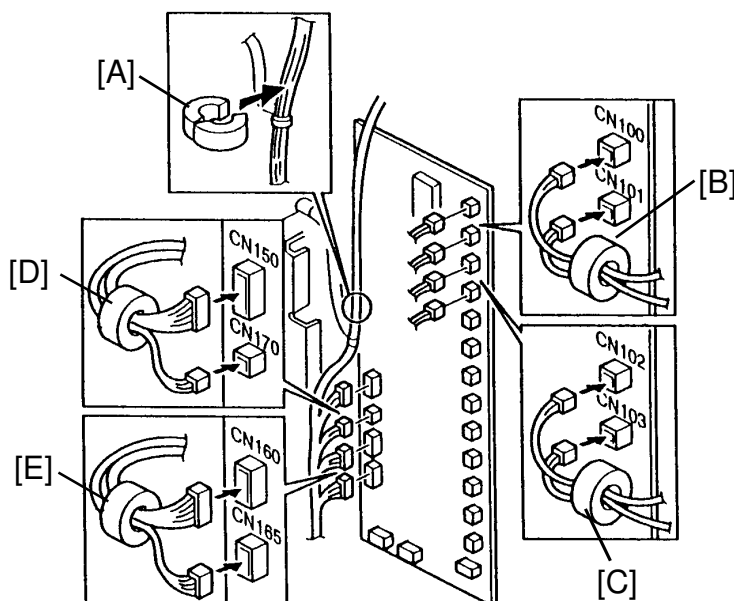
To comply with the CE mark, it is necessary to attach five ferrite cores when installing a sorter on DFC - α . The ferrite cores have been enclosed in the screw bag of the DFC - α from September production. Please refer to the following for the installation procedure of the ferrite cores.

4. Attach the ferrite core ([A] P/N 16070721) to the DC harness as shown.

5. Remove the harnesses for second bin solenoid (CN100) and third bin solenoid (CN101). Pass the both harnesses through the ferrite core ([B] P/N 16070418) and reconnect them to the sorter main board.

6. Remove the harnesses for the fourth bin solenoid (CN102) and the fifth bin solenoid (CN103). Pass the both harnesses through the ferrite core ([C] P/N 16070418) and reconnect them to the sorter main board.

7. Remove the harnesses for the encoder (CN150) and the entry sensor LED (CN170). Pass the both harnesses through the ferrite core ([D] P/N 16070418) and reconnect them to the sorter main board.

8. Remove the harnesses for the entry sensor Phototransistor (CN160) and the inlet sensor (CN165). Pass the both harnesses through the ferrite core ([E] P/N 16070418) and reconnect them to the sorter main board.
