SUBJECT: DF61 Dirty Mark on Back-side of Original

Phoenix-series
(DF61)

Model: DF61 (Phoenix series)		Date: 15-Aug-97	No: 20
Subject: Bent Original		Prepared by: S.Hizen	
From: QAC 1st Field Information Dept.			
Classification:	<input checked="" type="checkbox"/> Troubleshooting	<input type="checkbox"/> Part information	<input type="checkbox"/> Action required
	<input type="checkbox"/> Mechanical	<input type="checkbox"/> Electrical	<input type="checkbox"/> Service manual revision
	<input type="checkbox"/> Paper path	<input type="checkbox"/> Transmit/receive	<input type="checkbox"/> Retrofit information
	<input type="checkbox"/> Other ()

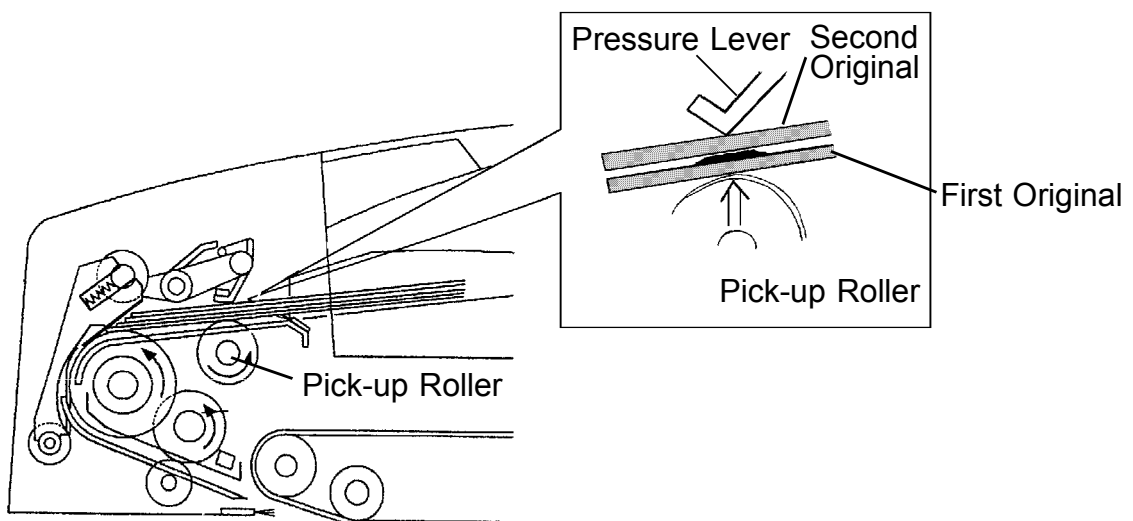
Problem: Three dirty marks on the back side of the original.

Cause: The toner on the first original is transferred to the back of the second original due to the pressure applied by the pressure lever and the pick-up roller.
(See the illustration)

The dirty marks created are one of the limitations of the DF61. The degree to which the marks appear varies depending on how completely the image on the first original is fused, the type of image, and the type of paper used.

The countermeasure for the dirty marks is designed to reduce the pressure applied to the originals by replacing the entrance guide stopper spring with a new one. This change also results in a decrease in the amount of force used to feed the original and may create an original non-feed problem. Therefore, the separation bracket has been modified to reduce the angle by 2 degrees.

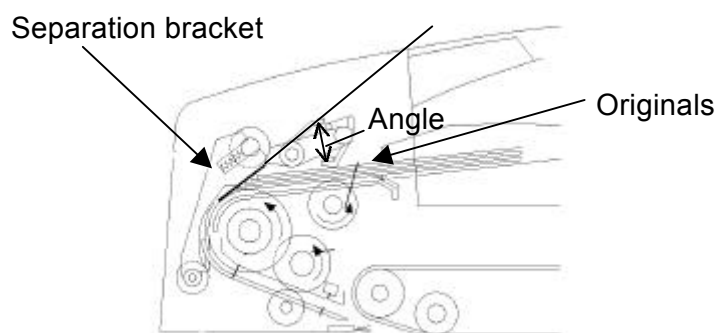
There is a bend (wrapping) on the leading edge of the original the same size as the width of the separation belt. If the bend in the original is large, dirty background may appear on the copy in the area that corresponds with that bend.

The problem occurs as a result of the contact between the edge of the original and the separation belt when the original is fed to the exposure glass. If the upward curl of the original is large or the cut in the leading edge of the paper is not smooth, this problem is more likely to occur.

The angle between the separation belt and the originals, and the symptoms caused by the angle.

Large: Good for separation, marginal for original leading edge bending

Small: Good for original leading edge bending, marginal for double-sheet feeds.

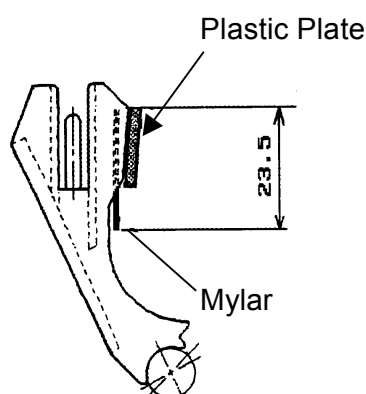
Separation bracket

Mass-production.

A548-1291

Bracket Spring: AA06-3503

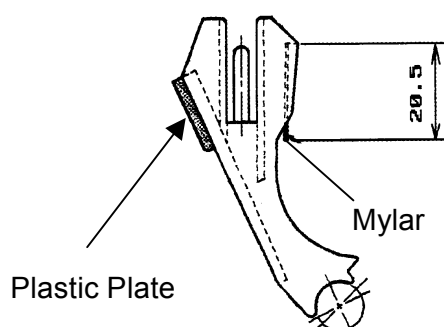
**RTB-11**

Bracket for the dirty mark
on the back side of original.

A548-9502

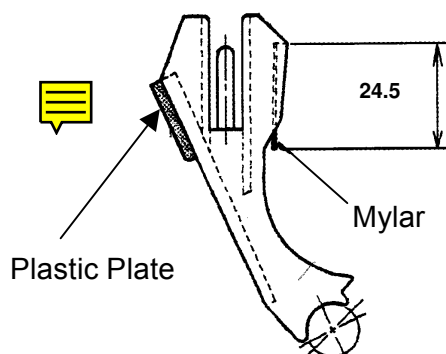
**RTB-20**

Bracket for the leading edge
bend.

A548-9504

(This number is for the Bracket and the Spring)
