Model: Phoenix II /Cattleya/Iris/Lilac (ADF)		Date: 15-Sep-99	No.: RA204010
Subject: ADF Jam		Prepared by: H.Matsui	
From: Technical Service Dept., GTS Division			
Classification:	<input checked="" type="checkbox"/> Troubleshooting <input type="checkbox"/> Part information <input type="checkbox"/> Action required <input type="checkbox"/> Mechanical <input type="checkbox"/> Electrical <input type="checkbox"/> Service manual revision <input type="checkbox"/> Paper path <input type="checkbox"/> Transmit/receive <input type="checkbox"/> Retrofit information <input type="checkbox"/> Other ()

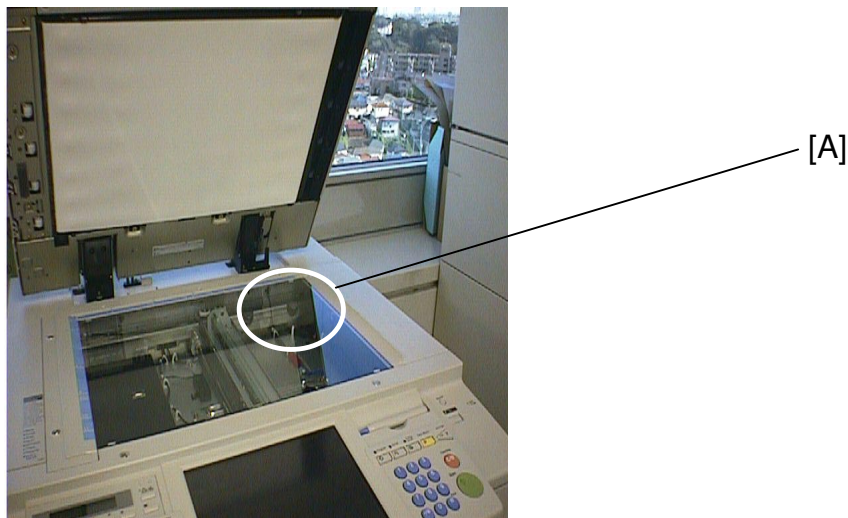
When feeding small size originals lengthwise, a original jam may occur in the area on the exposure glass where the original is to be fed out (position [A]).

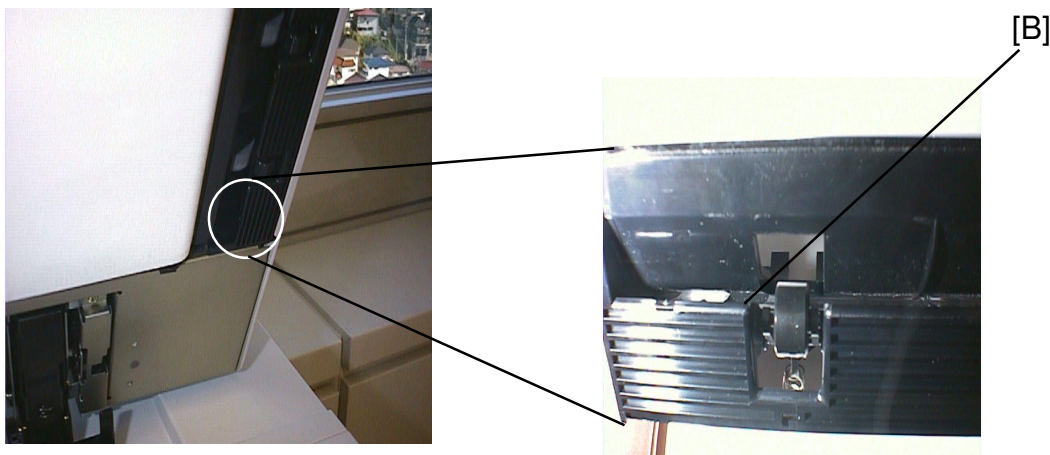
The rear side of the leading edge of the originals catches ridge [B] (this ridge was created during the molding process), near one of the ribs of the paper inverter guide plate (P/No. A5481210).

Until the permanent countermeasure is implemented, the ridge [B] should be smoothed down (remove if possible) with sandpaper.

From the serial numbers in the following table, a permanent countermeasure will be applied (the mold used to produce the inverter guide plate will be repaired). Therefore, the above action should not have to be done.
