Model: NAD 30S/30/40 DF (DF67)		Date: 15-Oct-98	No.: 1
Subject: Original MIsfeed		Prepared by: S. Hizen	
From: GTS and S Field Information Dept.			
Classification:	<input checked="" type="checkbox"/> Troubleshooting <input type="checkbox"/> Mechanical <input type="checkbox"/> Paper path <input type="checkbox"/> Other ()	<input type="checkbox"/> Part information <input type="checkbox"/> Electrical <input type="checkbox"/> Transmit/receive	<input type="checkbox"/> Action required <input type="checkbox"/> Service manual revision <input type="checkbox"/> Retrofit information

Model: NAD 30S/30/40 (DF67)		Date: 17-Apr-00	No.: RA230058
Subject: Software Release Information		Prepared by: E. Fukuyama	
From: Technical Services Dept., GTS Division			
Classification:	<input type="checkbox"/> Troubleshooting <input type="checkbox"/> Part information <input type="checkbox"/> Action required <input type="checkbox"/> Mechanical <input type="checkbox"/> Electrical <input type="checkbox"/> Service manual revision <input type="checkbox"/> Paper path <input type="checkbox"/> Transmit/receive <input type="checkbox"/> Retrofit information <input checked="" type="checkbox"/> Other ()

Model: NAD 30S/30/

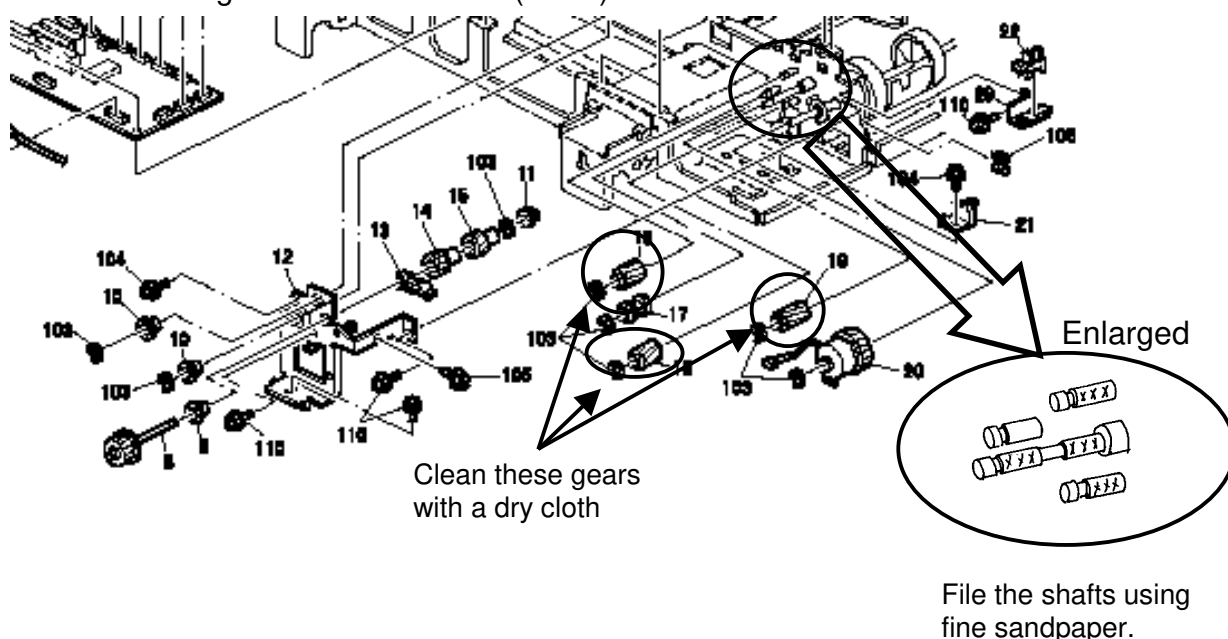
Original feed jam: The original is jammed just after the front edge is fed about 10 cm (A4/LT size) onto the exposure glass.

The friction between the 16Z gear and its shaft increases and exceeds the maximum torque of the feed motor. This is due to tiny burrs on the shaft.

The burrs on the shaft may be too tiny to be visible. You can check for burrs by removing the retaining rings and moving the 16Z gears back and forth slowly by hand. If the gear seems to be stuck, then burrs exist.

File off the tiny burrs on the shaft and lubricate as shown in the following procedure.

1. Take off the retaining rings for the 16Z gears.
 2. File the shafts using fine sandpaper. (Do not use a metal file to file the shaft because this will increase the friction.)
 3. Clean the shafts and the inside of the gears with a dry cloth.
 4. Lubricate the shafts and the inside of the gears with plastic grease (white resin based grease for plastic parts).
 5. Reassemble the gears and the rings.
- Parts Catalog: 7. Drive Section 2 (A680) -
