Model: Decurl Unit DU5000 (D457)	Date: 09-Sep-09	No.: RD457001a
----------------------------------	-----------------	----------------

RTB Reissue

Subject: Undetected roller unit due to deformed feeler		Prepared by: K. Tsutsui	
From: PPMC Service Planning Department 1G			
Classification:	<input type="checkbox"/> Troubleshooting <input type="checkbox"/> Mechanical <input type="checkbox"/> Paper path <input type="checkbox"/> Product Safety	<input type="checkbox"/> Part information <input type="checkbox"/> Electrical <input type="checkbox"/> Transmit/receive <input type="checkbox"/> Other ()	<input checked="" type="checkbox"/> Action required <input type="checkbox"/> Service manual revision <input type="checkbox"/> Retrofit information <input type="checkbox"/> Tier2

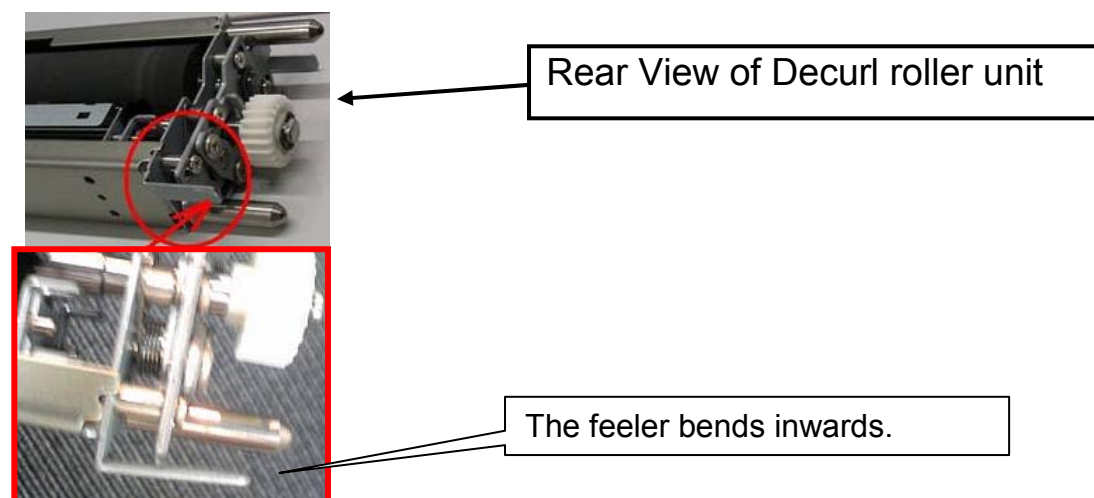
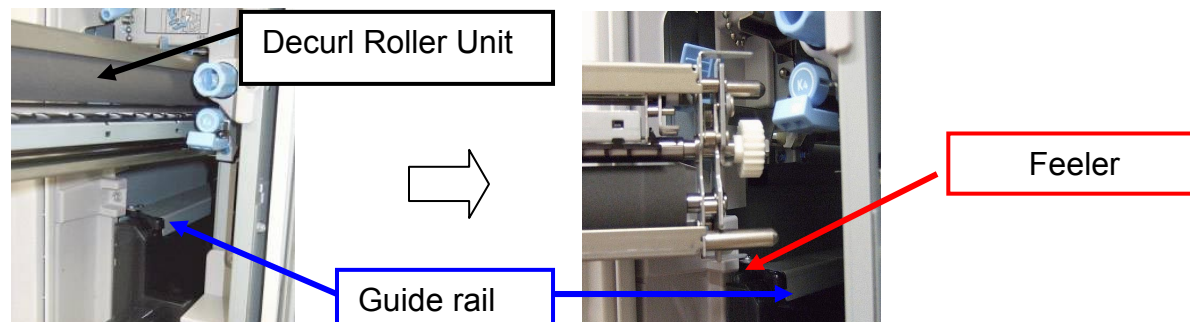
A message indicating "Set Decurler correctly." could appear on the operation panel when the Decurl unit is set after being removed.

When pulling out the roller unit, the feeler, which is positioned to fit between the sensors, hits another component (such as the guide rail) and deforms due to its own weight, causing it to incorrectly fit in a position where it cannot be detected by the sensors.

Fix the bent feeler with pliers or a similar tool so that the feeler will be inserted into the correct position and detected by the decurl unit set sensor.

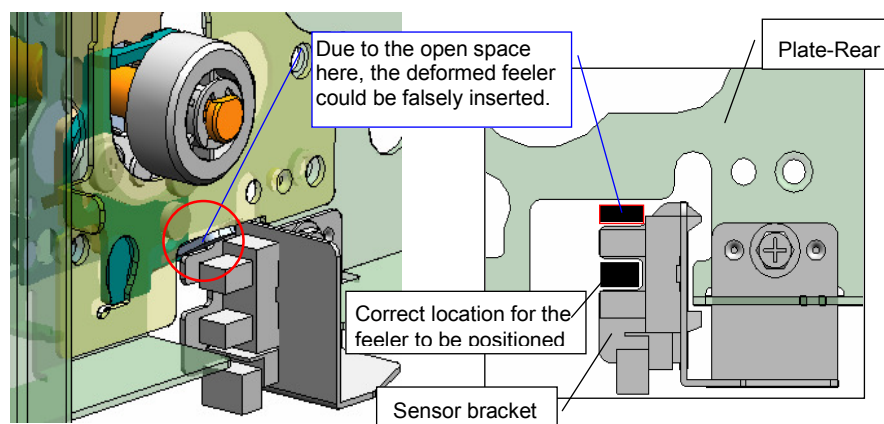
The decurl unit set sensor cannot detect the feeler when the feeler is falsely inserted into the area colored red in the following diagram.

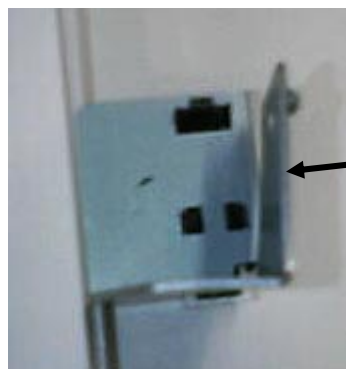
Deformed sensor bracket

In addition to the above "countermeasure 1", please replace with the modified sensor bracket if it is deformed.

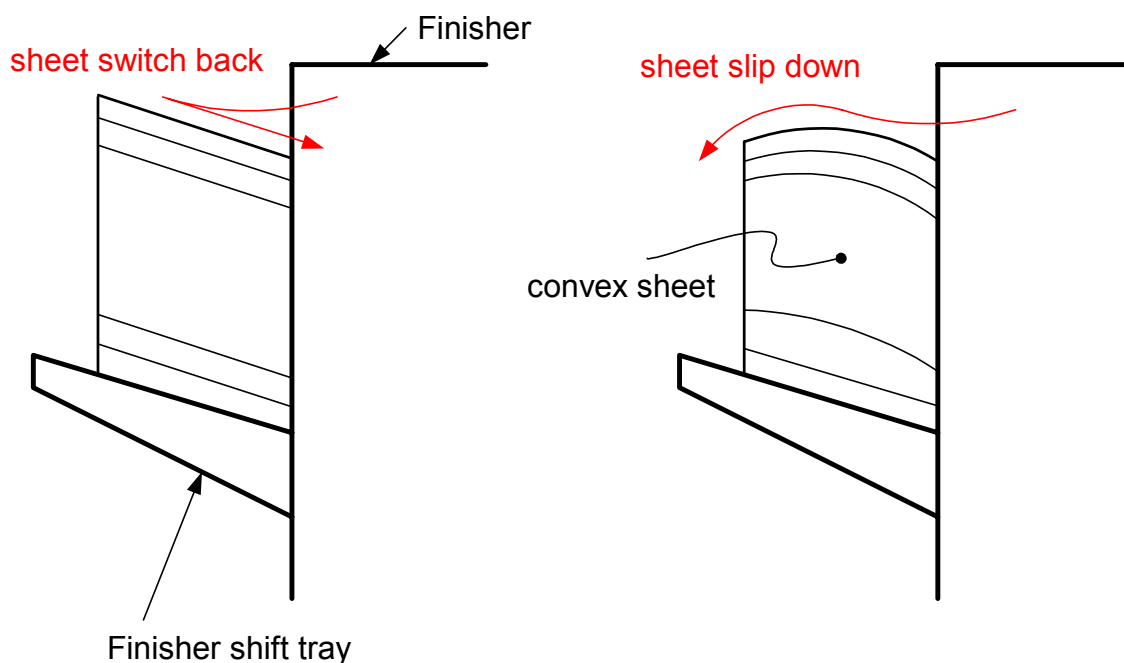
When convex-curved sheets are stacked on the Finisher shift tray, they could slip down from the tray to the ground.

The exited sheets are switched back on the Finisher shift tray, which is at an angle. However, when the sheets have convex curl and are stacked in a large amount, the slope becomes flat at the top of the stack. The flat stack stops the exited sheets from switching back and causes them to slip over due to their momentum.

Set the de-curl roller unit upside down and adjust the value in the User Tools. Refer to the service manual and the operation manuals.

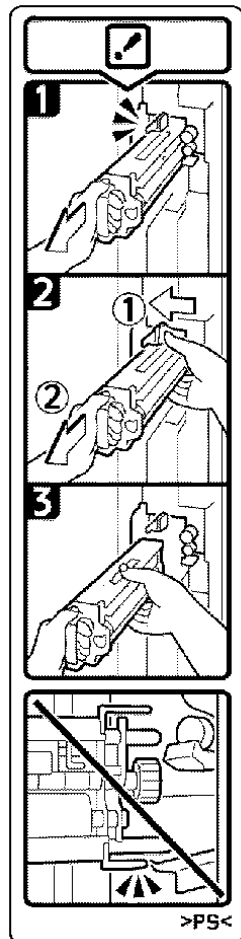
Decal figure

Symptom: Feeler bent in the roller unit.

Solution: Added a decal to draw attention.

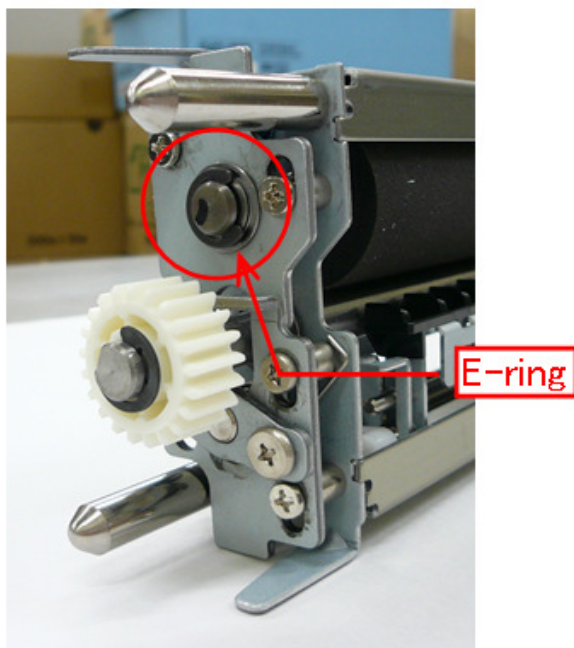
NOT Modified

Jam occurs after approximately 5000k. (Based on the APV of 300k, the jam is expected to occur approximately 16.6 months after installation.)

Replace with the modified unit if the “NOT Modified” version is installed.
