Model: Iris2/Lilac2 (Controller E-310)		Date: 21-Mar-01	No.: RB017008
Subject: E-310 Ver.1.1 (128MB) model release		Prepared by: Chisato Tsuji	
From: Technical Services Dept., GTS Division			
Classification:	<input type="checkbox"/> Troubleshooting <input checked="" type="checkbox"/> Part information <input type="checkbox"/> Action required <input type="checkbox"/> Mechanical <input type="checkbox"/> Electrical <input checked="" type="checkbox"/> Service manual revision <input type="checkbox"/> Paper path <input type="checkbox"/> Transmit/receive <input type="checkbox"/> Retrofit information <input type="checkbox"/> Other ()

Model: Iris2/Lilac2 Controller E-310		Date: 15-Nov-01	No.: RG938001
Subject: "Please Wait", White Line Scans, etc.		Prepared by: Chisato Tsuji	
From: Technical Services Dept., GTS Division			
Classification:	<input checked="" type="checkbox"/> Troubleshooting <input type="checkbox"/> Part information <input type="checkbox"/> Action required <input type="checkbox"/> Mechanical <input type="checkbox"/> Electrical <input type="checkbox"/> Service manual revision <input type="checkbox"/> Paper path <input type="checkbox"/> Transmit/receive <input type="checkbox"/>

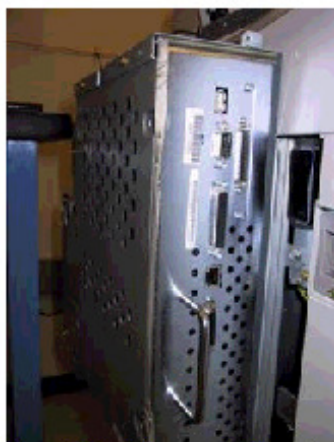
1. Some units were shipped from the factory with the connector in the condition shown in Fig. A below, i.e. the connector was not sticking out at least 4.2mm from the unit (as it should).
2. The connector clears the unit side face by at least 4.2mm, but the controller unit was not inserted far enough into the interface unit at installation (Fig. 1-4 below).

Figure 1 Front view – not fully seated

1. Shut down the Fiery system and turn off the copier main power.
2. Pull out the Fiery controller unit and check to see if the video interface connector sticks out from the unit 4.2mm or more (Fig. A). If not, then follow the instructions in Fig. B below.
3. Fully reseat the controller all the way into the interface unit until the connector fully engages (Fig. 5, 6).
4. Turn on the copier main power.

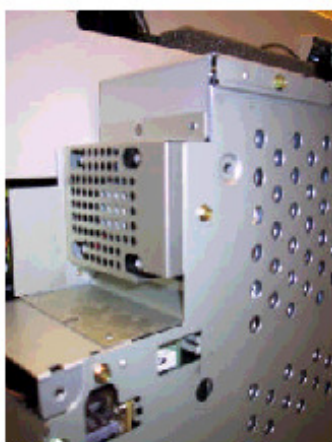
Figure 2 Rear view – not fully seated

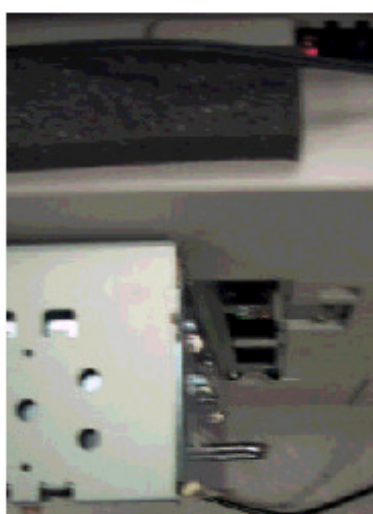
Figure 3 Top view – not fully seated
