Model: Cattleya2 Controller E-710		Date: 15-Nov-01	No.: RG939001
Subject: "Please Wait", White Line Scans, etc.		Prepared by: Chisato Tsuji	
From: Technical Services Dept., GTS Division			
Classification:	<input checked="" type="checkbox"/> Troubleshooting <input type="checkbox"/> Part information <input type="checkbox"/> Action required <input type="checkbox"/> Mechanical <input type="checkbox"/> Electrical <input type="checkbox"/> Service manual revision <input type="checkbox"/> Paper path <input type="checkbox"/> Transmit/receive <input type="checkbox"/> Retrofit information <input type="checkbox"/> Other (      )

Model: Cattleya2		Date: 19-Jul-02	No.: RG939002
Subject: E-710 System Version 1.01 Release Information		Prepared by: Chisato Tsuji	
From: Technical Services sec. Service Planning Dept.			
Classification:	<input type="checkbox"/> Troubleshooting <input type="checkbox"/> Mechanical <input type="checkbox"/> Paper path <input type="checkbox"/> Other (      )	<input type="checkbox"/> Part information <input type="checkbox"/> Electrical <input type="checkbox"/> Transmit/receive	<input checked="" type="checkbox"/> Action required <input type="checkbox"/> Service manual revis

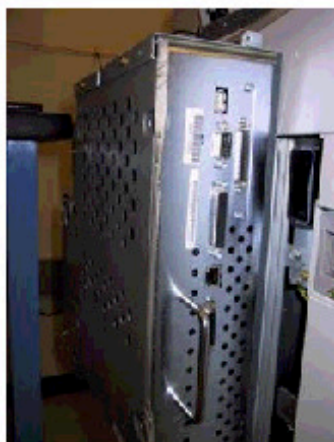
1. Some units were shipped from the factory with the connector in the condition shown in Fig. A below, i.e. the connector was not sticking out at least 4.2mm from the unit (as it should).
2. The connector clears the unit side face by at least 4.2mm, but the controller unit was not inserted far enough into the interface unit at installation (Fig. 1-4 below).

Figure 1 Front view – not fully seated

1. Shut down the Fiery system and turn off the copier main power.
2. Pull out the Fiery controller unit and check to see if the video interface connector sticks out from the unit 4.2mm or more (Fig. A). If not, then follow the instructions in Fig. B below.
3. Fully reseal the controller all the way into the interface unit until the connector fully engages (Fig. 5, 6).
4. Turn on the copier main power.

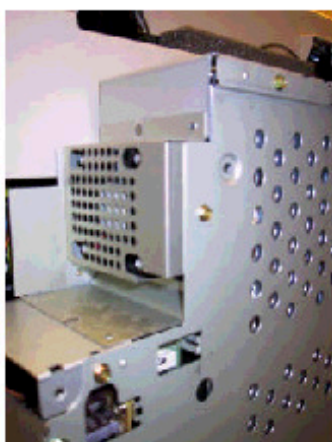
Figure 2 Rear view – not fully seated

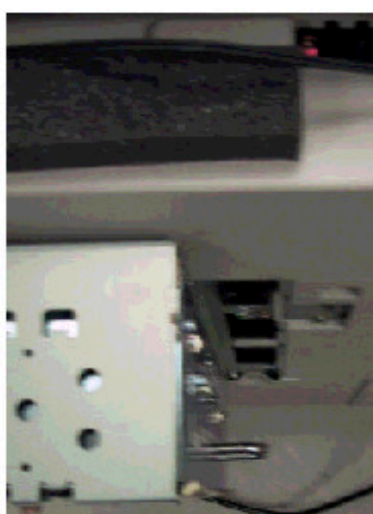
Figure 3 Top view – not fully seated

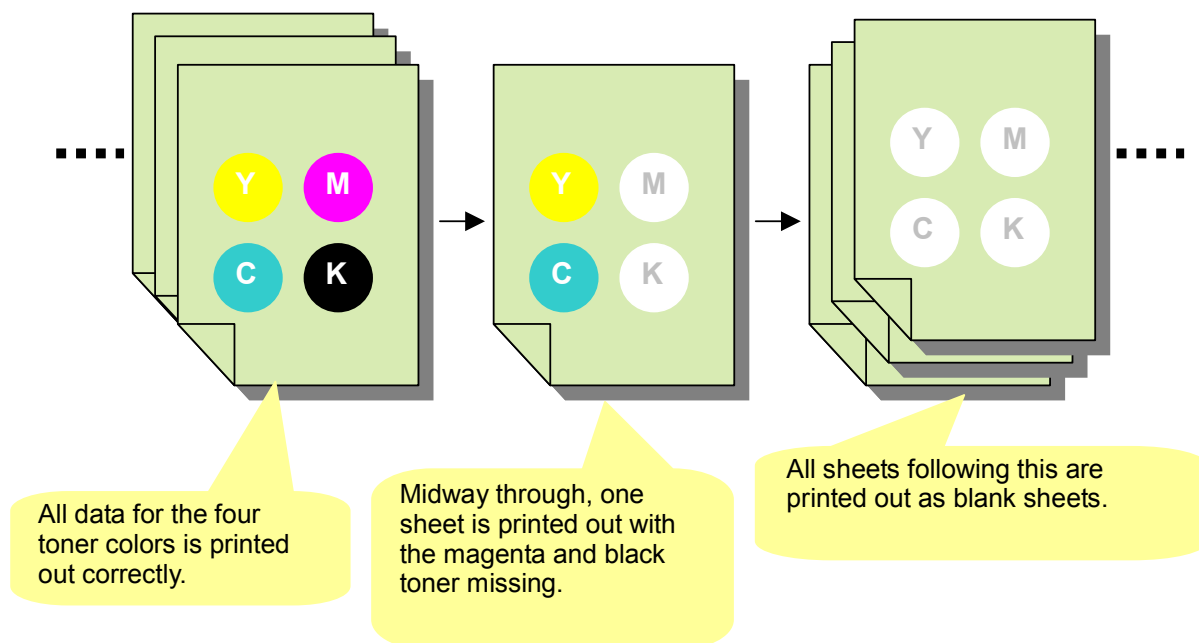
### Symptom A

Midway through a job set for a large number of prints, one sheet is missing both magenta and black toner. Following this sheet, the machine prints out blank sheets until the job is reset, completed, or resumed after being interrupted (e.g. after toner/paper replenishment).

When the following two events occur simultaneously, a bug in the controller software disrupts the timing of the color plate data transmission to the engine.

Install patch file: 1-8RD6Y.ps

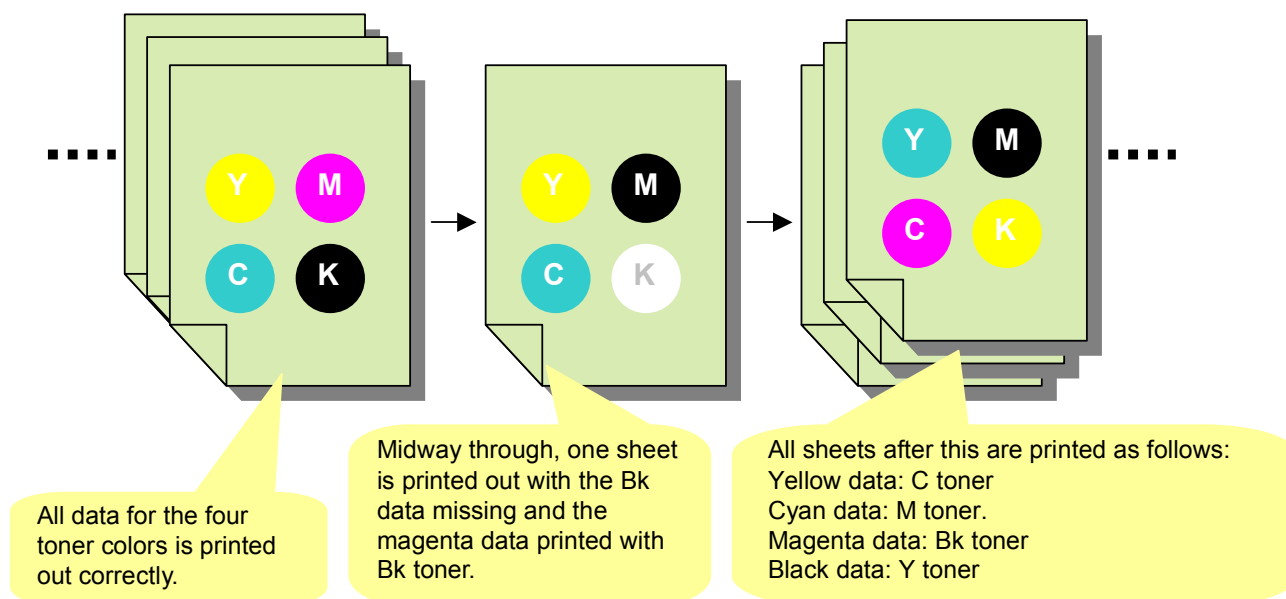
## Symptom B

Midway through a job set for a large number of prints, one sheet has the magenta data printed out with black toner, and the black data missing. All sheets are then printed out as shown in the bottom right illustration (i.e.  $Y \rightarrow C$ ,  $C \rightarrow M$ ,  $M \rightarrow K$ ,  $K \rightarrow Y$ ) until the job is reset, completed or resumed after being interrupted.

With Symptom B, a delay in the transmission of the magenta color plate causes the engine to receive this data while performing black toner development. All color plate data is then shifted by one, resulting in the pattern shown in the far right illustration.
