Model: OR-C2	Date: 28-Aug-13	No.: RD759001a
---------------------	-----------------	----------------

Subject: Firmware Release Note: Fax		Prepared by: T.Nihei	
From: 2nd Tech Service Sect., MFP/Printer Tech Service Dept.			
Classification:	<input type="checkbox"/> Troubleshooting <input type="checkbox"/> Mechanical <input type="checkbox"/> Paper path <input type="checkbox"/> Product Safety	<input type="checkbox"/> Part information <input type="checkbox"/> Electrical <input type="checkbox"/> Transmit/receive <input checked="" type="checkbox"/> Other (Firmware)	<input type="checkbox"/> Action required <input type="checkbox"/> Service manual revision <input type="checkbox"/> Retrofit information <input checked="" type="checkbox"/> Tier 2

Model:OR-C2 Fax		Date: 24-Oct-13	No.: RD759002
Subject: Service Manual Correction for Installing the Double G3 Boards (TWN only)		Prepared by: T. Nihei	
From: 2nd Tech Service Sect., MFP/P Tech Service Dept.			
Classification:	<input type="checkbox"/> Troubleshooting <input type="checkbox"/> Mechanical <input type="checkbox"/> Paper path <input type="checkbox"/> Product Safety	<input type="checkbox"/> Part information <input type="checkbox"/> Electr

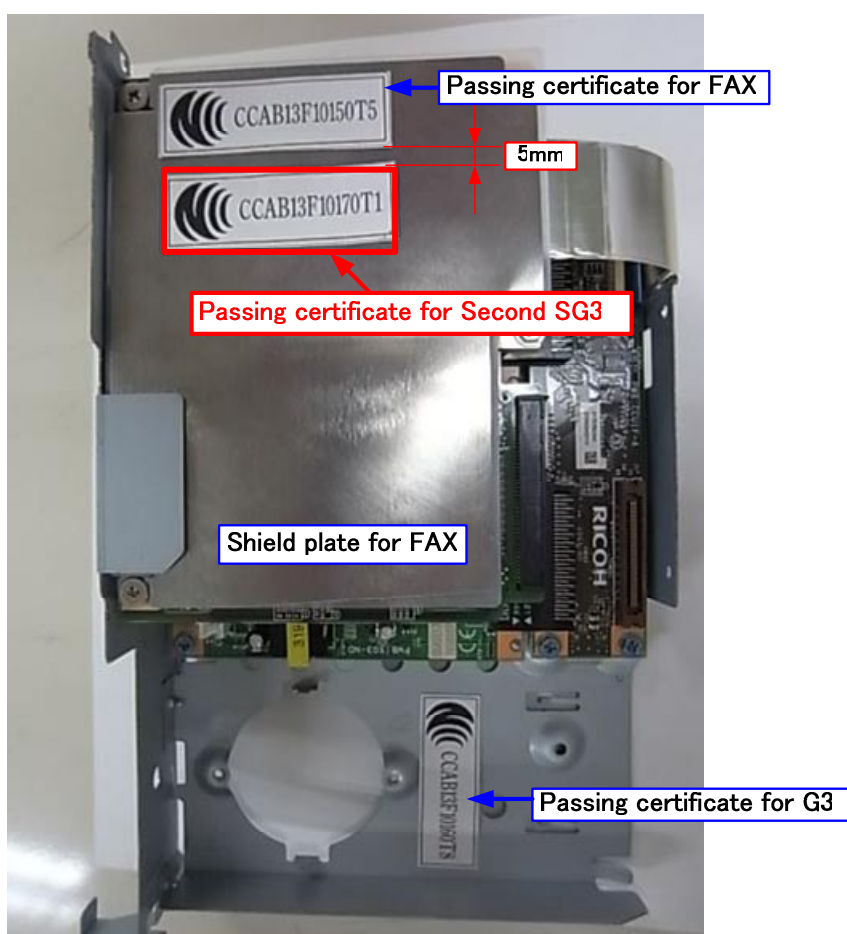
Attach the decal packaged with the G3 Interface Unit to the area shown in red below.

Add the following as **Step 6** to the Installation Procedure.

6. [TWN model only]:

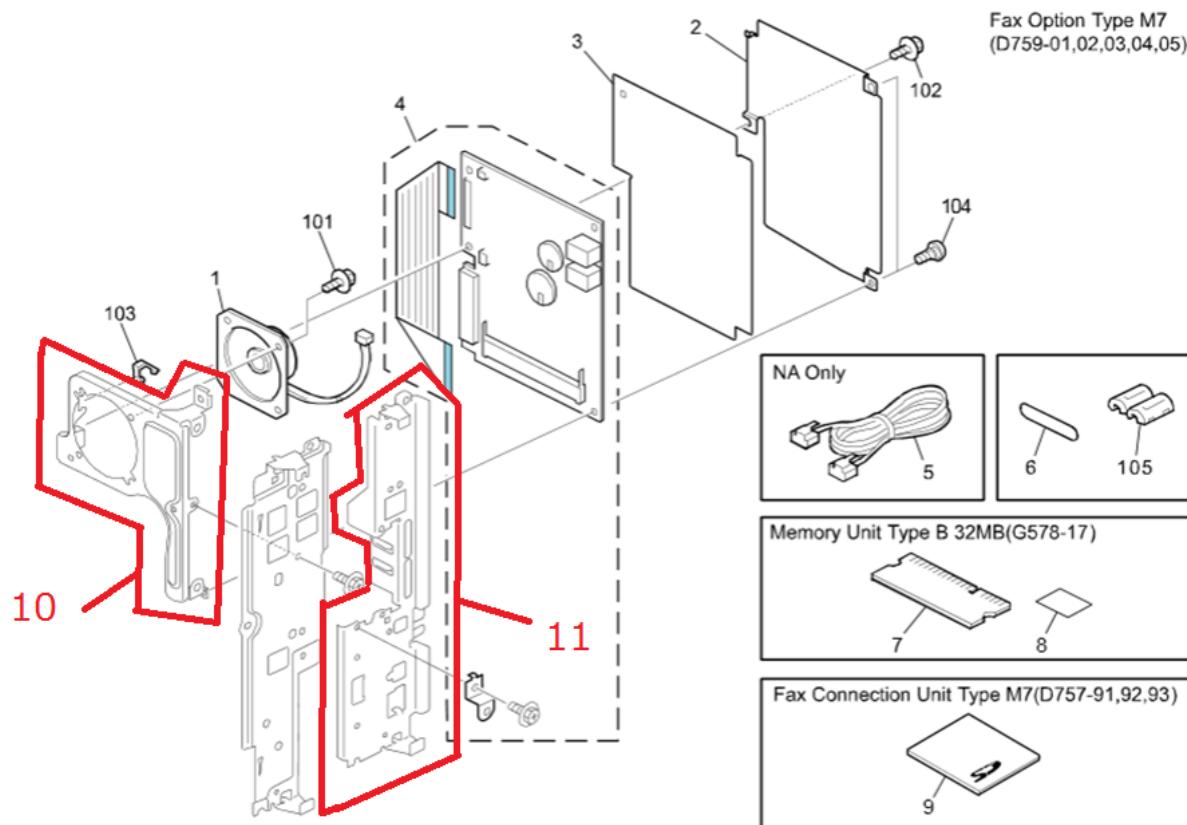
1. FAX Option (D759)

Change: The parts boxed in red in the illustration were registered as service parts.

Reason: To meet requests from the field.
