| Model: Multi-Folding Unit FD4000 | Date: 17-May-12 | No.: RD615001c |

| Subject: Firmware Release Note: Multi-Folding Unit FD4000 | | Prepared by: K. Moriizumi | |

No.: RD615002

Subject: Wrong knob decal

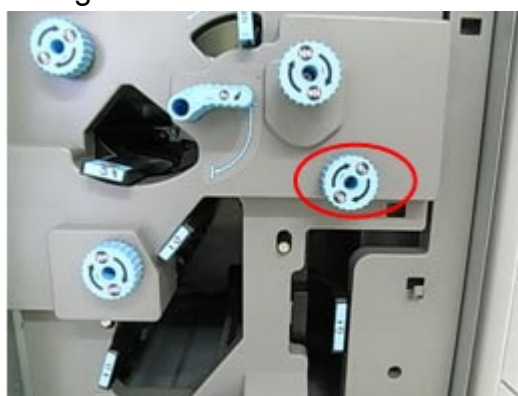
The arrow on the jam recovery knob (circled in red below) was printed on the knob in the wrong direction.

The parts vendor mistakenly printed the arrows for all four knobs (shown above) pointing in the same direction. In fact, the arrows on the jam recovery knob should be pointing counterclockwise, and those on the other three are pointing clockwise.

Replace the decal for the jam recovery knob (D6157111) with the correct one at machine installation or the next service visit. See **Affected Serial Numbers** below.
