Technical Bulletin

Model: Multi-Folding Unit FD5000 Da				:e: 12-Jun-	09	No.: RD454001		
Subject: Correct procedures for pulling out inner folding unit / Grip modification					Prepared by: T.Tadokoro			
From: PPMC Service Planning Department 1G								
Classification:	Troubleshooting	Part info	orma	ation 🛛 Action required				
	Mechanical	Electric	al		Servic	e manual revision		
Paper path Transmit/rec			eive	Retrof	fit information			
	Product Safety	🛛 Other ()	Tier2

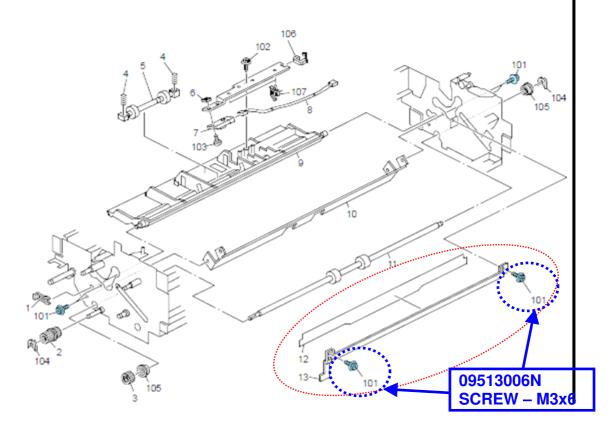
19.Fold Unit 13 (D454)

Change: Shape of the parts and screw types

Reason: To prevent misalignment of the brackets (D4554216 & D4554217) in the manufacturing process

Old Part Number	New Part Number	Description	Q'ty	Ir	nt	Page	Index	Note
D4553611	D4543615	GUIDE PLATE:NO.1	1	X/O		29	1	
D4544101	D4544105	PAPER CRIMP SUB- UNIT:NO.1:ASS'Y	1	X/O	X/O	31, 35	*	
D4544216	D4544218	GUIDE PLATE:NO.1:ENTRANCE	1	X/O	as a set	39	13	
D4544217	D4544219	SHEET:GUIDE:NO.1	1	X/O	Sel	39	12	
	09513006N	SCREW - M3X6	2			39	108	Add

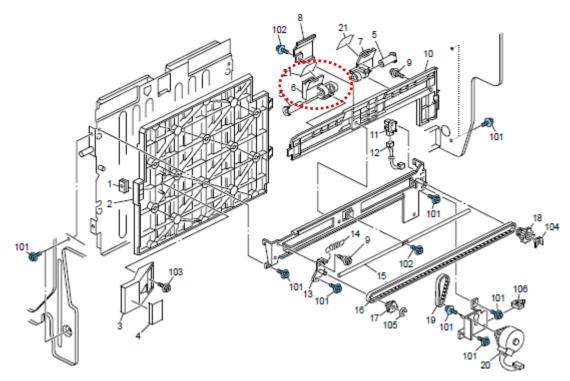
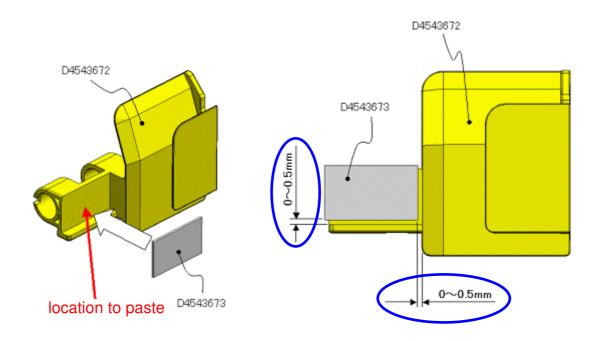
12.Fold Unit 6 (D454)

Reason: To prevent the paper detection sensor from falsely detecting the jogger fence

A pad has been added to the jogger fence to optimize the distance between the paper detection sensor and the jogger fence which will give a larger margin of error.

Old Part Number	New Part Number	Description	Q'ty	Ir	nt	Page	Index	Note
D4543693	D4543672	JOGGER FENCE:FRONT	1	X/O	X/O	25	6	
	D4543673	PAD:SENSOR	1		as a set	25	22	Add

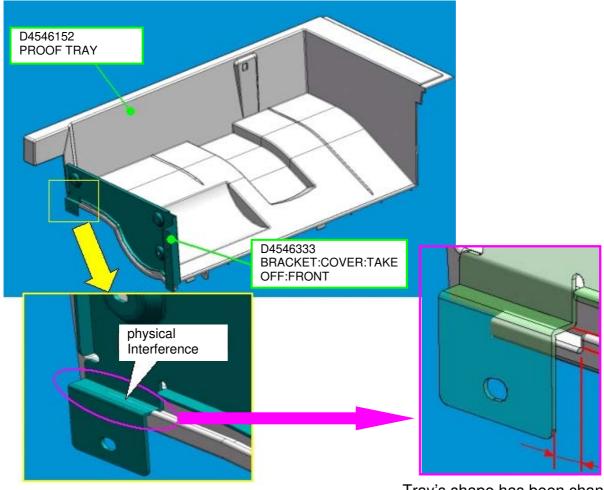
Reason: As a result of the bracket modification (D4546332 \rightarrow D4546333), interference occurred as shown in the following diagram. This modification is to standardize for releasing Multi-Folding Unit FD5010.

Tray's shape has been changed. (D4546152 - \rightarrow D4546153)

Old Part Number	New Part Number	Description	Q'ty	I	/C	Page	Index
D4546152	D4546153	PROOF TRAY	1	X/O	20.0	59	4
D4546332	D4546333	BRACKET:COVER:TAKE OFF:FRONT	1	X/O	as a set	3	8

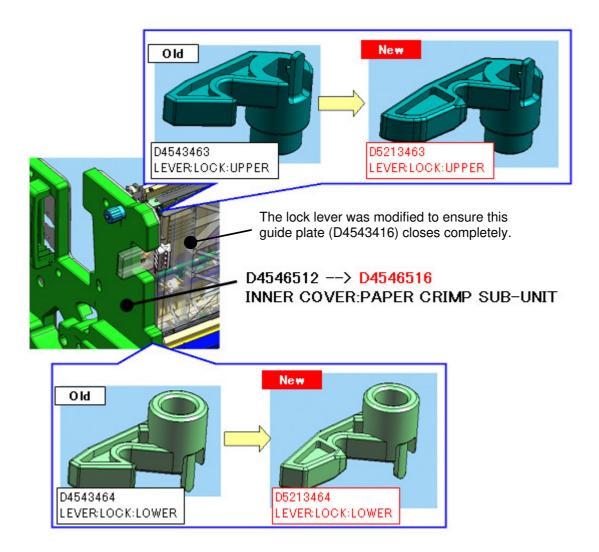
Change: Shape of the lock lever **Reason:** To ensure complete shut of the guide plate to prevent possible jams

Old Part Number	New Part Number	Description	Q'ty	Ir	nt	Page	Index	Note
D4543463	D5213463	LEVER:LOCK:UPPER	1	X/O		17	20	
D4543464	D5213464	LEVER:LOCK:LOWER	1	X/O	as a set	17	21	
D4546512	D4546516	INNER COVER:PAPER CRIMP SUB-UNIT	1	X/O		15	6

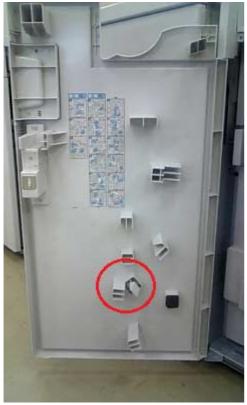
Change: The following parts were added as service parts. **Reason:** To increase magnetic strength for secure closing of the door.

PM: D4546385 TORSION SPRING: LEVER: GUIDE PM: D4546381 LEVER: GUIDE PLATE: LEFT COVER: OPEN AND CLOSE

Old Part Number	New Part Number	Description	Q'ty	Int	Page	Index	Note
-	D4546381	LEVER:GUIDE PLATE:LEFT LOWER:OPEN AND CLOSE	1	-	3	22	Add
-	D4546382	BRACKET:LEVER:GUIDE PLATE:LEFT LOWER:OPEN AND CLOSE	1	-	3	23	Add
-	D4546385	TORSION SPRING:LEVER:GUIDE PLATE:55N	1	-	3	24	Add

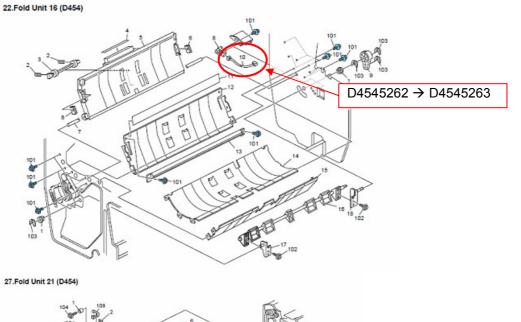
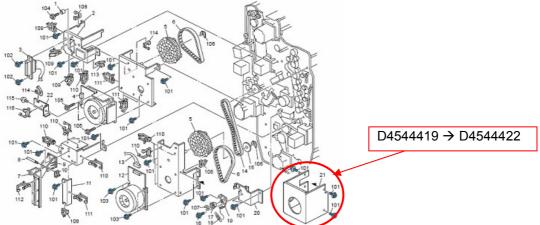
Change: P/N modification of the motor cover and harness **Reason:** To allow application of common parts with the Multi-Folding Unit FD5010

Old Part Number	New Part Number	Description	Q'ty	Int	Page	Index	Note
D4544419	D4544422	COVER:DC MOTOR:NO.1	1	X/O	55	21	-
D4545262	D4545263	HARNESS:SENSOR:PULL OUT:SENSOR	1	X/O	45	10	-

When replacing the above parts for the first time, replace as a set.

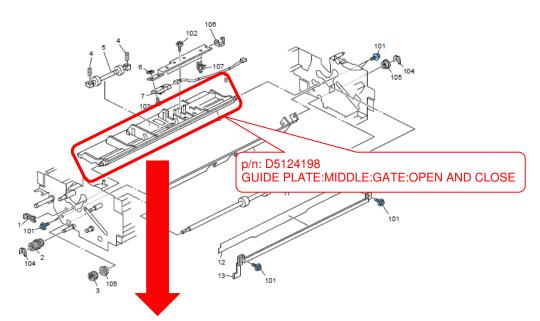
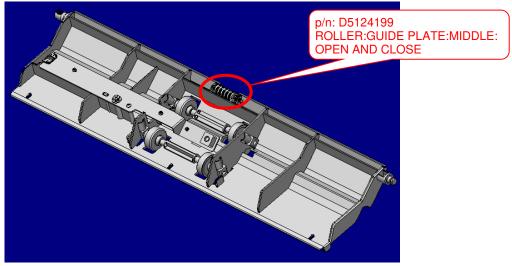
19.Fold Unit 13 (D454)

The following parts were modified to prevent the drive gear of the first fold roller from breaking as a result of jams.

Old p/n	New p/n	Description	Q'ty	Ir	nt	Page	Index	Note
D4544198	D5214198	GUIDE PLATE:MIDDLE:GATE: OPEN AND CLOSE	1	X/O	As a	39	9	Change
-	D5214199	ROLLER:GUIDE PLATE:MIDDLE: OPEN AND CLOSE	1	-	set	39	14	Add
