Model: Internal Finisher Type 3352	Date: 12-Sep-11	No.: RD586001a
------------------------------------	-----------------	----------------

Model: Internal Finisher Type 3352		Date: 26-Dec-11	No.: RD586002
Subject: Stopper		Prepared by: T. Nihei	
From: 2nd Tech Service Sect., MFP/P Tech Service Dept.			
Classification:	<input checked="" type="checkbox"/> Troubleshooting	<input type="checkbox"/> Part information	<input type="checkbox"/> Action required
	<input type="checkbox"/> Mechanical	<input type="checkbox"/> Electrical	<input type="checkbox"/> Service manual revision
	<input type="checkbox"/> Paper path	<input type="checkbox"/> Transmit/receive	<input type="checkbox"/> Retrofit information
	<input type="checkbox"/> Product Safety	<input type="checkbox"/> Other ()	<input type="checkbox"/> Tier 2

Model: Internal Finisher Type 3352		Date: 19-Apr-12	No.: RD586003
Subject: Parts Catalog Correction for Lock Lever		Prepared by: T. Nihei	
From: 2nd Tech Service Sect., MFP/P Tech Service Dept.			
Classification:	<input type="checkbox"/> Troubleshooting <input type="checkbox"/> Mechanical <input type="checkbox"/> Paper path <input type="checkbox"/> Product Safety	<input checked="" type="

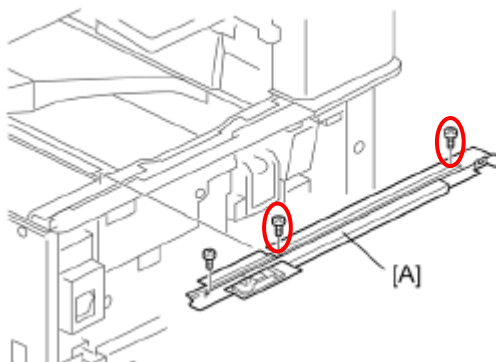
In some cases, the internal finisher slides outward and becomes disconnected from the mainframe when the following operations are performed:

- The duplex cover is closed with force
- The extension tray is extended during a copy job (which can cause a paper jam)

The two operations described above produce slide loads that are larger than expected, causing the finisher to slide to the left.

If the symptom occurs, attach the new stopper (P/N D5869900) to the front rail.

1. Remove the internal finisher and the finisher right cover (or Punch Unit if installed).
2. Remove the screws (screw x 2).
