| Model: DI-C1 Internal Finisher Type C2550 | Date: 24-Dec-09 | No.: RD429001a |

| Subject: Parts Catalog Correction | | Prepared by: M.Saiki | |

| Subject: SC742 (stapler motor error) | | Prepared by: M.Saiki | |

| Subject: RoHS Compliance Issue (Stapler) | | Prepared by: T. Nihei | |

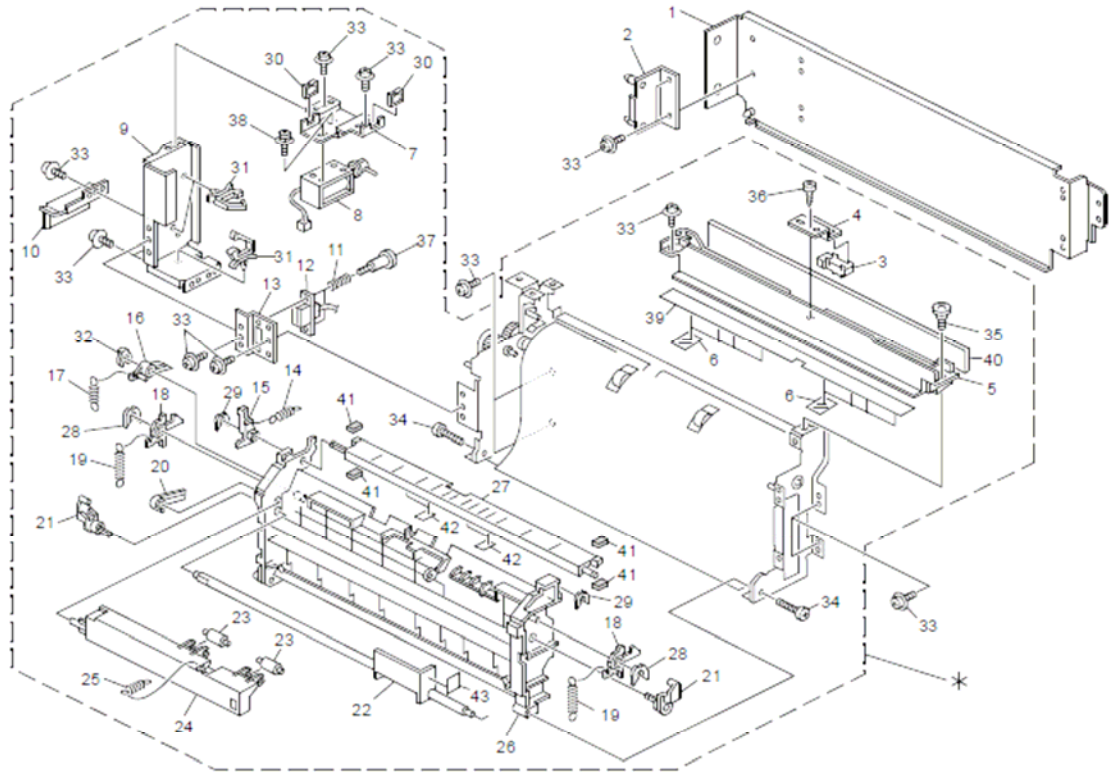
## Incorrect

**Change:** The indexes of the illustration were changed.

**Reason:** Correction of the illustration and part numbers

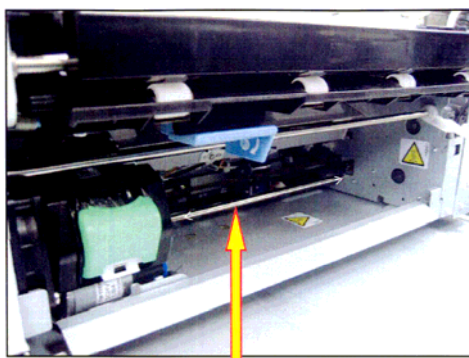
SC742 (finisher stapler motor error)

The friction between the stapler unit shaft and its bushings is too high, which prevents the stapler unit from operating smoothly.

If the symptom is reported, apply the following grease to the shaft:

**P/N A2579300     Grease Barrierta – S552R**

- Apply the amount of grease shown in the photograph (which just covers the head of a small flathead screwdriver).

- Apply the grease to the shaft shown in the photo below. Move the stapler unit carefully so that you can apply the grease evenly across the shaft. And verify if the guide plate doesn't rub the front plate. If so, push it gently inside to avoid friction.
