Model: NAD 30S/30/40		Date: 31-May-98	No: 3
Subject: Service Manual Corrections		Prepared by: Y. Furuya	
From: Technical Service Department.			
Classification:	<input type="checkbox"/> Troubleshooting	<input type="checkbox"/> Part information	<input type="checkbox"/> Action required
	<input type="checkbox"/> Mechanical	<input type="checkbox"/> Electrical	<input checked="" type="checkbox"/> Service manual revision
	<input type="checkbox"/> Paper path	<input type="checkbox"/> Transmit/receive	<input type="checkbox"/> Retrofit information
	<input type="checkbox"/> Other (       )

This bulletin contains corrections for the Fax Option Type 450 service manual.

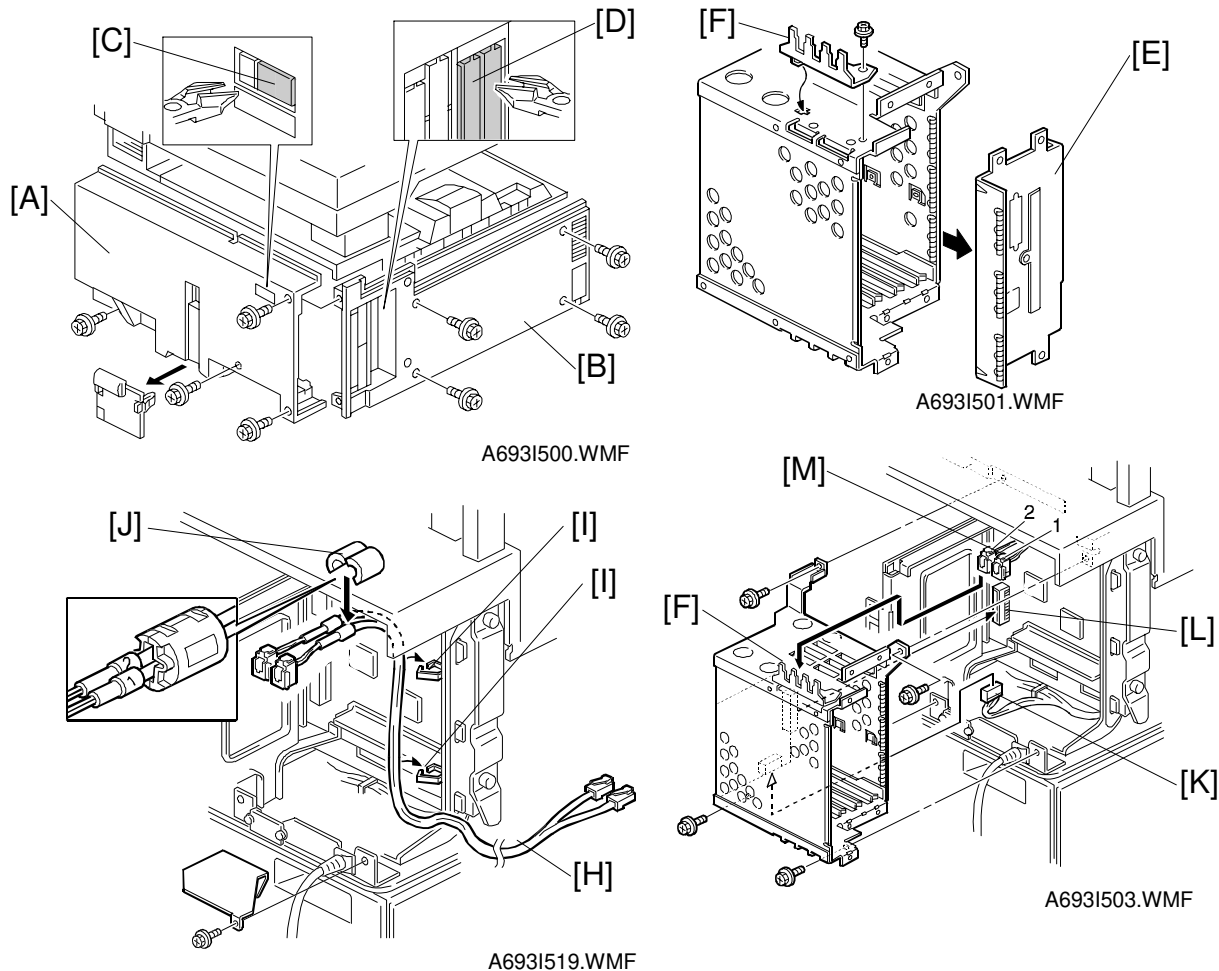
- 1) The installation procedure was not suitable for the Taiwan version
- 2) A bracket must be removed before installing the expansion box; this was not mentioned.
- 3) The procedure for attaching the PTT approval label was missing.

1. Remove the rear cover [A] (4 screws) and the left side cover [B] (4 screws), as shown.
2. Cut away the covers [C] and [D] (shaded parts), as shown.

**NOTE:** If installing the fax hard disk option at the same time, refer to the hard disk installation procedure before going on to the next step.
3. Remove the cover [E] from the expansion box, then install the FCU cover bracket [F] (1 screw) as shown.

**NOTE:** The bracket [F] is included in the fax unit.
4. Remove the bracket [G], and run the cable [H] through the clamps [I], then install a metal core [J] as shown.

**NOTE:** The metal core [J] is not installed the model for Taiwan.
5. Connect the harness [K] to CN355 on the expansion box, then install the expansion box (4 screws) so that the CN350 fits in CN304 [L] on the BiCU.

**NOTE:** Use a magnetic screwdriver so as not to drop any screws inside the machine.
6. Attach the modular jacks [M] to the bracket [F] as indicated on the bracket.
