Model: Adonis-C2		Date: 20-Sep-01	No.: RB003020
Subject: NCS(NIB) Firmware History		Prepared by: K. Takagi	
From: Technical Services Dept., GTS Division			
Classification:	<input type="checkbox"/> Troubleshooting <input type="checkbox"/> Part information <input checked="" type="checkbox"/> Action required <input type="checkbox"/> Mechanical <input type="checkbox"/> Electrical <input type="checkbox"/> Service manual revision <input type="checkbox"/> Paper path <input type="checkbox"/> Transmit/receive <input type="checkbox"/> Retrofit information <input checked="" type="checkbox"/> Other ()

Model: Adonis-C2		Date: 22-Oct-01	No.: RB003025
Subject: Service Card Release History (MFP)		Prepared by: K. Takagi	
From: Technical Services Dept., GTS Division			
Classification:	<input type="checkbox"/> Troubleshooting <input type="checkbox"/> Part information <input type="checkbox"/> Action required <input type="checkbox"/> Mechanical <input type="checkbox"/> Electrical <input type="checkbox"/> Service manual revision <input type="checkbox"/> Paper path <input type="checkbox"/> Transmit/receive <input type="checkbox"/> Retrofit information <input checked="" type="checkbox"/> Other ()

Model:

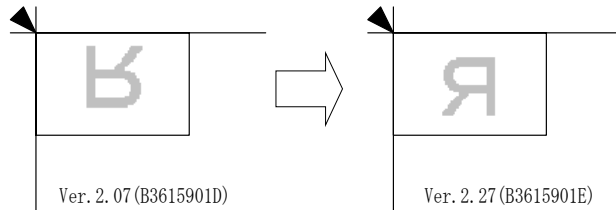
Descriptions	Version
<p><i>Firmware modified to correct the following:</i></p> <p>1. Software changed so that the original can be placed on the exposure glass just as with copying, i.e. there is no need to turn the original upside-down (for <u>both</u> directions).</p> <div data-bbox="316 751 928 959">
