Technical Bulletin

Model: PB3030 (PR-C1 2-paper tray unit)			Dat	:e: 20-Sep	-07	No.: RD331001				
Subject: Friction	Subject: Friction pad					Prepared by: M. Ishihara				
From: 1st Tech. S										
Classification:	 Troubleshooting Mechanical Paper path Product Safety 	Part info Electric Transm	al		Servic	n required ce manual revision fit information

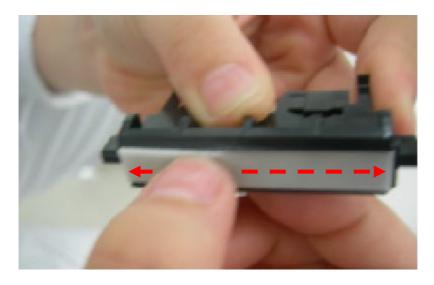
Dog ears may occur when the paper is fed from the optional 2-tray paper unit. **Note:** This only occurs on some of the Affected Units listed below.

Part of the friction pad peels off the pad bracket.

Do the following when you install the optional 2-tray paper unit on the Parisian-C1: Press the friction pad firmly with your thumb, and while doing so, slide your thumb across the length of the pad. Do this three or four times.

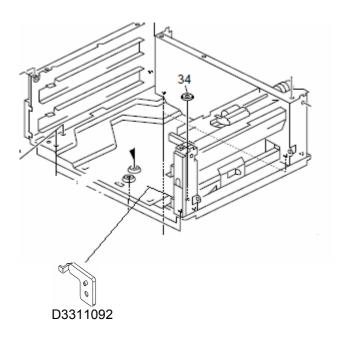
Change/Reason: This part was missing in the parts catalog of the Paper Feed Unit PB3030 (D331).

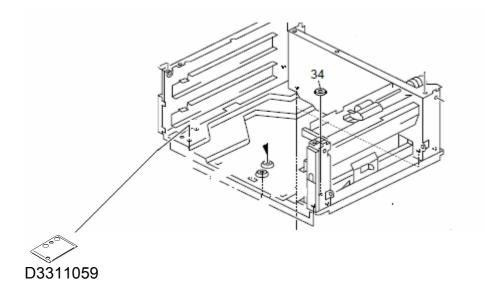
Change: A guide was added to the area shown below. **Reason:** To minimize the sound that occurs when the paper tray is pulled out or pushed in.

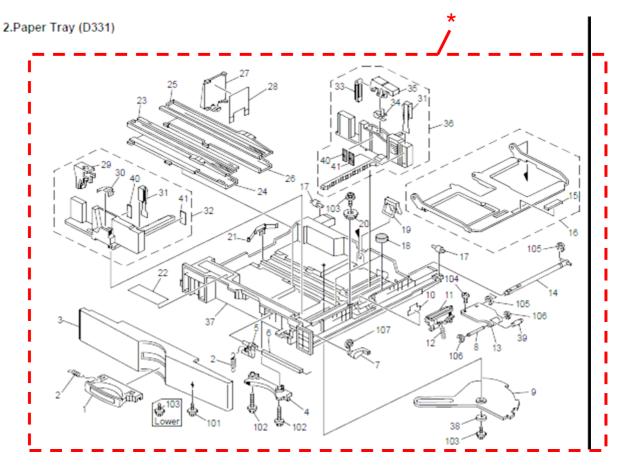
Change / **Reason:** These assembly parts are now available as service parts. **Note:** D3312531 is for the lower tray and D4252532 is for the upper one.

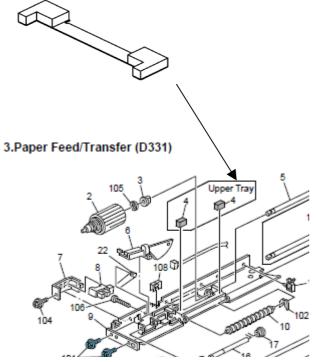
Change: 2 cushions were assembled and became the spacer (D4252558) as shown in the figure below. The spacer is affixed on the upper tray only. **Reason:** To unify the part with other models.

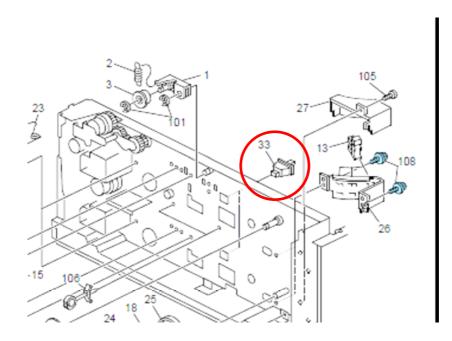
Change: An index for the illustration is added.

Reason: The part information was not available.
