Model: Diana-C1/C1L Paper Feed Unit PB3070		Date: 16-Mar-09	No.: RD425001
Subject: No feed paper jam from PFU		Prepared by: K. Moriizumi	
From: 1st Tech. Support Sec. Service Support Dept.			
Classification:	<input checked="" type="checkbox"/> Troubleshooting <input type="checkbox"/> Mechanical <input type="checkbox"/> Paper path <input type="checkbox"/> Product Safety	<input type="checkbox"/> Part information <input type="checkbox"/> Electrical <input type="checkbox"/> Transmit/receive <input type="checkbox"/> Other ()	<input type="checkbox"/> Action required <input type="checkbox"/> Service manual revision <input type="checkbox"/> Retrofit information <input checked="" type="checkbox"/> Tier 2

Model: DI-C1/C1L Paper Feed Unit PB3070		Date: 15-Apr-10	No.: RD425002
Subject: Loud noise from optional paper tray		Prepared by: M.Saiki	
From: 2nd Overseas Tech Support Sec., 2nd PQM Dept.			
Classification:	<input checked="" type="checkbox"/> Troubleshooting <input type="checkbox"/> Mechanical <input type="checkbox"/> Paper path <input type="checkbox"/> Product Safety	<input type="checkbox"/> Part information <input type="checkbox"/> Electrical <input type="checkbox"/> Transmit/receive

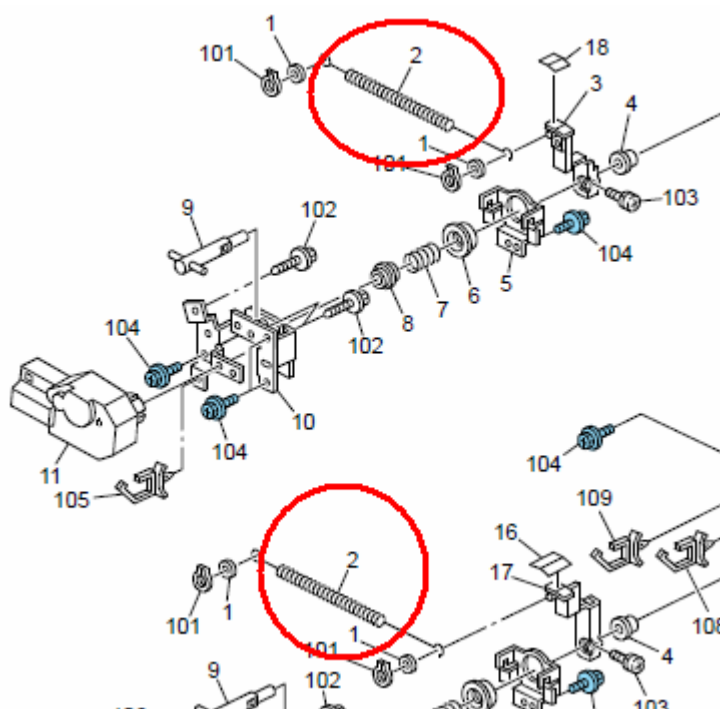
A non-feed paper jam occurs when the machine tries to feed relatively heavy paper from the PFU.

There is not enough pressure on the top sheet of paper to separate it from the other sheets.

1. Advise users not to load the tray full when using heavy paper types, OR
2. Replace the pressure tension springs (P/N D3312773) with special springs (P/N D3312774).

Note: These "special springs" will increase the paper feed pressure. Therefore, if the operator uses thin paper types after this spring is installed, multi-feeds may occur.

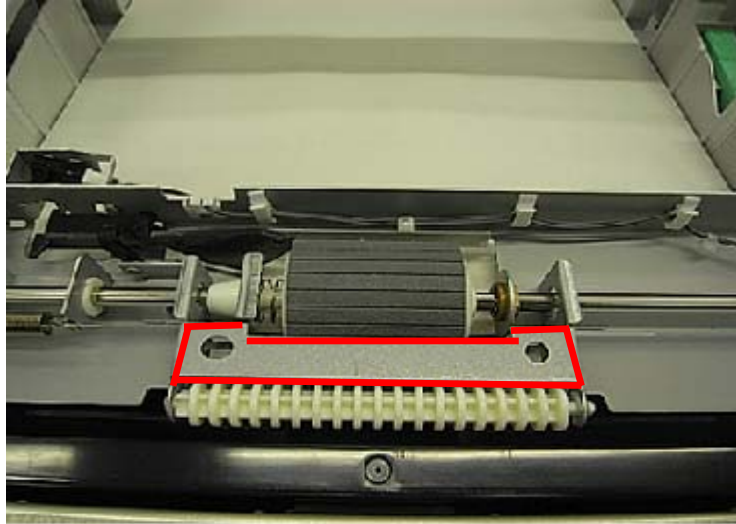
A loud vibration can be heard while the paper is being fed from the optional paper tray.

When the paper is fed, vibration is transmitted through the friction pad to the stay of the paper tray.

1. Remove the optional paper tray(s).
2. Clean and dry the attachment surface for the spacer (marked in red below).

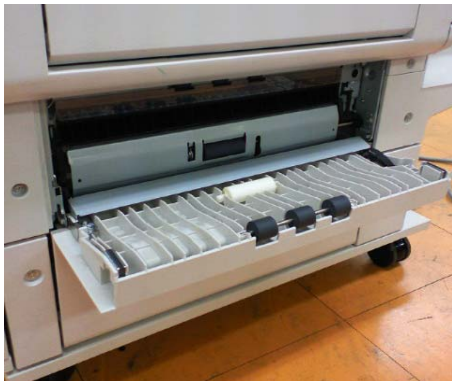
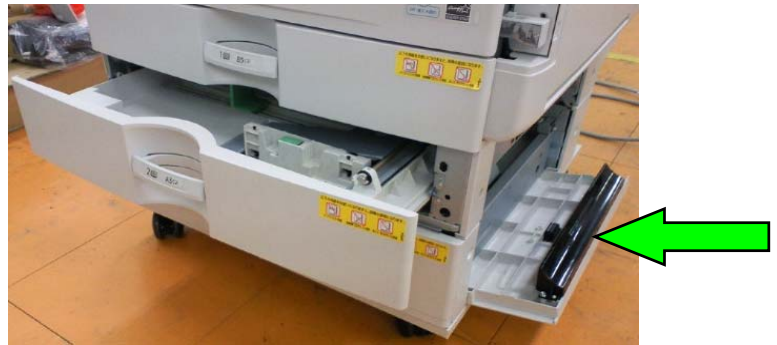
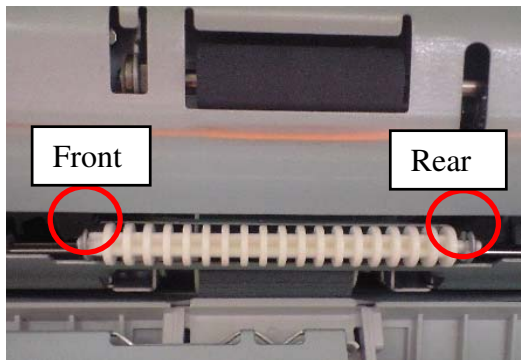
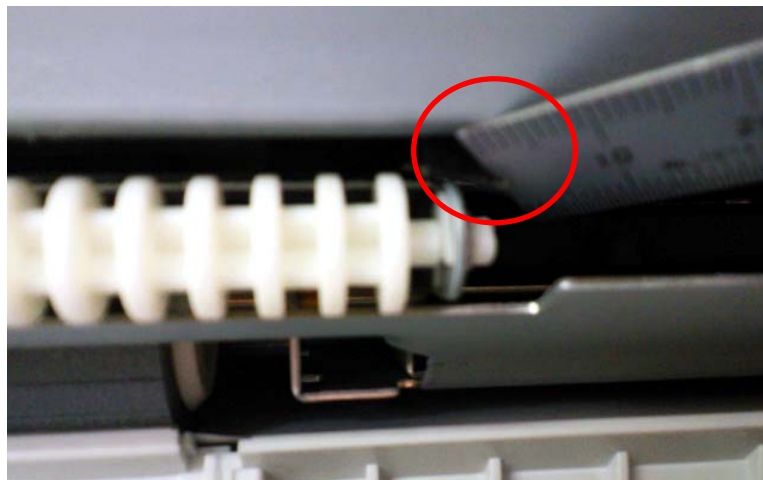
- Make sure the sponges are not hanging outside the width of the guide roller (left and right sides).
- Make sure the sponges are not hanging outside the front edge of the guide roller.

If they are, use a ruler to correct the position of the sponges, as shown below.
