Model: LCIT PB3170	Date: 26-Jun-13	No.: RD695001c
--------------------	-----------------	----------------

Subject: Firmware Release Note: LCIT PB3170		Prepared by: Y. Ino	
From: 1st Tech Service Sect., MFP/Printer Tech Service Dept.			
Classification:	<input type="checkbox"/> Troubleshooting <input type="checkbox"/> Mechanical <input type="checkbox"/> Paper path <input type="checkbox"/> Product Safety	<input type="checkbox"/> Part information <input type="checkbox"/> Electrical <input type="checkbox"/> Transmit/receive <input checked="" type="checkbox"/> Other (Firmware)	<input type="checkbox"/> Action required <input type="checkbox"/> Service manual revision <input type="checkbox"/> Retrofit information <input checked="" type="checkbox"/> Tier 2

Model:LCIT PB3170		Date: 27-Feb-14	No.: RD695002
Subject: SC622 on machine with LCT		Prepared by: N. Yoshida	
From: 1st Tech Service Sect., MFP/P Tech Service Dept.			
Classification:	<input checked="" type="checkbox"/> Troubleshooting	<input type="checkbox"/> Part information	<input type="checkbox"/> Action required
	<input type="checkbox"/> Mechanical	<input type="checkbox"/> Electrical	<input type="checkbox"/> Service manual revision

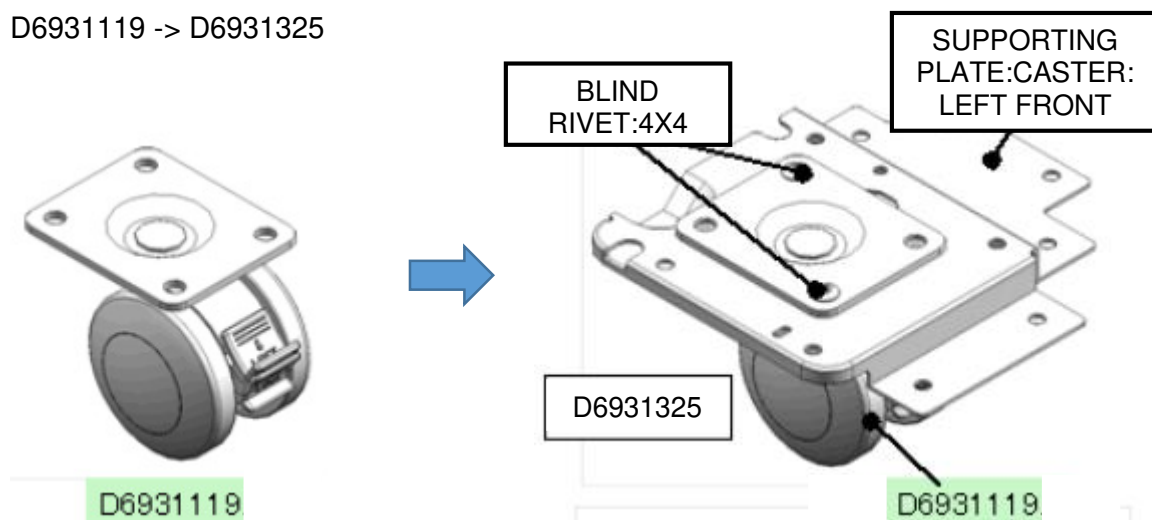
D6931119 -> D6931325

1. The caster and plate were registered together as an assembly.
2. The shape of the arm cover was changed.

1. To improve the part's strength against shock vibration.
2. To make the part easier to replace in the field.

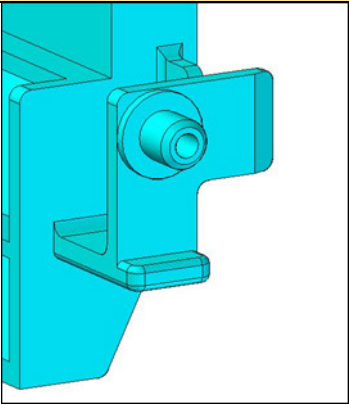
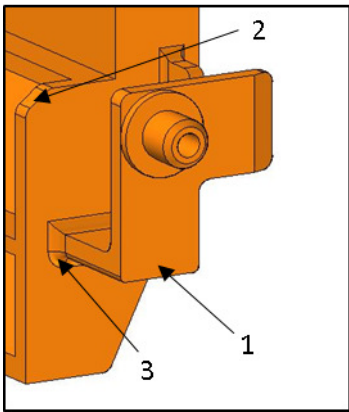
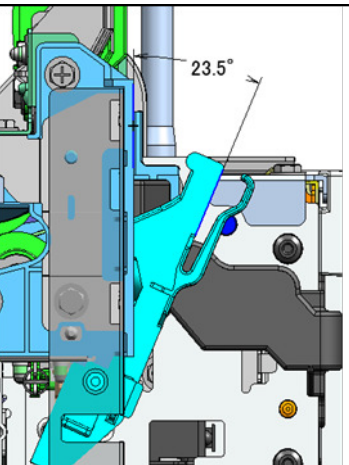
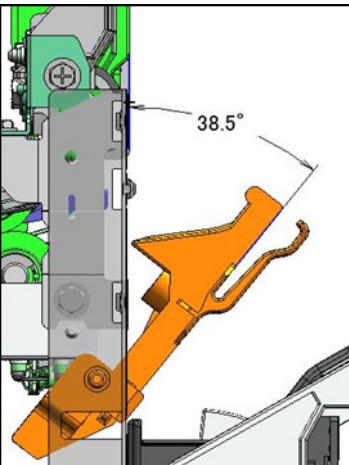
Old D1492721	New D6942721
Shape

Change: The shape of the guide plate was changed.

Reason: To further strengthen and prevent breaking of the guide plate.

<ol style="list-style-type: none"> Deleted stopper Changed angle regulation Strengthened part
Angle
