Model: Stella-F1		Date: 21-Feb-02	No.: RH555001
Subject: Optional Printer Controller		Prepared by: A. Ishiyama	
From: Technical Services Dept., GTS Division			
Classification:	<input checked="" type="checkbox"/> Troubleshooting <input type="checkbox"/> Part information <input checked="" type="checkbox"/> Action required <input type="checkbox"/> Mechanical <input type="checkbox"/> Electrical <input type="checkbox"/> Service manual revision <input type="checkbox"/> Paper path <input type="checkbox"/> Transmit/receive <input type="checkbox"/> Retrofit information <input type="checkbox"/> Other (      )

Please note the following when installing the optional Printer Controller in the model S-F1.

Subject: Printer Controller Firmware History		Prepared by: A.Ishiyama	
From: 1st Tech. Support Sec. Service Support Dept.			
Classification:	<input type="checkbox"/> Troubleshooting <input type="checkbox"/> Mechanical <input type="checkbox"/> Paper path <input type="checkbox"/> Other (      )	<input type="checkbox"/> Part information <input type="checkbox"/> Electrical <input type="checkbox"/> Transmit/receive	<input checked="" type="checkbox"/> Action required <input type="checkbox"/> Service

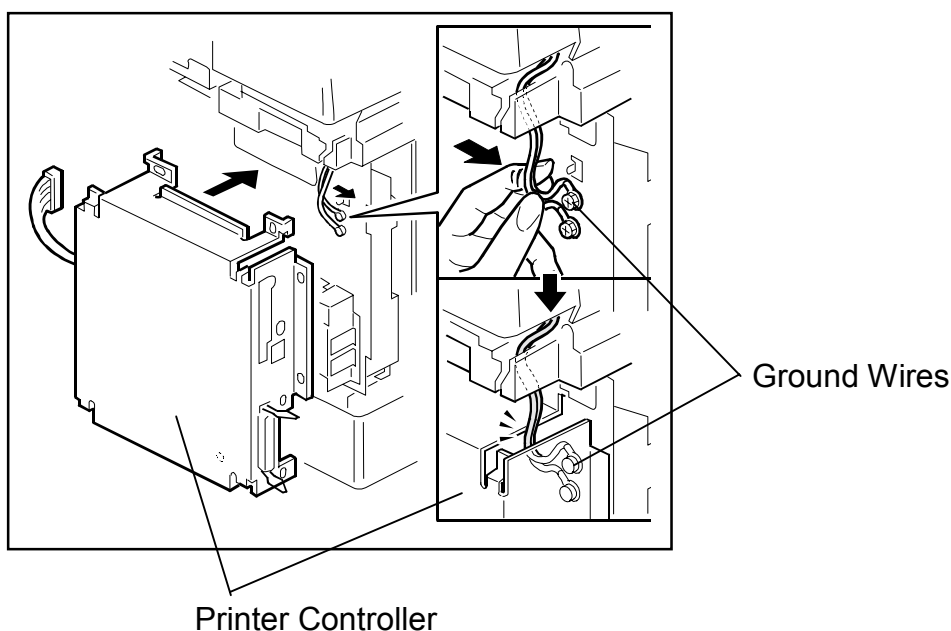
After installing the printer controller in Step 5 of the Installation Procedure, the ADF unit does not open all the way.

When the Controller was installed, the 2 ground wires were not led through the inlet (opening) in the upper right corner of the controller bracket, causing excess tension on the wires.

When installing the Printer Controller, be sure to set the wires into the opening in the upper right of the bracket as shown below. This will prevent excess tension on the wires and allow the DF to fully open.

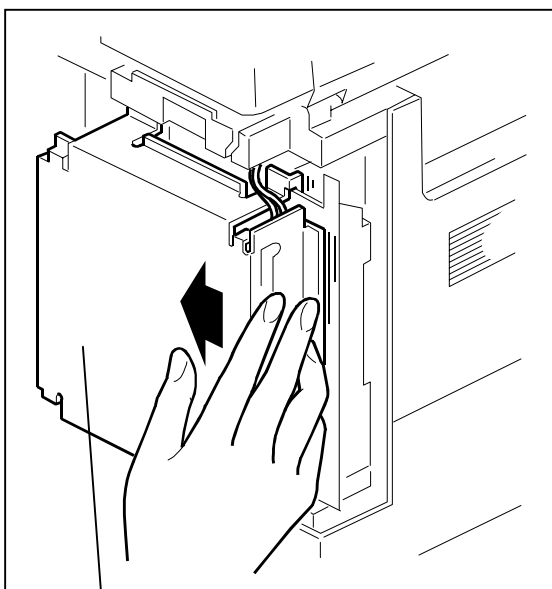
After installing the Printer Controller in Step 5 of the Installation Procedure, the 3 screw holes on the main face of the Rear Cover do not line up with the mainframe holes, making it difficult to reattach the cover.

When the Controller is attached slightly right of center, the width and circular (top) screw holes of the Rear Cover do not provide enough clearance for left/right cover adjustment, and the two contact one another.

When attaching the Controller, hold it flush against the left while tightening the bracket screws as shown in the illustration below.

The shape of the upper screw holes on the main face of the Rear Cover will be changed from circular to elliptical (running change) to allow for any necessary left/right adjustment.
