RTB CorrectionReissue date: **15- Jun -97**

Model: AD-1		Date: 19-Mar-97	No: 26A
Subject: Paper jam		Prepared by: M.Horiike	
From: QAC 2nd Field Information Dept.			
Classification:	<input type="checkbox"/> Troubleshooting	<input checked="" type="checkbox"/> Part information	<input type="checkbox"/> Action required
	<input type="checkbox"/> Mechanical	<input type="checkbox"/> Electrical	<input type="checkbox"/> Service manual revision
	<input type="checkbox"/> Paper path	<input type="checkbox"/> Transmit/receive	<input type="checkbox"/> Retrofit information
	<input type="checkbox"/> Other ()

Model: AD1-Paper Tray Unit (PS330)		Date: 23-Jul-97	No: 36
Subject: Noise		Prepared by: K.Ugaeri	
From: QAC 2nd Field Information Dept.			
Classification:	<input type="checkbox"/> Troubleshooting	<input type="checkbox"/> Part information	<input checked="" type="checkbox"/> Action required
	<input type="checkbox"/> Mechanical	<input type="checkbox"/> Electrical	<input type="checkbox"/> Service manual revision
	<input type="checkbox"/> Paper path	<input type="checkbox"/> Transmit/receive	<input type="checkbox"/> Retrofit information
	<input type="checkbox"/> Other ()

Model: PS330 (Paper Tray f

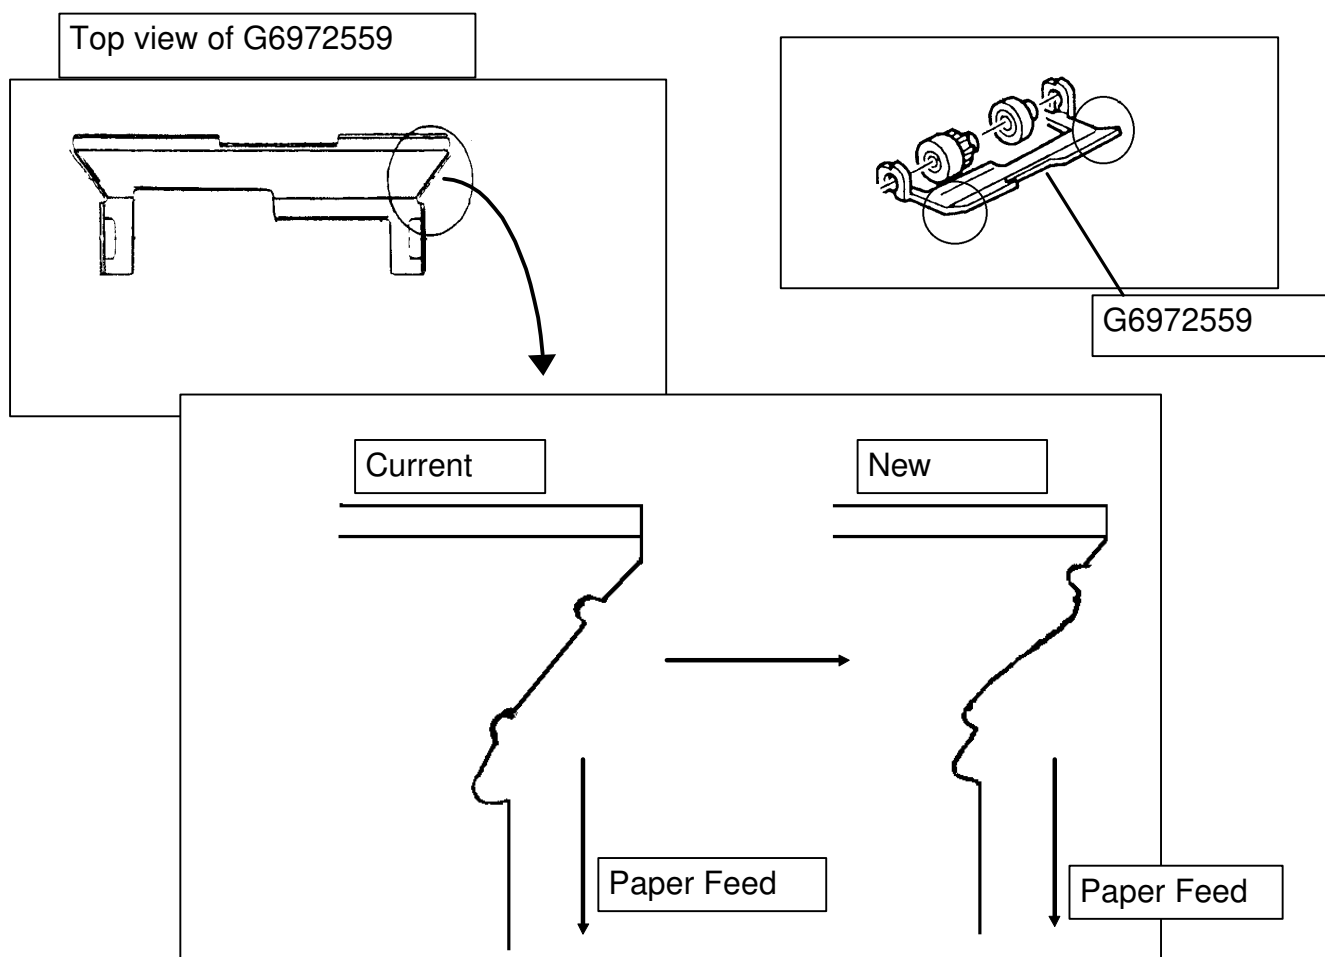
Paper jam from the ***paper tray unit (PS 330)***.

The paper contacted the uneven edge of the upper guide paper feed.

The shape of the upper guide - paper feed has been changed from January Production '97.

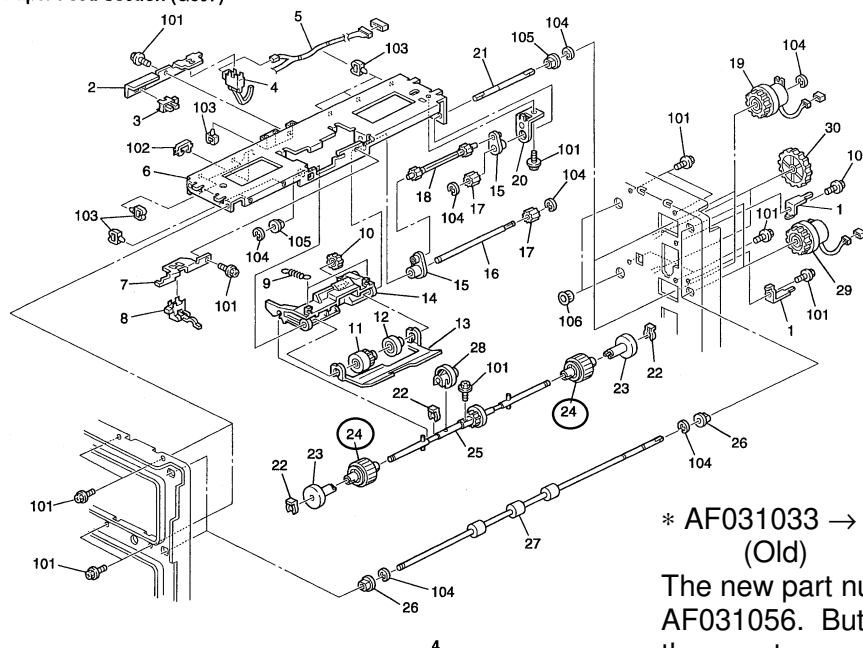
2. Paper Feed Section (G697)

SYMPTOM: Paper jam

CAUSE: Paper skewing or no feed from PS330 (Paper Tray)

Countermeasure: The diameter of the paper feed roller has been modified from 30φ to 32φ to improve paper feed.

* AF031033 → AF031056
(Old) (New)

The new part number of the feed roller is AF031056. But do not order this part until the countermeasure kit is out of stock.
