Model: Ring Binder RB5000	Date: 20-June -08	No.: RD392001a
---------------------------	-------------------	----------------

Subject: Firmware Release Note: Ring Binder_B1		Prepared by: T.Tadokoro	
From: PPBG QA/Service Planning Dept.			
Classification:	<input type="checkbox"/> Troubleshooting <input type="checkbox"/> Mechanical <input type="checkbox"/> Paper path <input checked="" type="checkbox"/> Other (      )	<input type="checkbox"/> Part information <input type="checkbox"/> Electrical <input type="checkbox"/> Transmit/receive	<input type="checkbox"/> Action required <input type="checkbox"/> Service manual revision <input type="checkbox"/> Retrofit information

Model: Model: Ring Binder RB5000		Date: 8-Jun-09	No.: RD392003a
Subject: Bracket:Coupling:Main:Ass'y		Prepared by: Nobuo iida	
From: PPBG QA/Service Planning Dept.			
Classification:	<input type="checkbox"/> Troubleshooting <input type="checkbox"/> Mechanical <input type="checkbox"/> Paper path <input type="checkbox"/> Product Safety	<input checked="" type="checkbox"/> Part information <input type="checkbox"/> Electrical <input type="checkbox"/> Transmit/receive <input type="checkbox"/> Other (     )	<input type="checkb

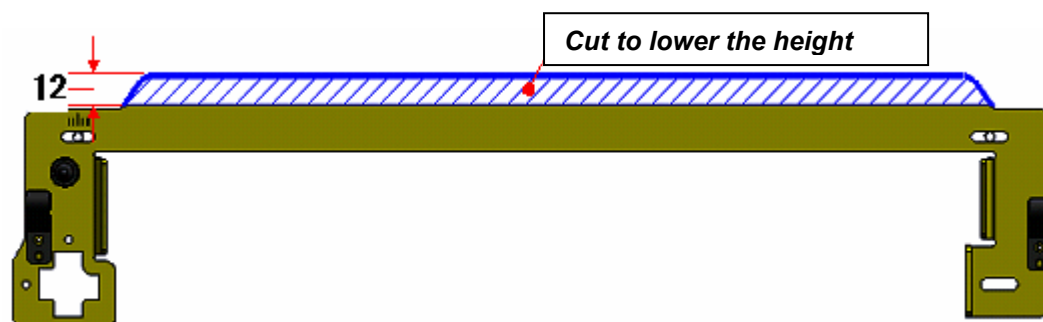
Change: Shape of the Bracket:Coupling:Main:Ass'y

Reason: To enable direct installation of the Ring Binder onto the Aegis mainframe

The docking bracket included in the Ring Binder package is applied to install the Ring Binder directly onto the Aegis mainframe, but the device could not be installed due to interference with the Decurler Unit. The shape of this bracket has been changed as shown below to resolve this problem. The modified bracket is included in the Ring Binder package from November 2008 production.

When installing the Ring Binder directly onto the Aegis mainframe, please install a Ring Binder of production after November 2008.

If you must use a Ring Binder that does not have this modification, please procure the modified docking bracket "D4341476" to enable installation.
