Model: Model AI-C1 LCIT RT3000		Date: 01-Apr-11	No.: RD353001
Subject: Part catalog correction		Prepared by: T.Hirakawa	
From: 1st Overseas Tech Support Sec., 1st PQM Dept.			
Classification:	<input type="checkbox"/> Troubleshooting <input type="checkbox"/> Mechanical <input type="checkbox"/> Paper path <input type="checkbox"/> Product Safety	<input checked="" type="checkbox"/> Part information <input type="checkbox"/> Electrical <input type="checkbox"/> Transmit/receive <input type="checkbox"/> Other ()	<input type="checkbox"/> Action required <input type="checkbox"/> Service manual revision <input type="checkbox"/> Retrofit information <input type="checkbox"/> Tier 2

Model: RT3000		Date: 20-Dec-11	No.: RD353002
Subject: Protection plate for the front LCT set switch.		Prepared by: H. Tamaki	
From: 1st Tech Service Sect., MFP/P Tech Service Dept.			
Classification:	<input type="checkbox"/> Troubleshooting <input type="checkbox"/> Mechanical <input type="checkbox"/> Paper path <input type="checkbox"/> Product Safety	<input checked="" type="checkbox"/> Part information <input type="checkbox"/> Electrical <input type="checkbox"/> Transmit/receive <input type="checkbox"/> Other ()	<in

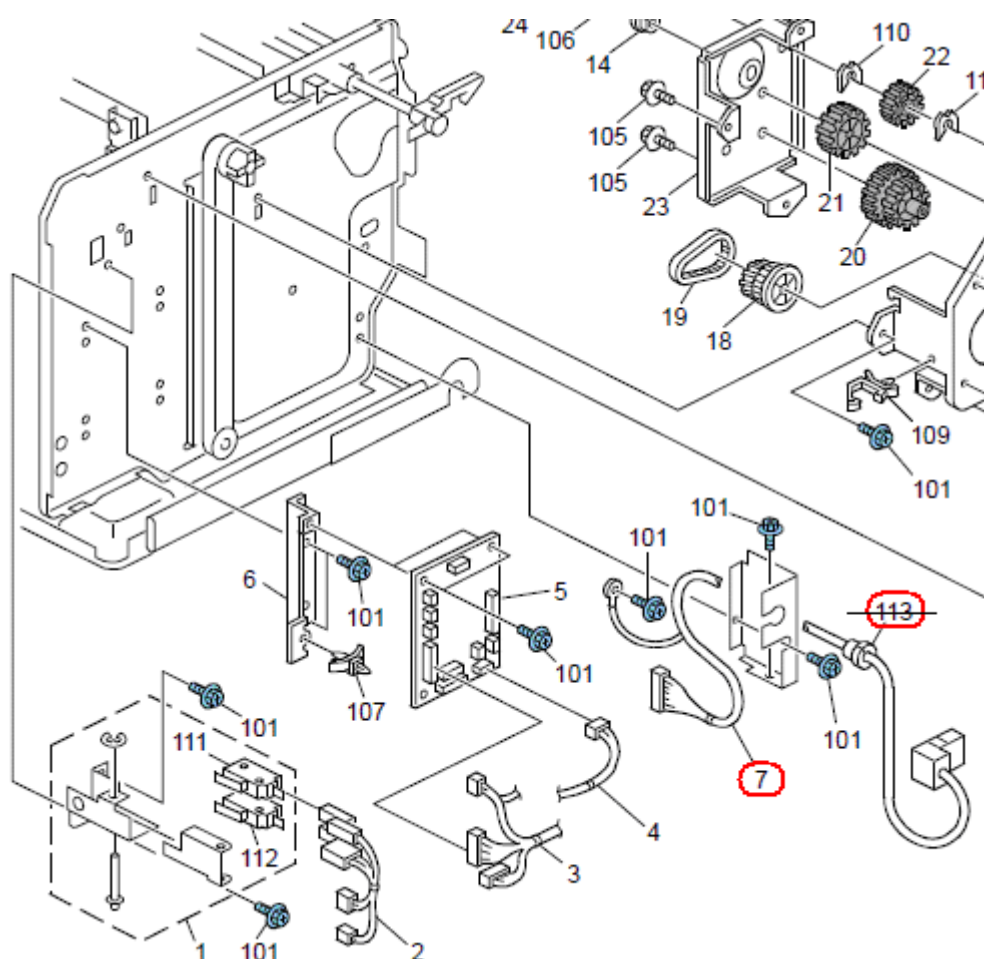
Change: The "Bushing - SR-5N-1" was deleted as an individual service part and included in the "INTERFACE CABLE: ASS'Y".

Reason: This bushing cannot be replaced individually in the field.

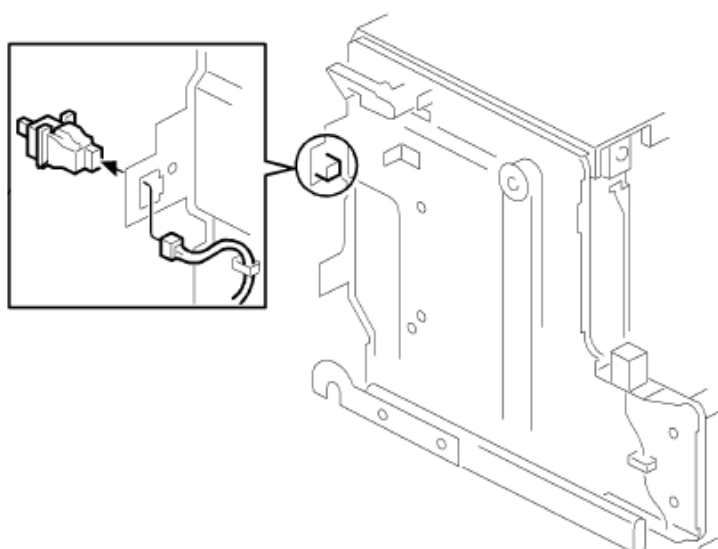
<New>

Reason: To ensure that the push switch is not damaged when the LCT is set forcefully.

- 1) A protection plate was added to the front LCT set switch.
- 2) The length of the tapping screw was changed to attach the new protection plate.
