Model: LCT for AD1-E		Date: 15-Feb-98	No: 1
Modified Article: Timing Pulley		Prepared by: K. Ugaeri	
From: QAC Field Information Dept.			
Reason for Modification:	<input checked="" type="checkbox"/> Parts catalog correction	<input type="checkbox"/> Vendor change	<input type="checkbox"/> To meet standards
	<input checked="" type="checkbox"/> To facilitate assembly	<input checked="" type="checkbox"/> To improve reliability	()
	<input checked="" type="checkbox"/> Part standardization	<input type="checkbox"/> Other

A.To reduce paper jams caused by dust between the timing pulley and the drive shaft :

B.To reduce the noise from the relay roller :

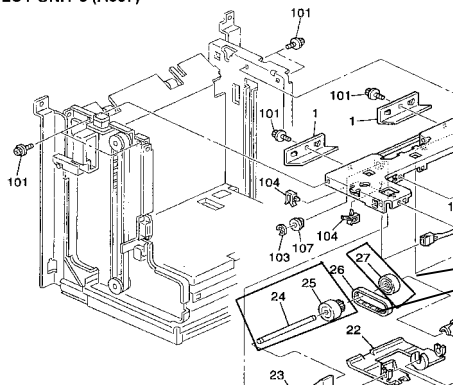
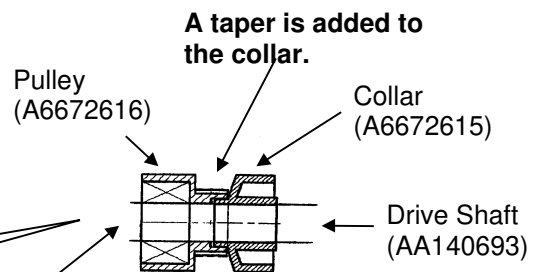
3.LCT UNIT 3 (A667)

The collar has been made so that a portion of it is inserted into the pulley.

| 1. AA140627(1) • AA140693(1) | Drive Shaft – Feed Roller | } X/O | P 7-24 |
| 2. H5194713(1) • A6672615(1) | Timing Pulley Collar – 6x8 | | P 7-27 |
| 3. H5194714(1) • A6672616(1) | Timing Pulley – 22Z | | P 7-25 |

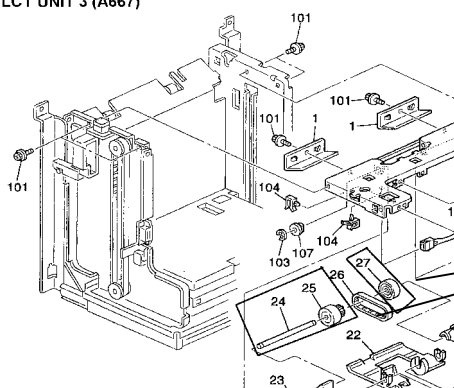
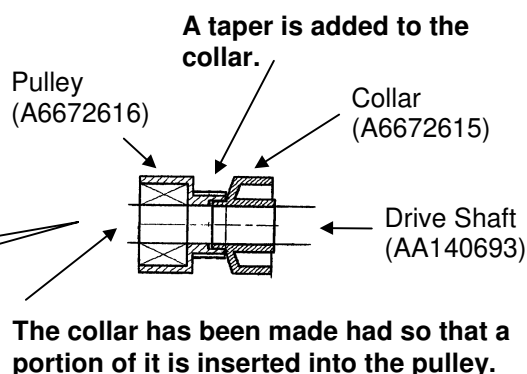
3.LCT UNIT 3 (A667)

A. To reduce paper jams caused by dust between the timing pulley and drive shaft :

| 1. AA140627(1) • AA140693(1) | Drive Shaft – Feed Roller | } X/O | P 7-24 |
| 2. H5194713(1) • A6672615(1) | Timing Pulley Collar – 6x8 | | P 7-27 |
| 3. H5194714(1) • A6672616(1) | Timing Pulley – 22Z | | P 7-25 |

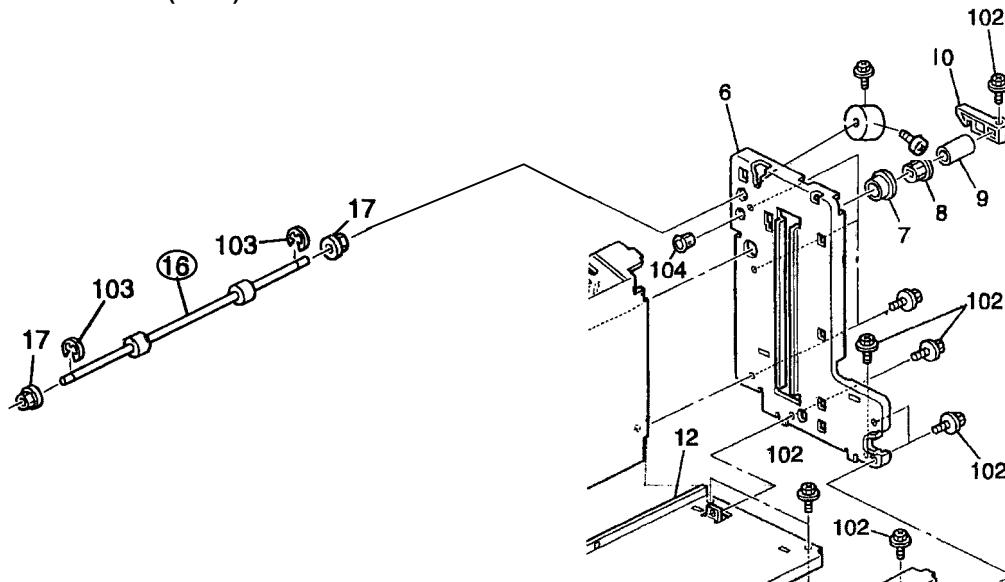
5.LCT UNIT 5 (A667)

B. To reduce the noise from the relay roller :

| 1. AF020385(1) → AF020452(1) → Relay Roller | } X/O | P11-16 |
| 2. A6672516(1) Fly Wheel (New) | | |
| 3. 03140060W(2) Philips Pan Head Screw-M4x6(New) | | |
