## RTB Correction

Model: AD1(LCT Option)		Date: 31-Jan-98	No: 48A
Subject: Paper jam and Noise		Prepared by: K.Ugaeri	
From: QAC Field Information Dept.			
Classification:	<input checked="" type="checkbox"/> Troubleshooting	<input checked="" type="checkbox"/> Part information	<input type="checkbox"/> Action required
	<input type="checkbox"/> Mechanical	<input type="checkbox"/> Electrical	<input type="checkbox"/> Service manual revision
	<input type="checkbox"/> Paper path	<input type="checkbox"/> Transmit/receive	<input type="checkbox"/> Retrofit information
	<input type="checkbox"/> Other (      )

## SYMPTOM

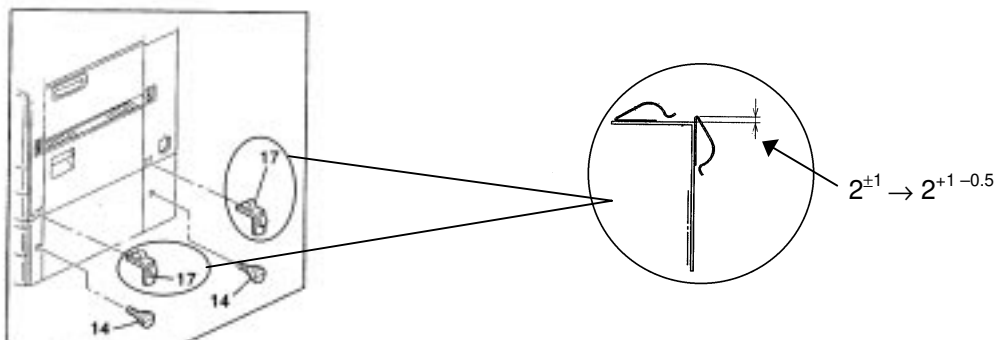
1.LCT UNIT 1(A667)

1. The grounding plate (A6676151) was broken at installation.
2. Paper jam
3. Noise

1. When the LCT is installed on the main frame, the spring plate might be cracked.
2. When the dust rubbed off the timing belt gets between the timing pulley and the drive shaft, the rotation of the pulley is affected and paper jams might occur.
3. Rotation noise from the relay roller (but the noise level is still within specification)

1. When installing the LCT, take care not to press the grounding plate too hard.

The shape of the grounding plate has been modified (A6676151->A6676151A) and RCL will supply the countermeasure parts to each subsidiary.
