Technical Bulletin

Model: V-C2 RT4000 (SIBERIA)	Date:24-Jun-09	No.: RD350001
,

Subject: Paper	Size Sensor		Prepared	d by: T.Toriumi
From: 2nd Tech.	Support Sec. Service Support	Dept.		
Classification:	☐ Troubleshooting ☐ Mechanical ☐ Paper path	☐ Part informated ☐ Electrical ☐ Transmit/rec		☐ Action required☐ Service manual revision☐ Retrofit information
	Other ()

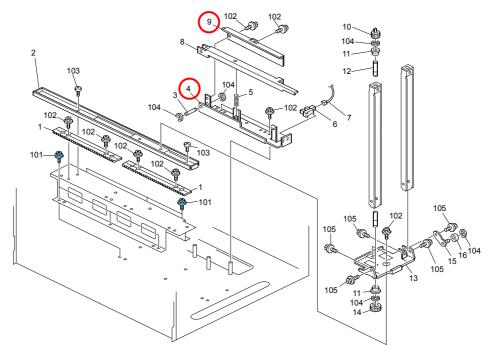
10. Paper Tray 8 (D350)

Change: The following parts (Index#4 and #9) were changed.

Reason: To correct the bug in which the paper size is not displayed on the operation panel correctly.

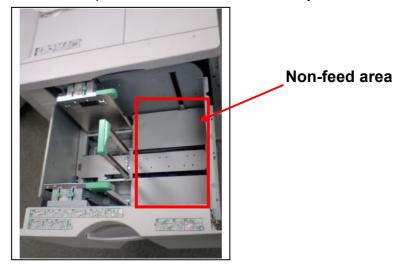
The machine tries to move the tray bottom plate (P/N: D3554620) past the upper limit, creating noise. As a result, the paper tray cannot be opened and the tray bottom plate (P/N: D3554620), bottom plate support (P/N: D3554621), and/or paper feed sensor (P/N: AW020160) breaks.

The customer loads A4/A5/LT-sized paper in the LCT in the "non-feed area" shown in the photograph, instead of in the correct space on the left side of the tray.

- If the bottom plate, bottom plate support, or paper feed sensor is damaged due to the above cause, replace the damaged part(s).
- Remind customers of the correct way to load paper in the tray, emphasizing that paper should not be loaded in the "non-feed area" shown in the photo.

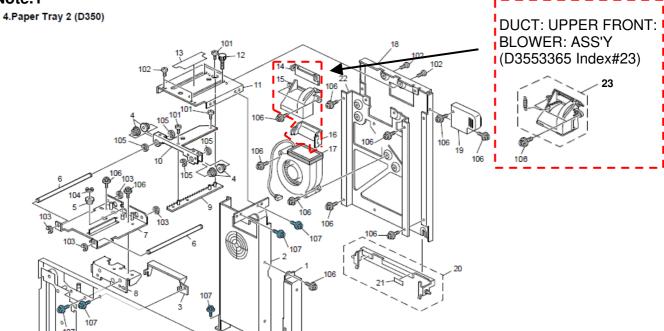
Note.1

Cover: Duct (D3553363 Index#14), DUCT:UPPER FRONT:BLOWER (D3553361 Index#15) and Duct: Lower: Brower (D3553372 Index#16) can't be replaced independently. If these parts need to be replaced, please install DUCT: UPPER FRONT: BLOWER: ASS'Y (D3553365 Index#23).

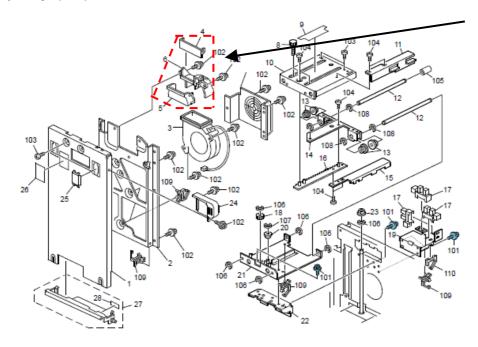
Note.2

Cover: Duct (D3553363 Index#4), DUCT:UPPER REAR:BLOWER (D3553361 Index#6) and Duct: Lower: Brower (D3553372 Index#5) can't be replaced independently. If these parts need to be replaced, please install DUCT: UPPER REAR: BLOWER: ASS'Y (D3553375 Index#29).

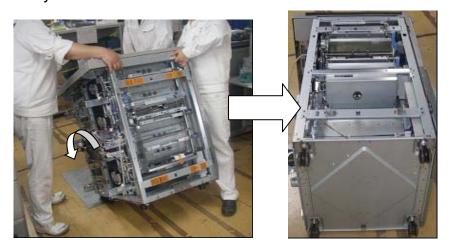
Broken caster on the following LCITs:

One lot of casters was manufactured with an incorrect molding process, resulting in lower durability.

3. Replace the broken caster with a new one. (Screw x4)
